Construction Safety

SSC Construction Inspection
Safety Findings/Stats

January 2017

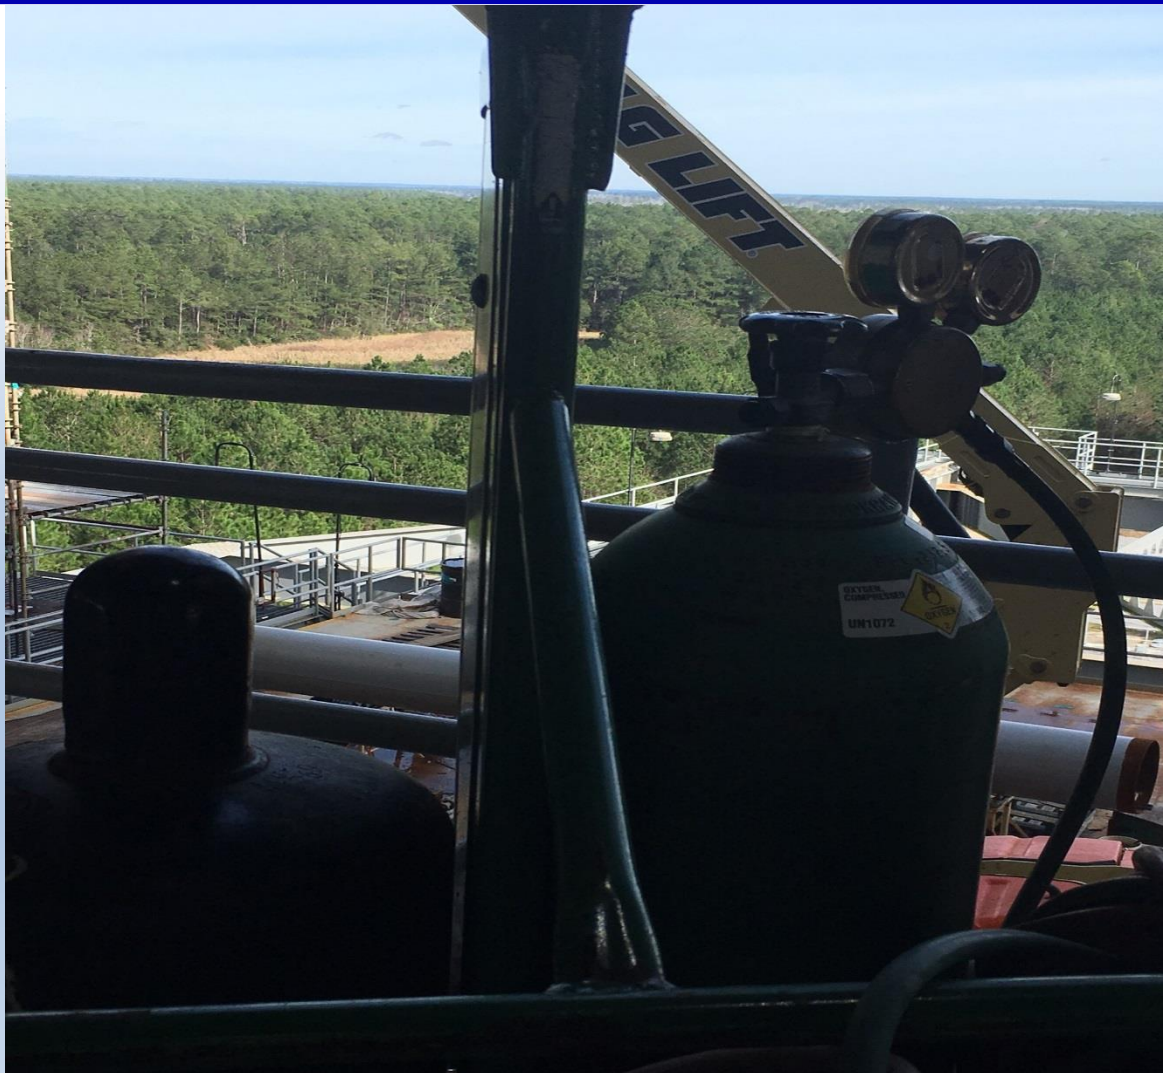
- **B2 WP3** – Stored unused oxygen cylinder without required protective valve cap
Ref: 29CFR1910.253 (b) (2) (iv)
- **B2 WP3** – One employee failed to follow the Lock out/Tag out requirement by failing to place his lock and tag as required. Ref: 29CFR1910.147 (F)(3)(ii)[d]
- **ATTC** – An employee failed to wear approved PPE footwear. He was wearing a cowboy style pointed toe work boot. SCWI-8715-0001 PPE states: Pointed toe cowboy style safety boots are NOT permitted because of the inadequate protection afforded to the foot behind the limited cup of the pointed toe. Shall meet ASTM F2412-11 and F2413-11 requirements.

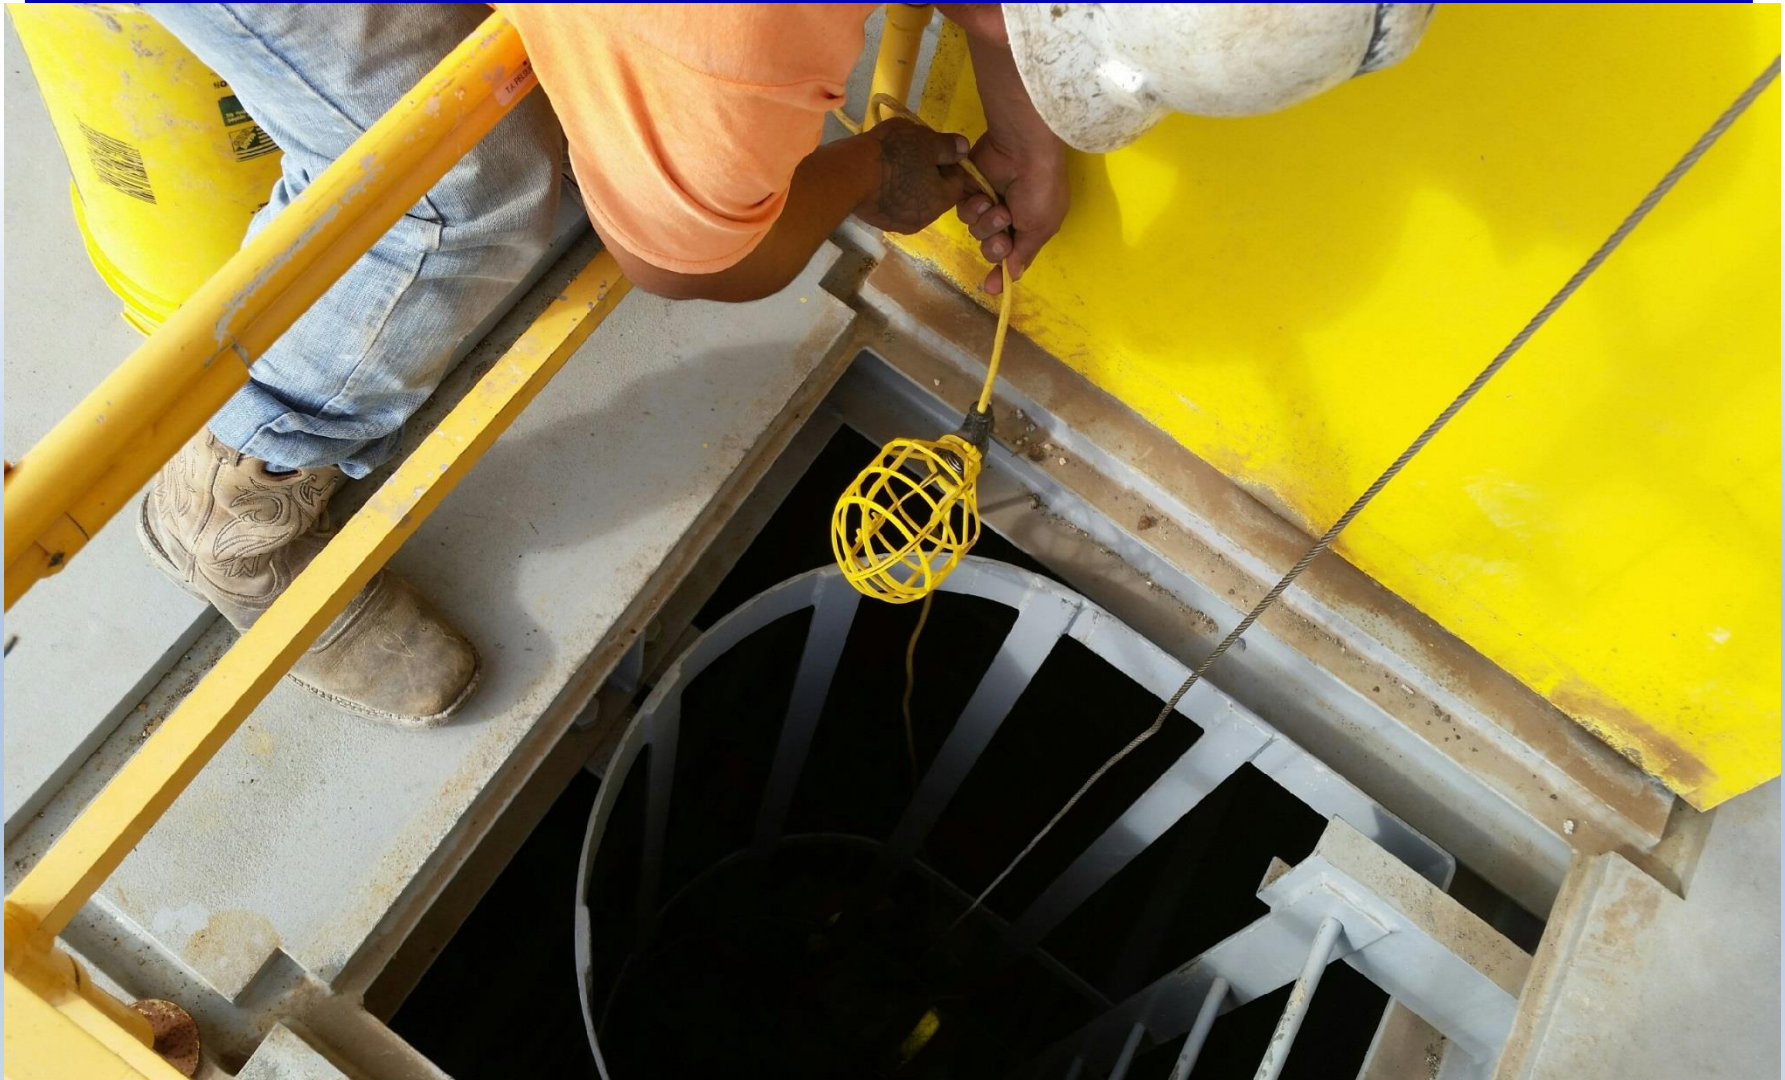
- **B2 Tarmac:** The attendant assigned to the confined space operation at the pipe gallery failed to maintain constant verbal contact with the entrants. He was playing on his phone not paying attention to entrant activities. When asked how do you contact the entrants he stated, “ I don’t know”. The contractor safety representative brought over two portable radios for the attendant and the entrant supervisor. SCWI-8715-0004 Section 4.5.3 Item L SHEtrak Closed

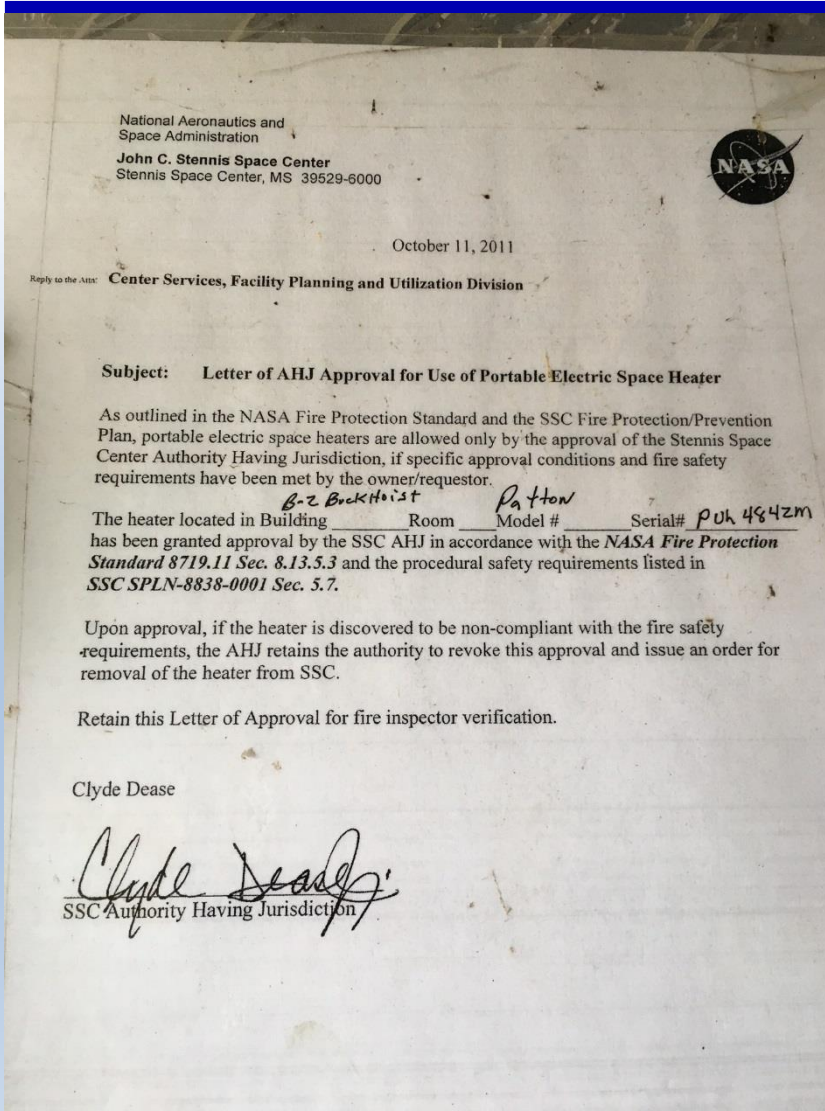
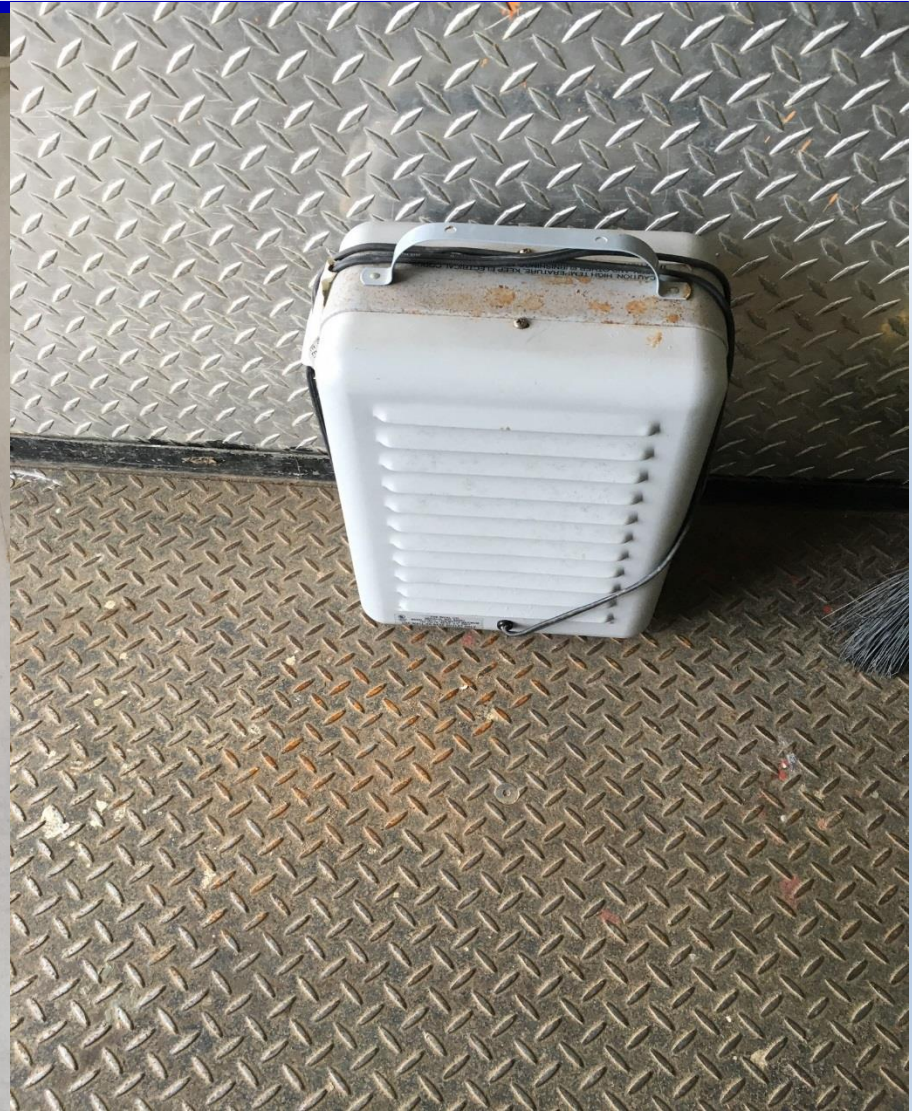
- **B2 Tarmac:** Contractor was using a temporary light stringer in the pipe gallery. The light stringer was energized and one light bulb casing was missing a bulb rendering that casing energized with an unprotected energized socket. 29CFR1926 (j)(1)(i) SHEtrak Closed.
- **B2 WP3:** Contractor replaced the approved listed heater for a heat producing device in the buck hoist. This requires them to obtain a new letter of approval and SSC Form 221 permit. SSC SPLN-8838-0001 Sec 5.7.11

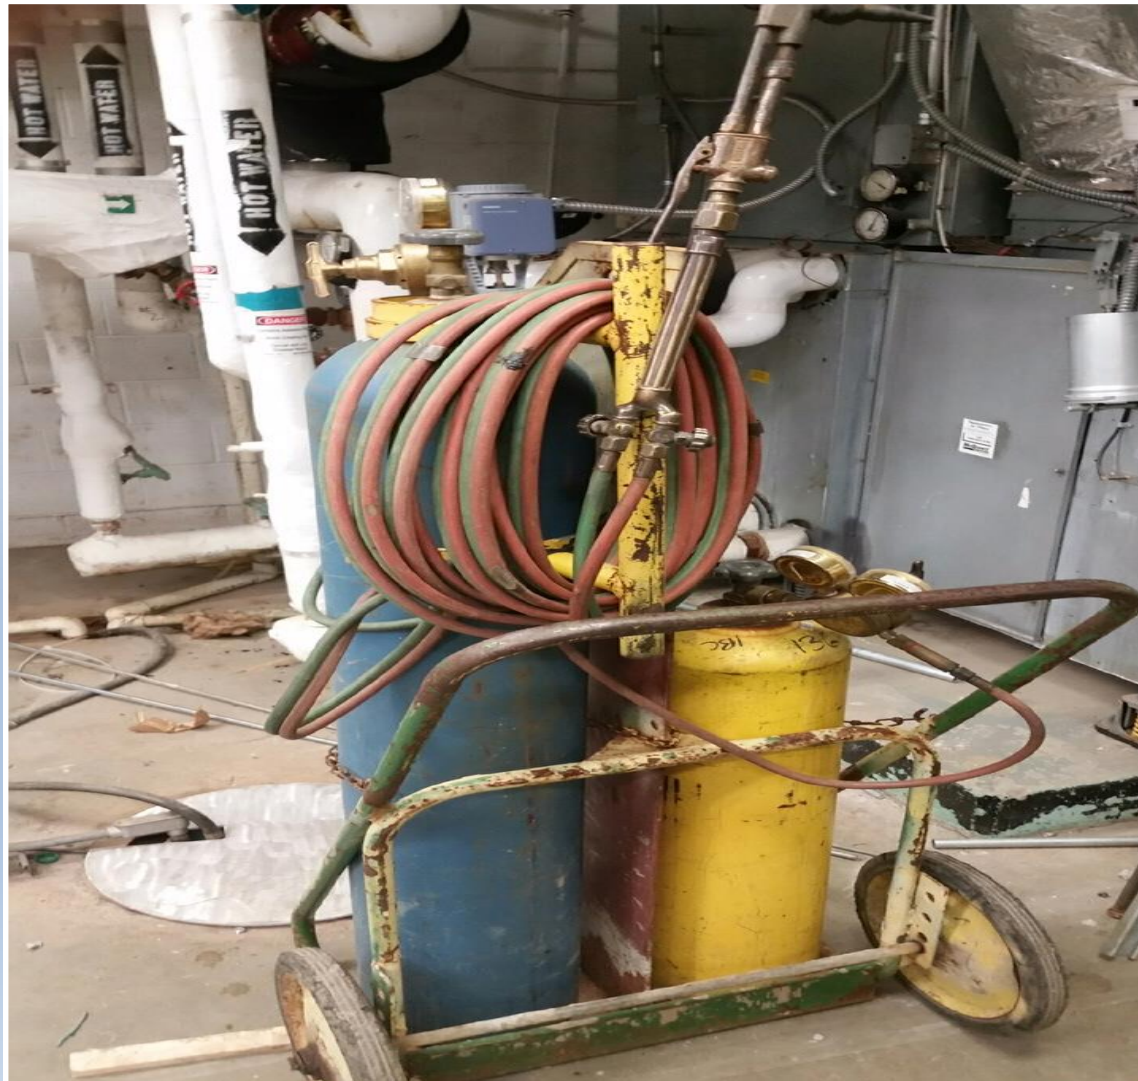
- **ATTC HVAC:** Contractor failed to properly store gas cylinders as required by removing gauges and applying protective caps. Ref: 29CFR1910.253 (b) (2) (iv) SHEtrak Closed
- **Bascule Bridge:** Contractor failed to perform the required OSHA weekly First-Aid kit inspections resulting in the cabinet having several expired products. 29CFR1926.50 (d)(2) SHEtrak Closed

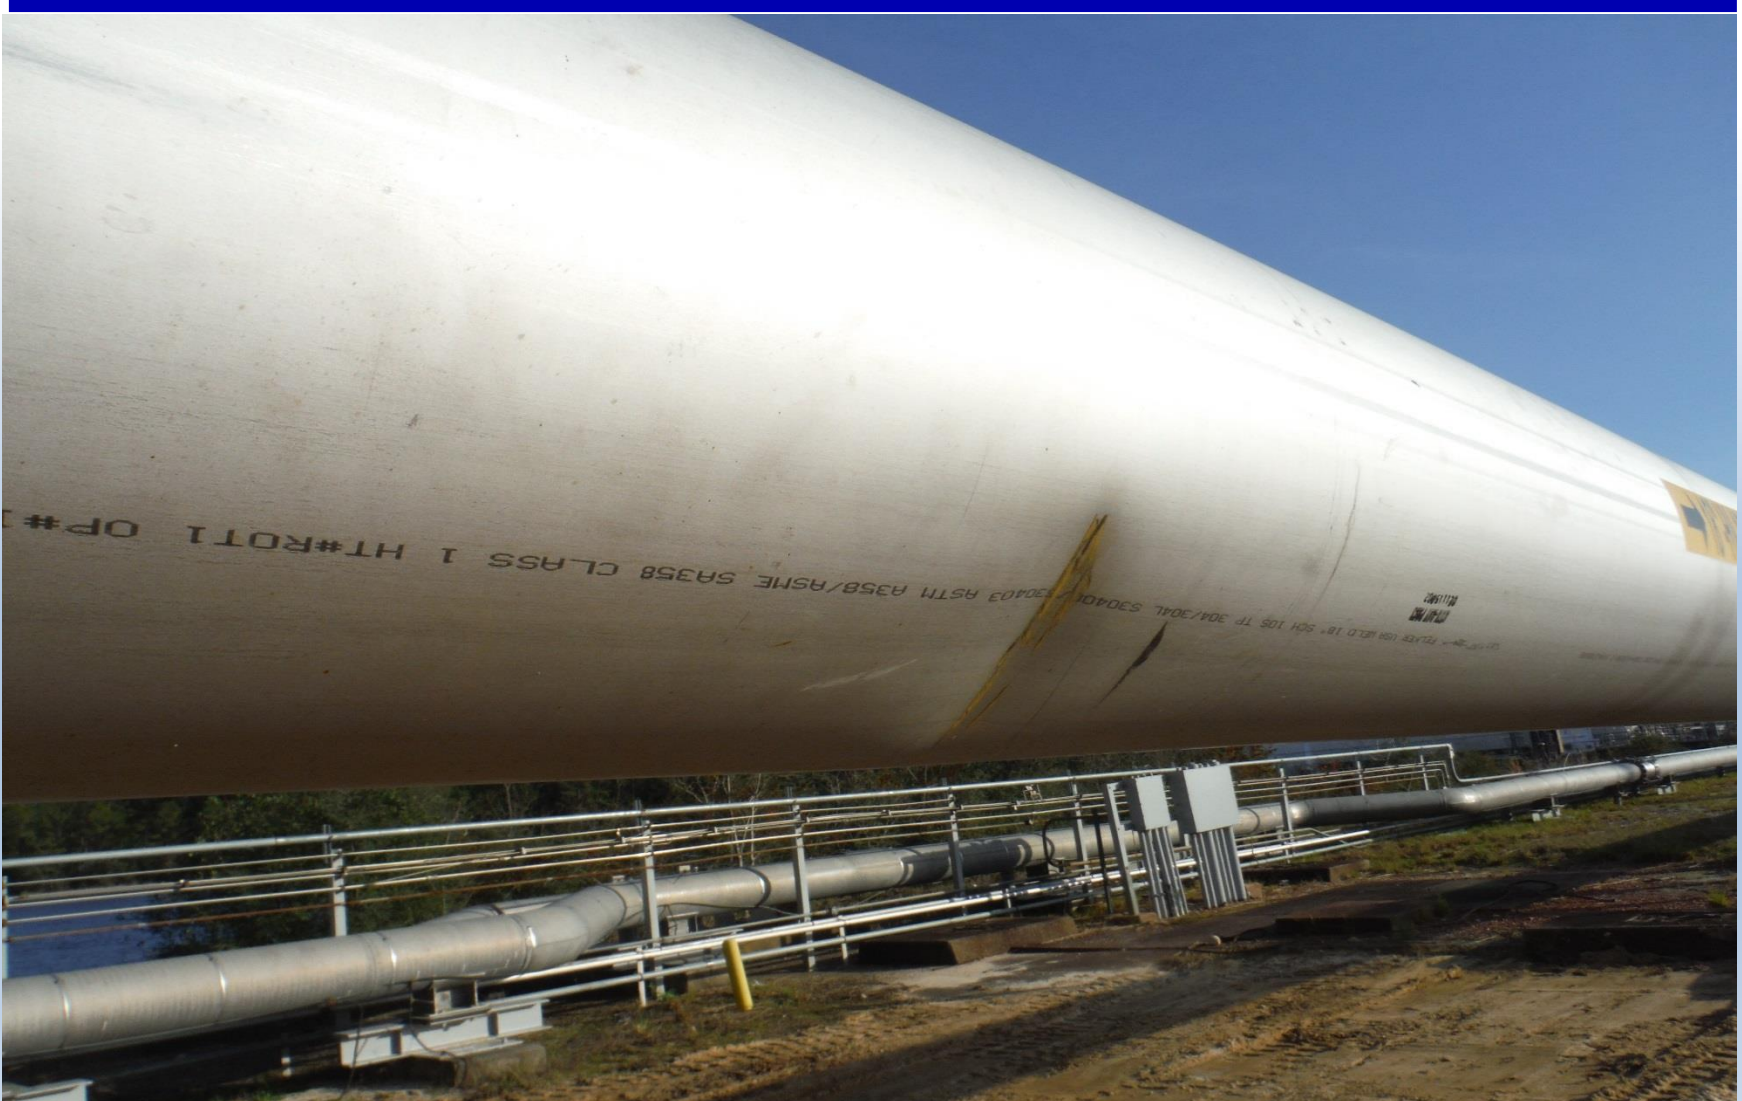
B2 Tarmac: Contractor struck and dented the 18 inch diameter hydrogen vent line with a piece of heavy equipment while performing earthwork operations. Currently under investigation. NIMIS entered

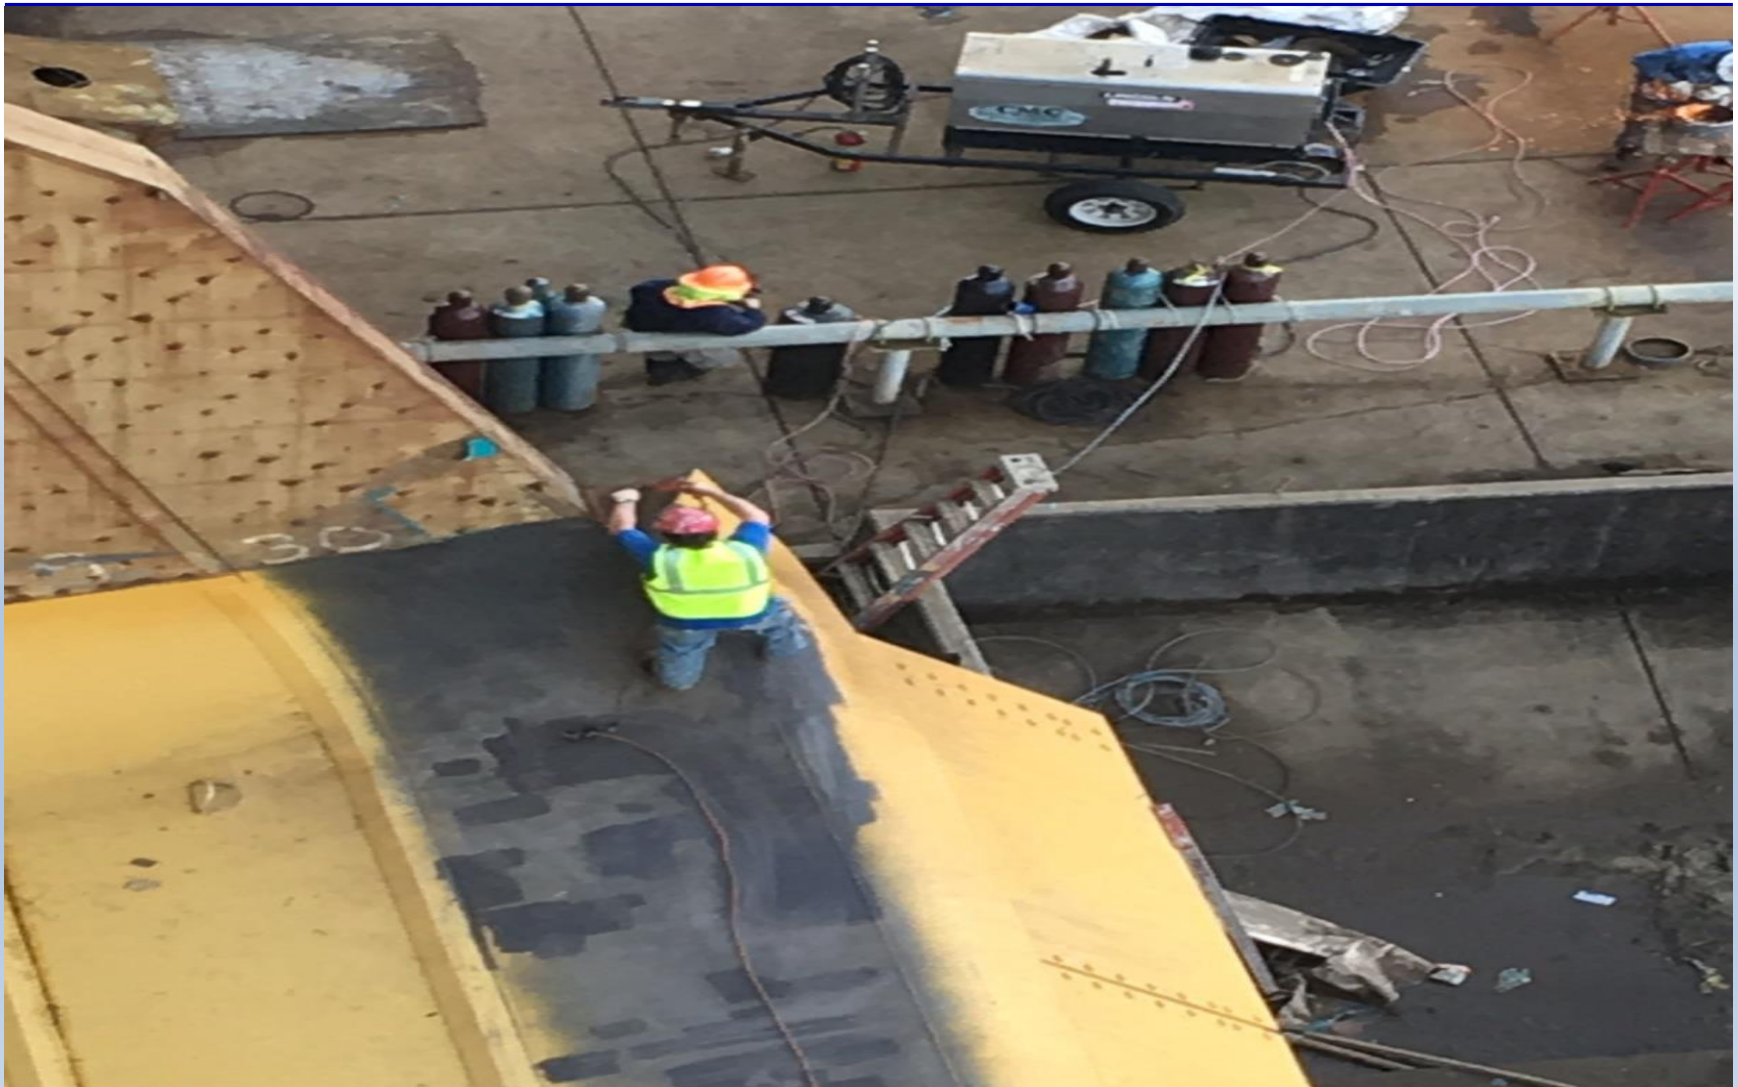
- **B2 WP3** – Contractor failed to meet fall protection requirements when exposed to a fall to a lower level. SCWI-8715-0008 Section 5.2 Item a. SHEtrak Closed.
- **B2 WP3** – A welding lead positive cable voltage between 70 and 100 volts was skinned as it was being pulled over a sharp metal edge causing an arc. Cable was repaired on the spot and a protective pad was placed over the rough metal area. SHEtrak Closed

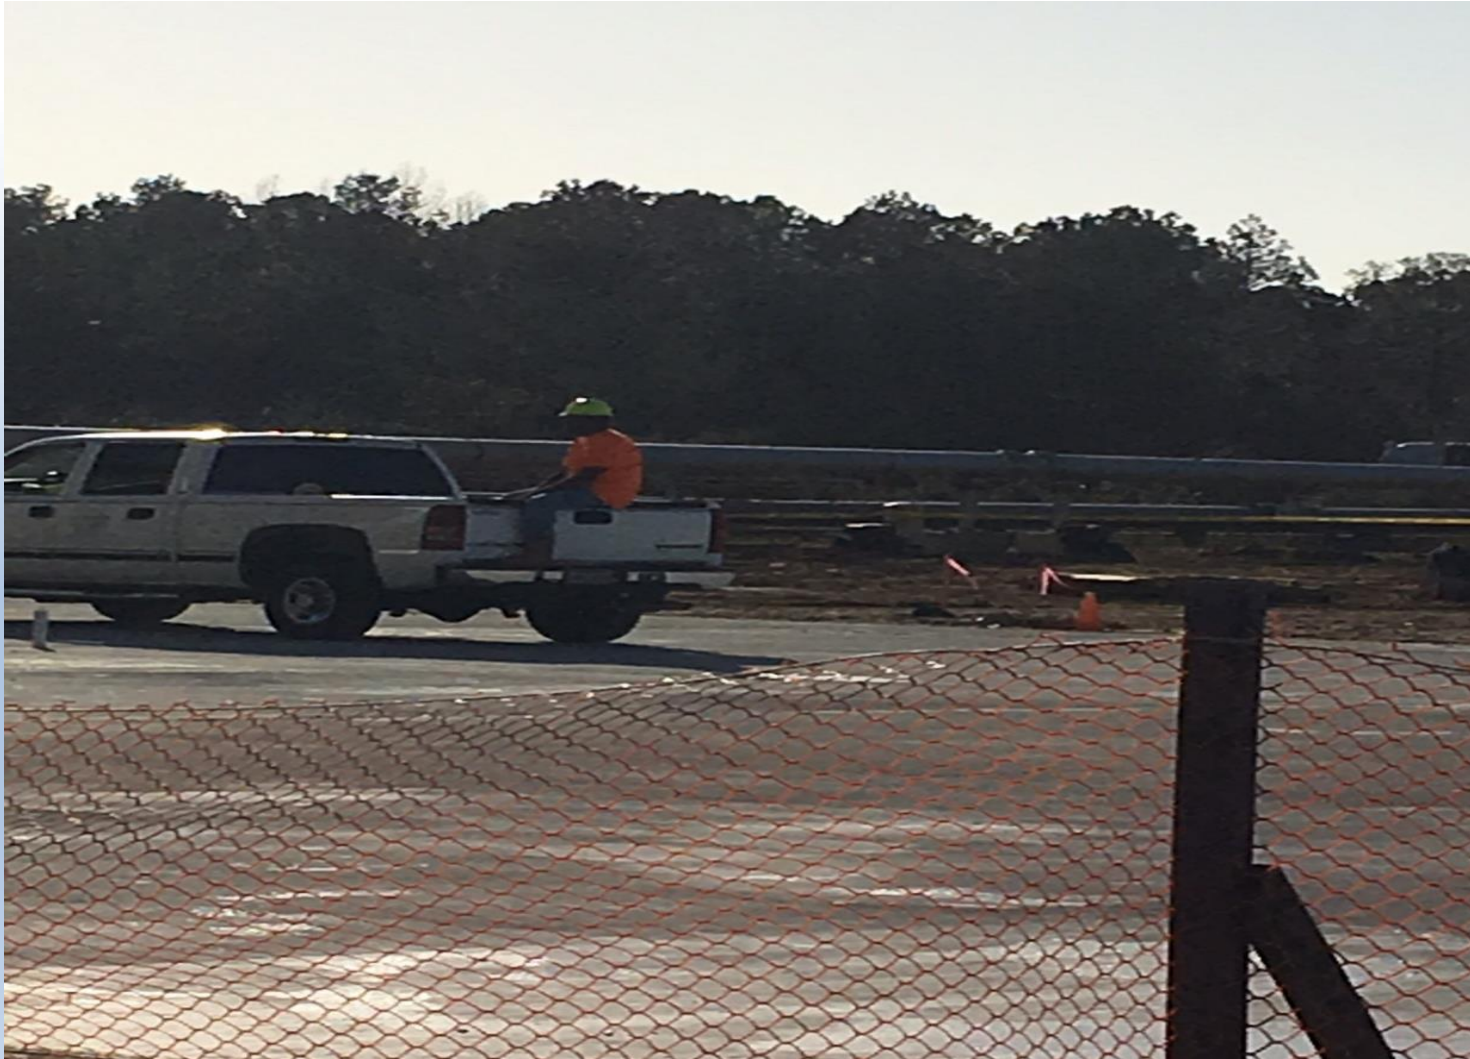
- **B2 WP3** – Contractor failed to properly use a Ground Fault Circuit Interrupter. 29CFR1926.404 (b)(1)(ii) SHEtrak Closed
- **B2 Tarmac** –An employee was observed riding in the bed of a truck not equipped with a seat and seat belt. 29CFR1926.601 (b)(8) SHEtrak Closed
- **Demolition Bldg. 4302:** Contractor employees failed to meet SSC requirements of attending Gulf Coast Safety Counsel Training to work at SSC. SCWI-8715-0008 Paragraph 6.3.1 Items 1 and 2. SHEtrak Open.

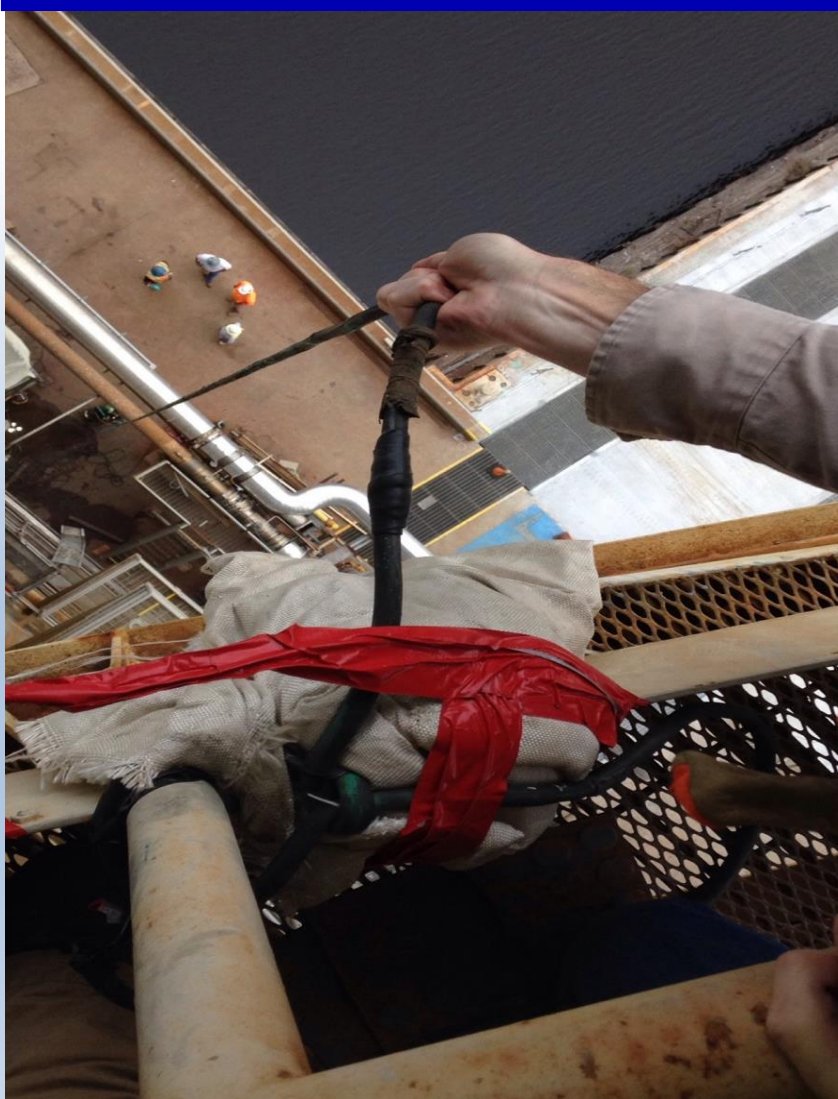
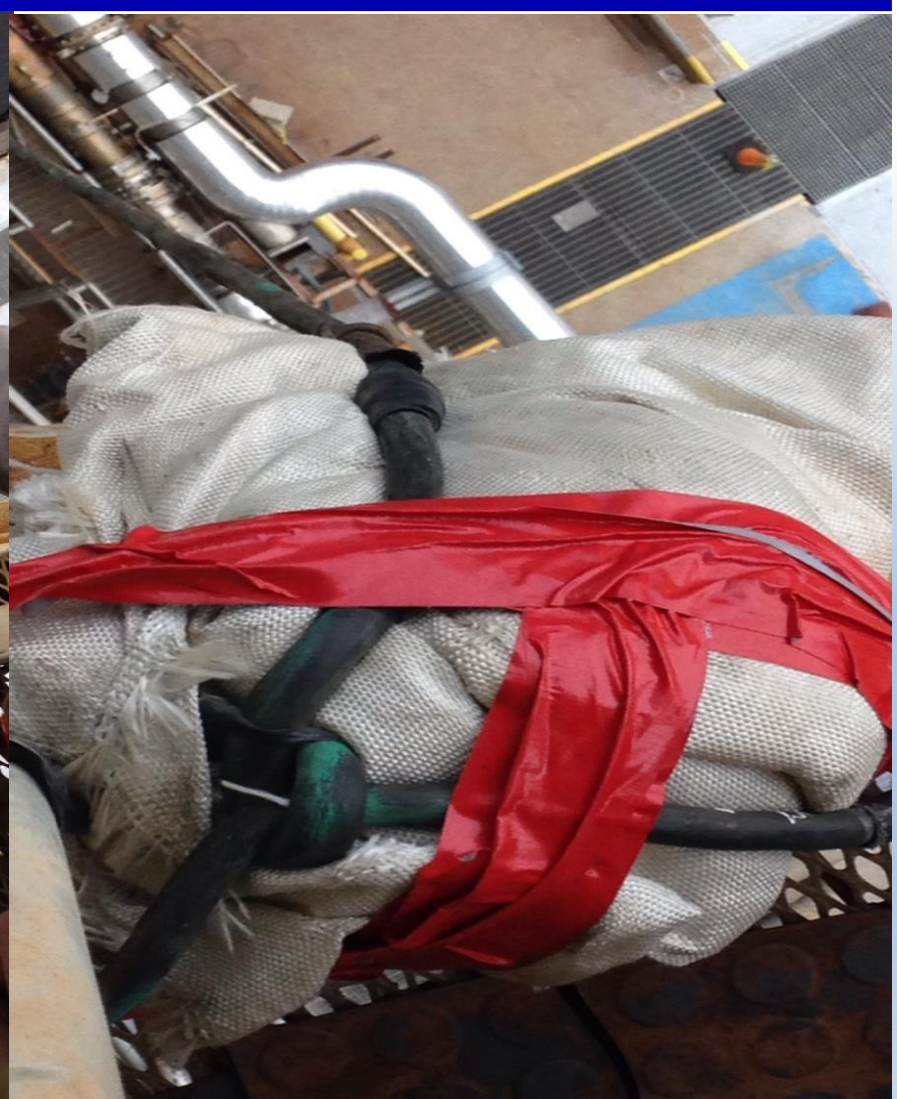
- **Demolition Bldg. 4302:** Contractor failed to prepare an Activity Hazard Analysis on definable features of work prior to work commencement. SCWI-8715-0008 Section 6.5 Paragraph 6.5.1 Item 1. SHEtrak Closed
