# SSC Construction Inspection Safety Findings/Stats

# January 2011

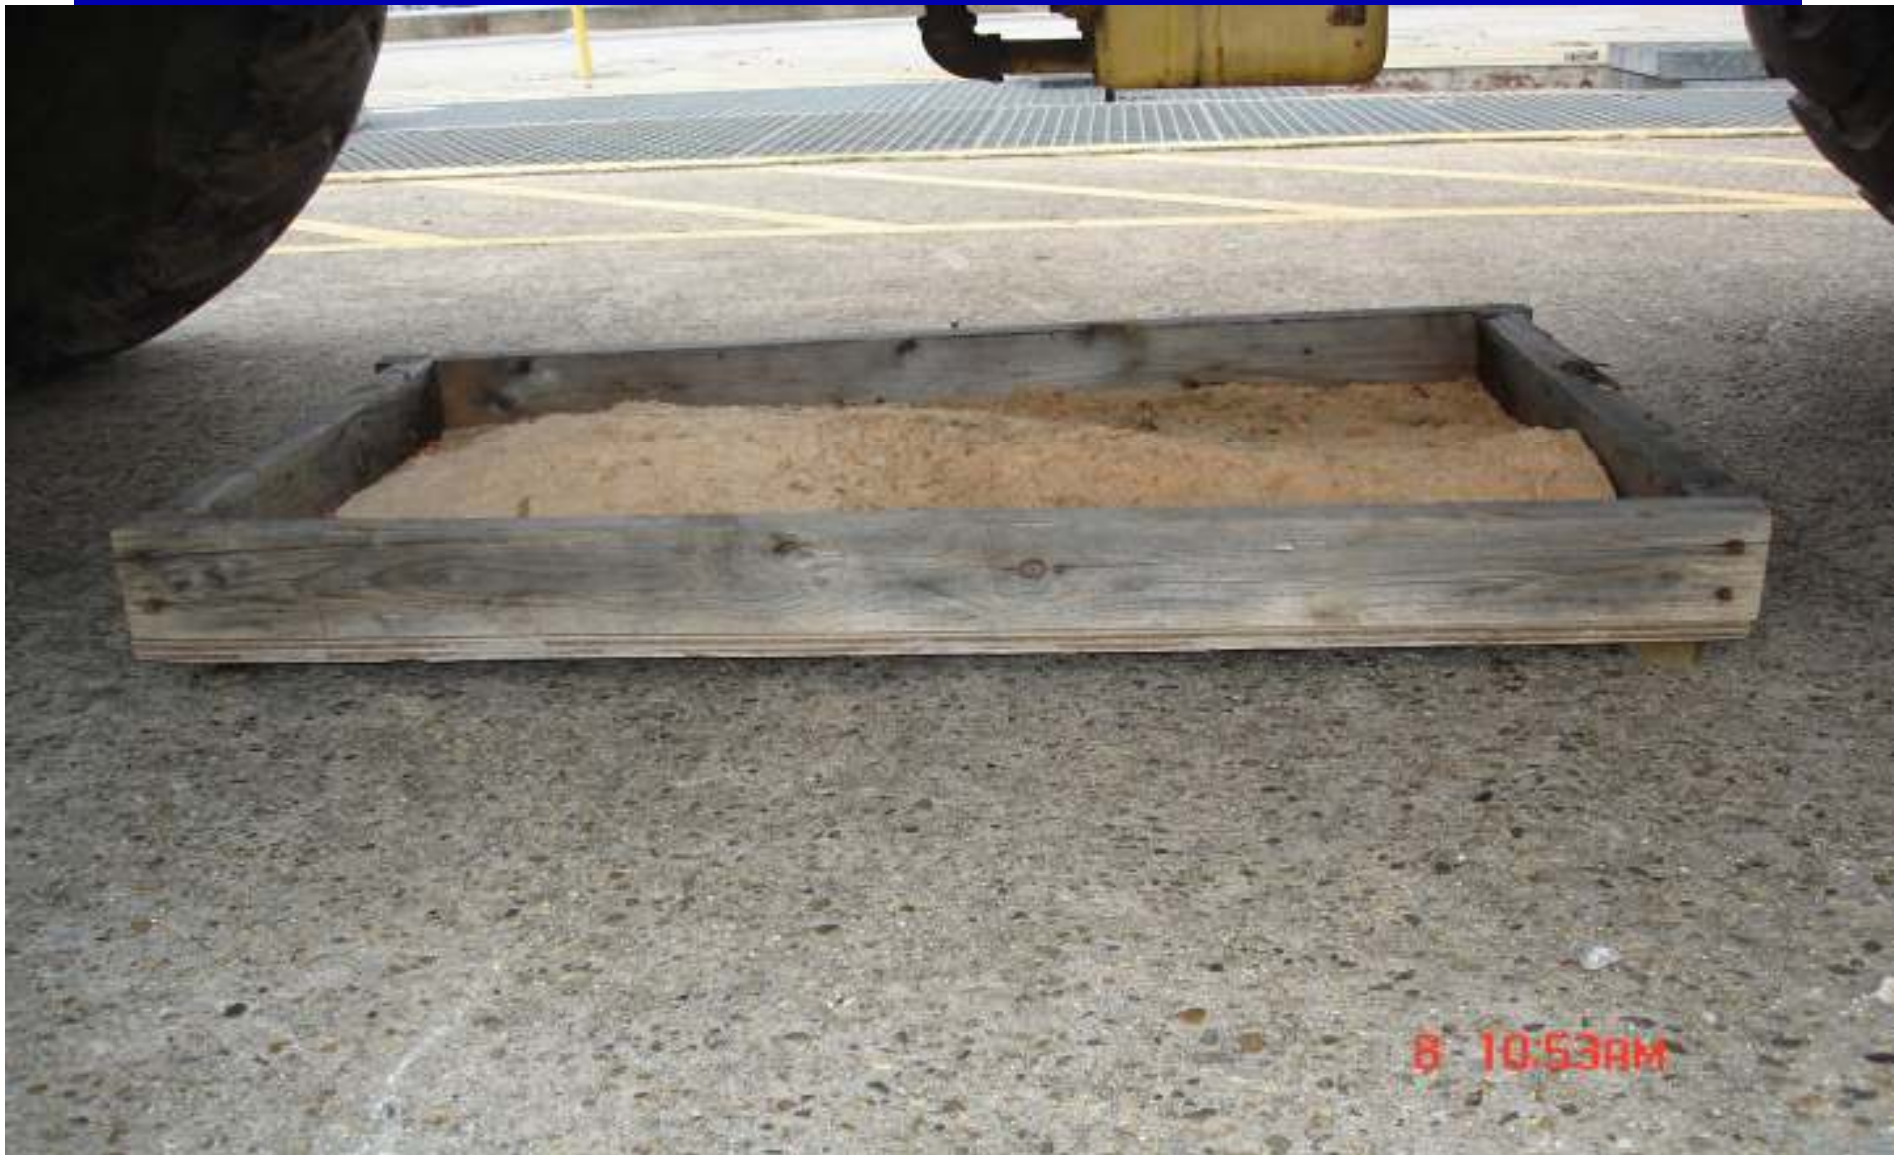
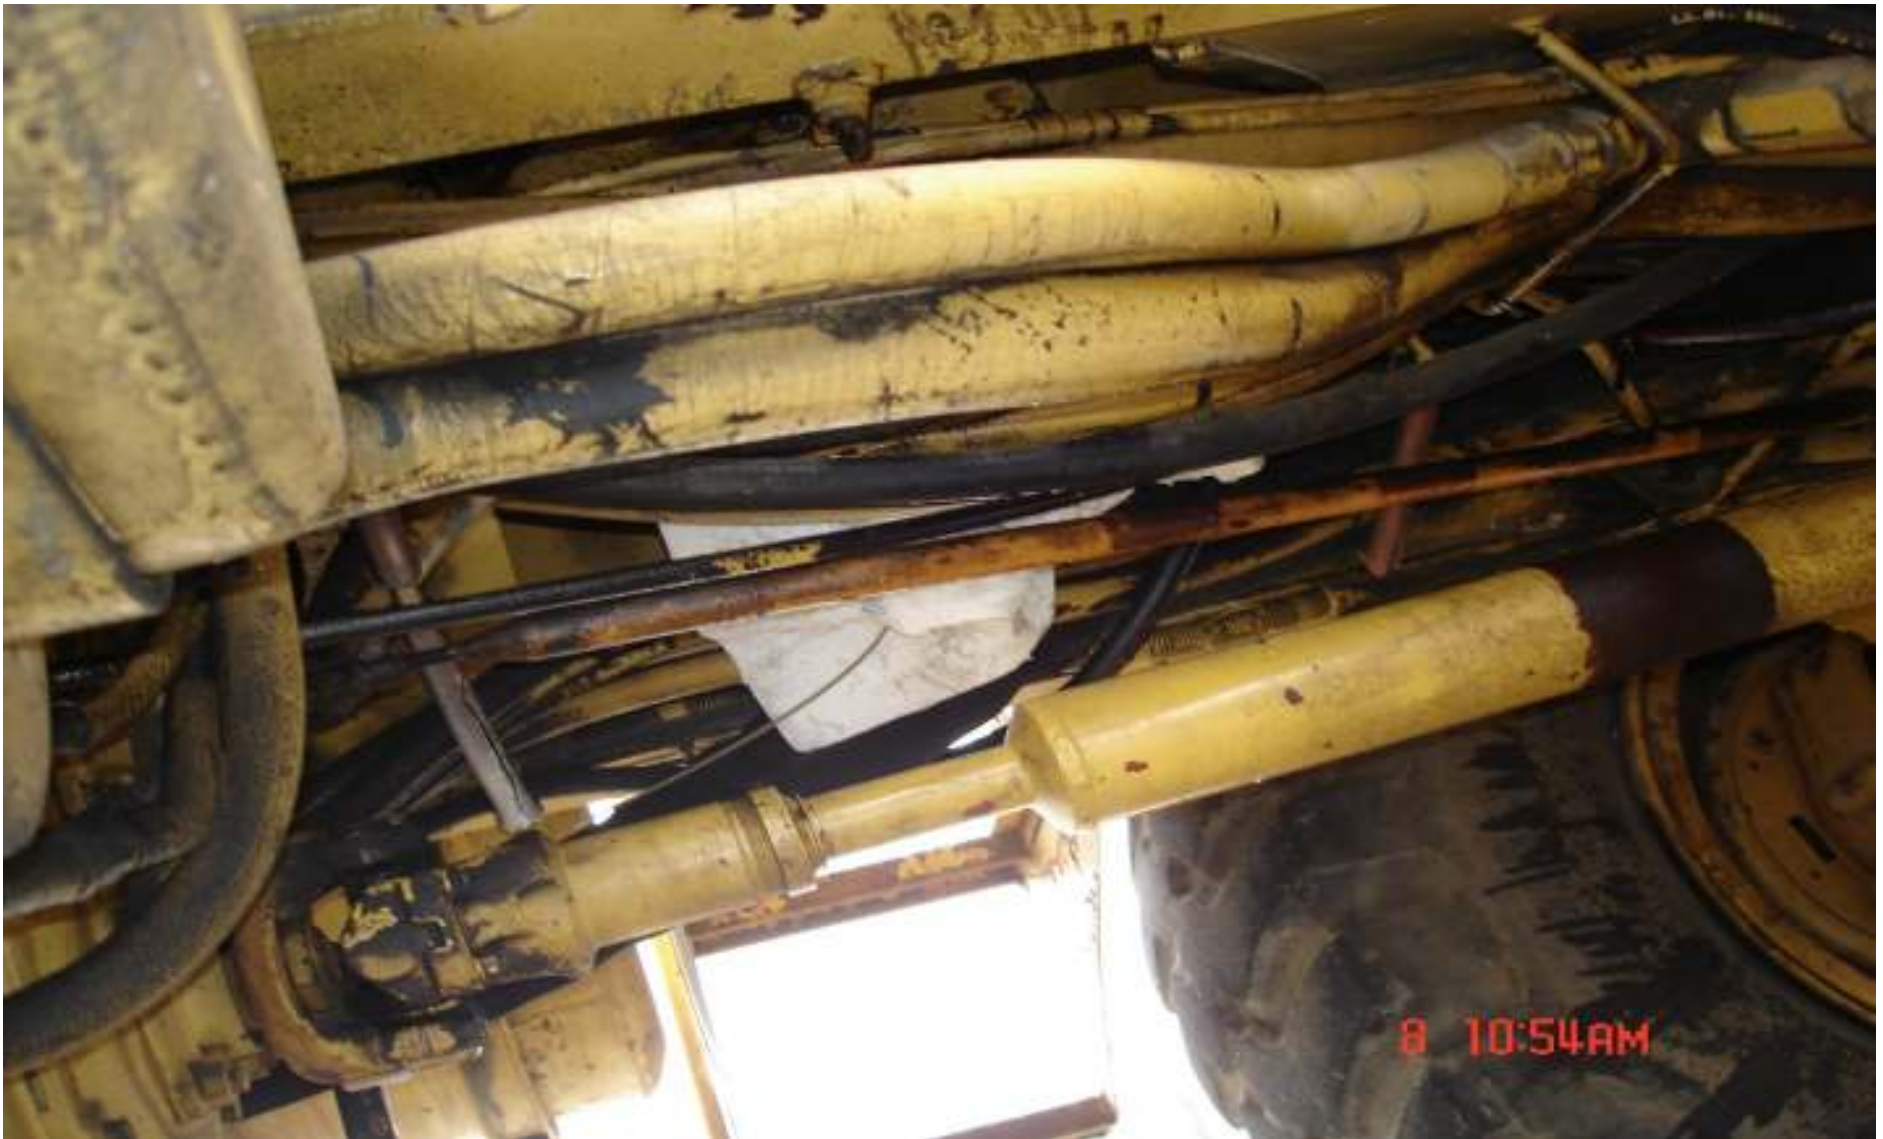
Crane 1

- While conducting an audit of Trans-Gulf Constructors, it was noted that the two grove RT-58D cranes were leaking hydraulic fluid; the foreman was asked to investigate the issue. A mechanic was site to investigate and measures were taken to contain the leaking hydraulic fluid.
