Construction Safety

SSC Construction Inspection
Safety Findings/Stats

February 2017

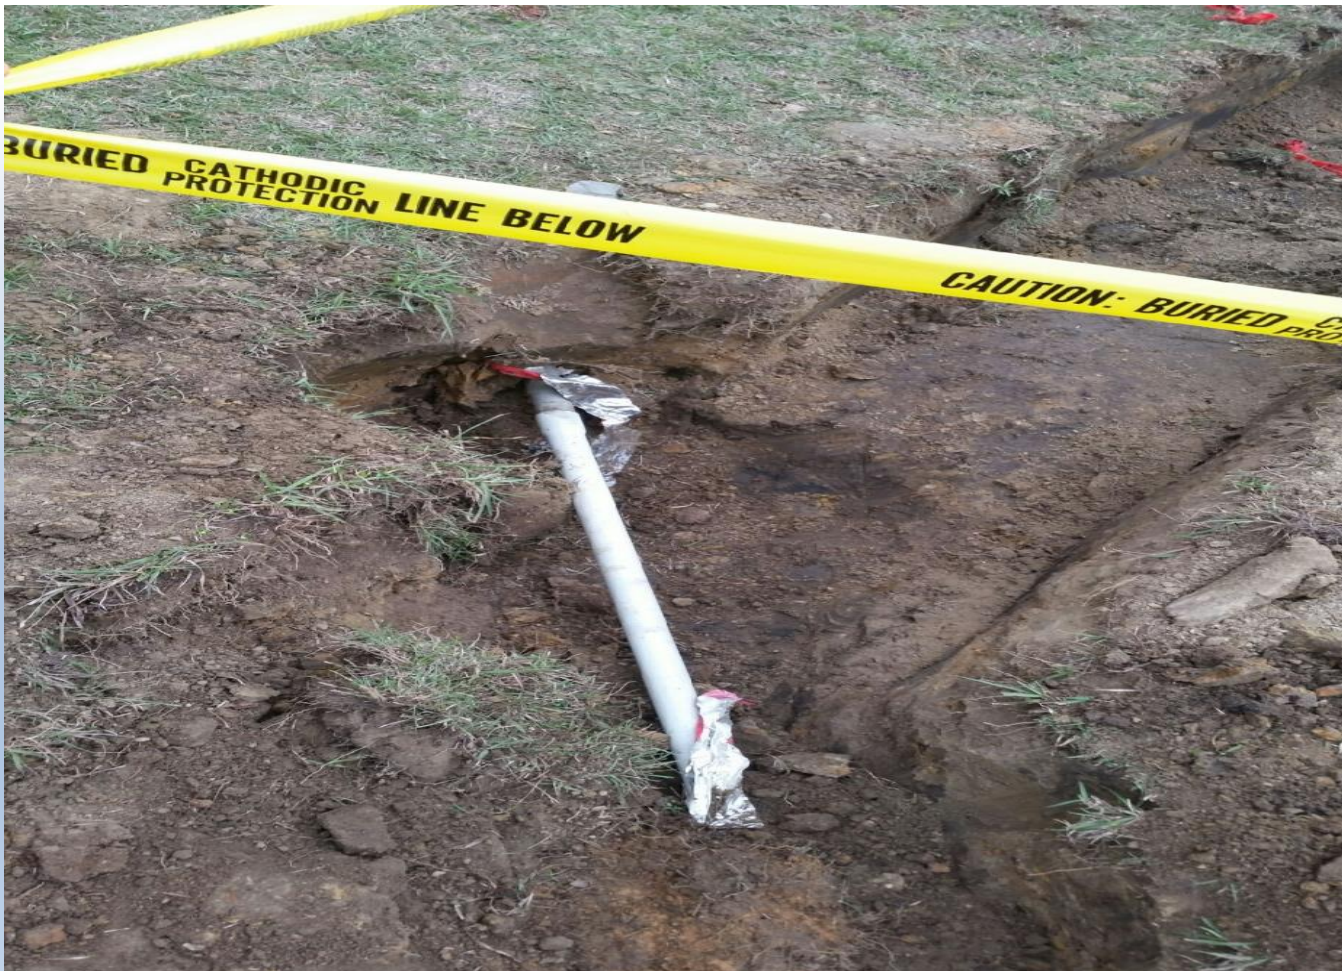
—**Cathodic Protection**: While in the process of excavating dirt attempting to locate an identified buried 110 volt electrical line behind Building 4010, the contractor struck the buried $\frac{3}{4}$ " electrical pvc conduit with a mini-excavator and cracked the outer casing. No internal electrical wires were exposed or damaged. Their initial probe found an obstruction at a depth of 3 feet which the contractor assumed was the marked electrical line. The contractor continued to probe and dig 1 inch at a time, missing the actual conduit buried at 18 inches. The line was hit at 18 inches, the electrical breaker was located and turned off, then locked and tagged out for repairs. SSC 1627 Close Call initiated.

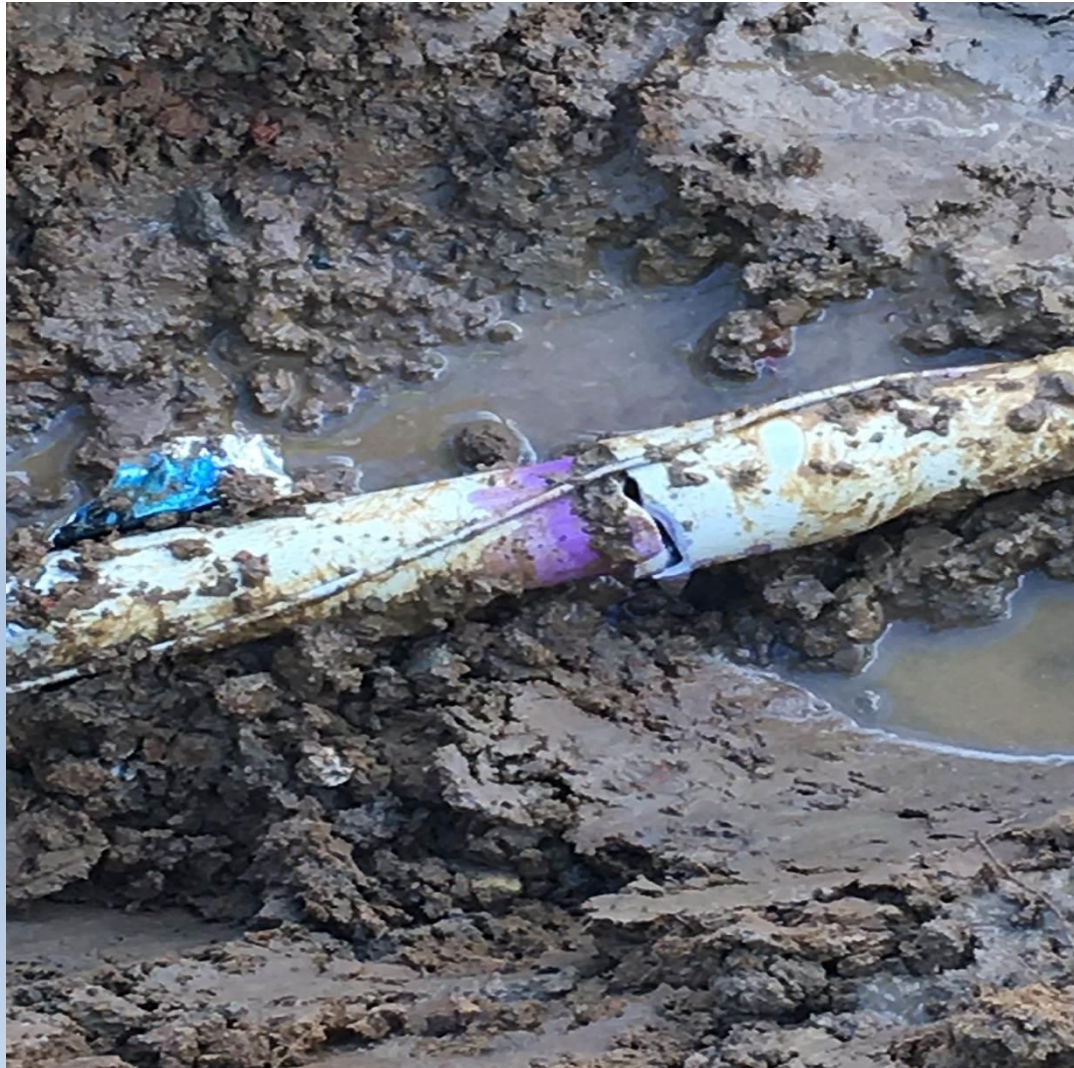
- **Cathodic Protection:** While in the process of excavating dirt behind Building 4010, the contractor struck and damaged an unmarked and unidentified 1 " pvc water line that fed an emergency shower station at the E-Complex. S3 was notified and made repairs. SSC 1627 was completed.
