Construction Safety

SSC Construction Inspection
Safety Findings/Stats

March 2017

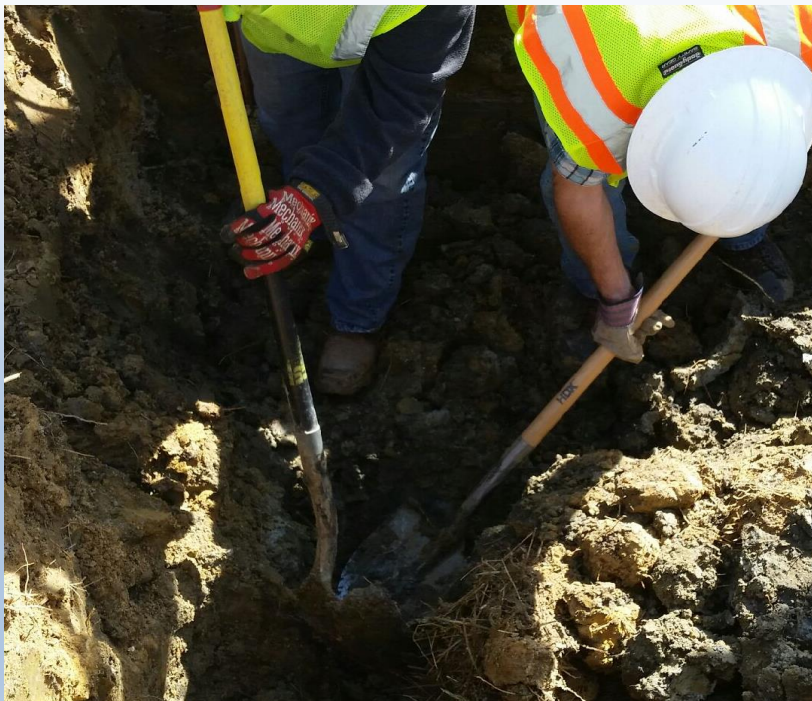
Hand Dig and Locate

Information: Contractors following proper procedures to locate underground 13,800 volt duct bank after issued permit with map and imaging. **NOTE:** No deviations from proposed and approved dig area drawing.

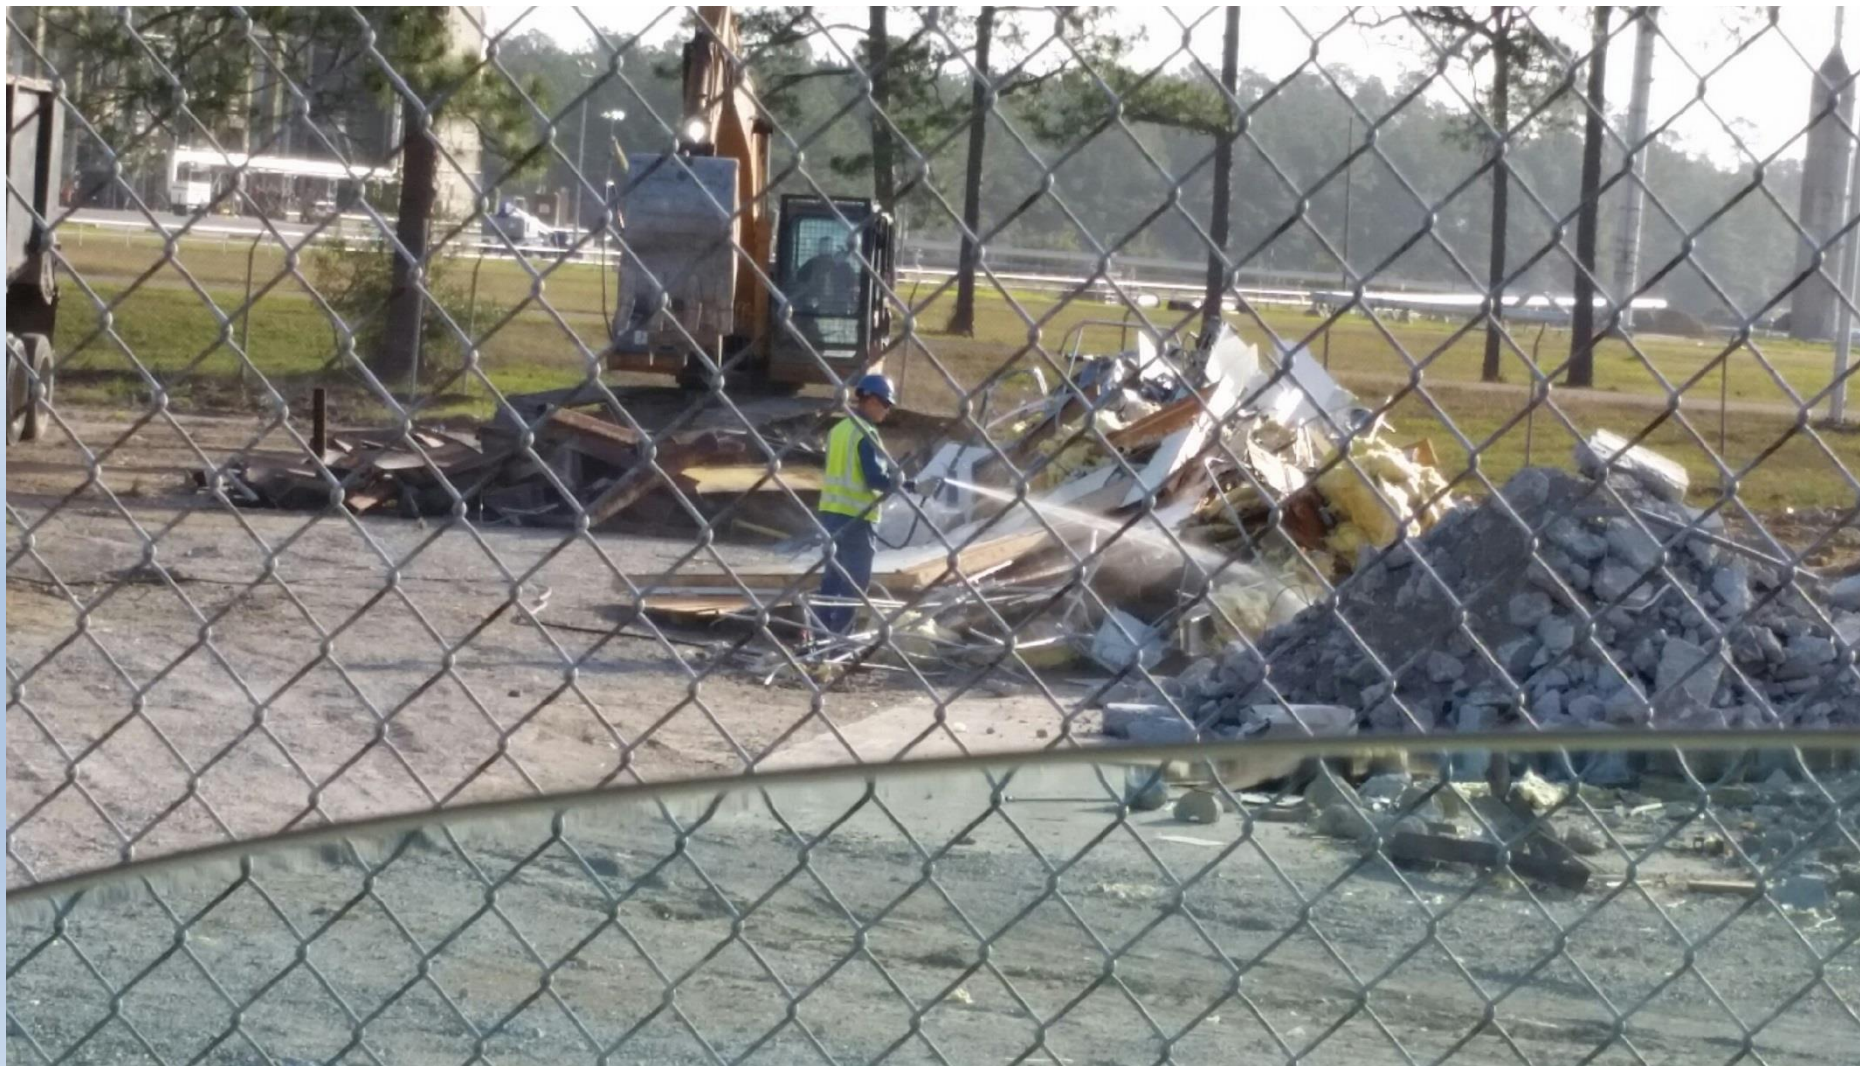
Dust and Sicilia Control

- **Information**: Contractors following proper procedures to wet concrete and debris during demolition and debris loading at bldg. 4302

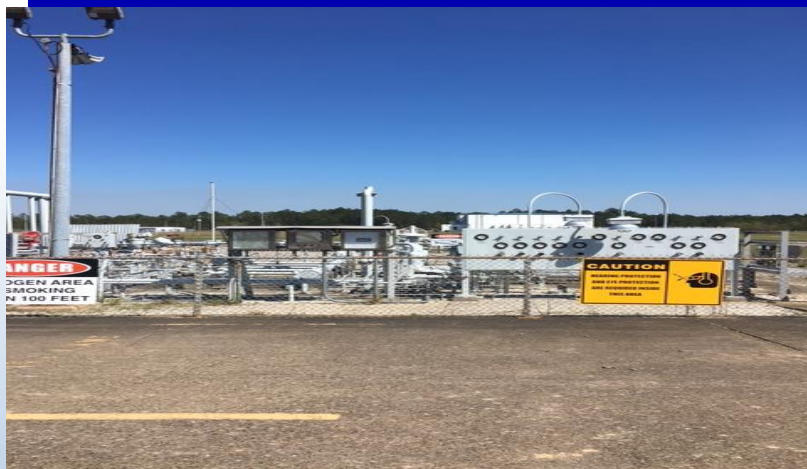
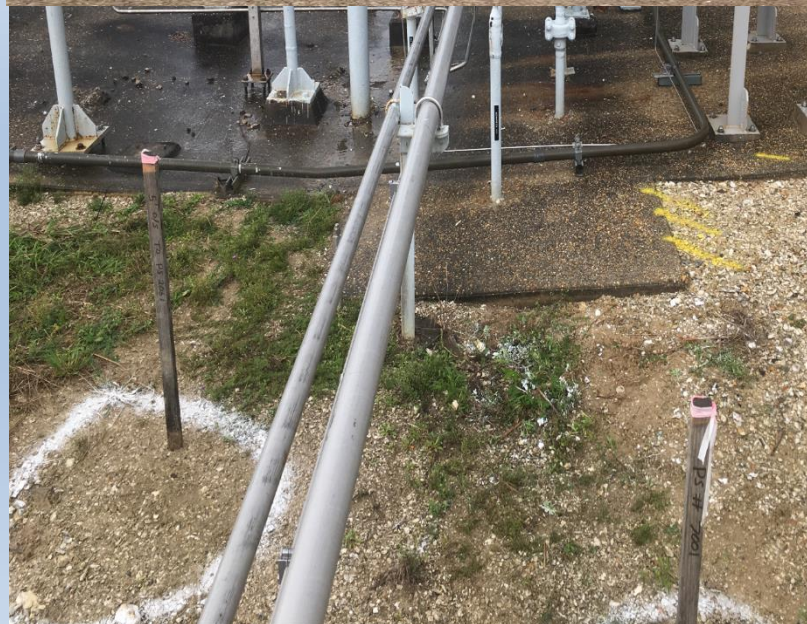
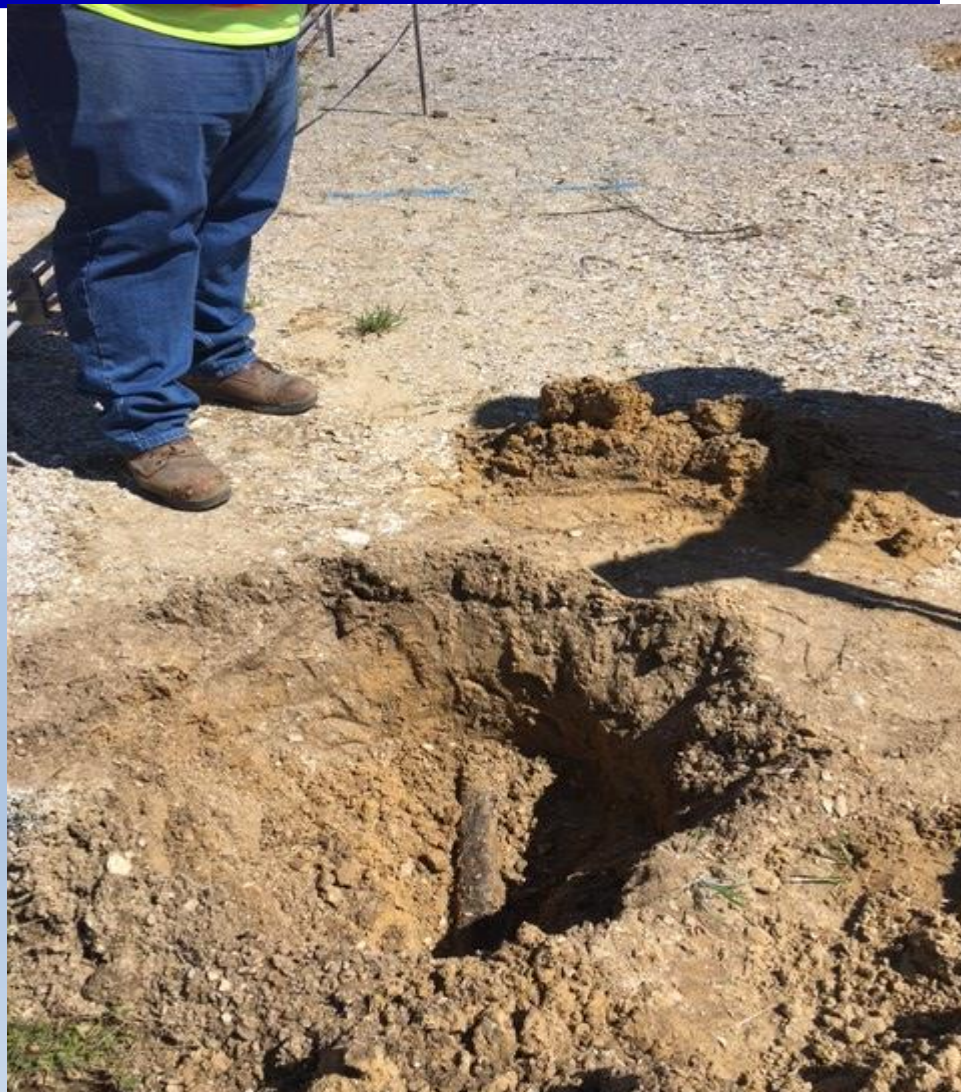
On 3/15/17 at 2:15pm a contractor in the A-2 PRA was drilling into the dirt using an auger bit felt resistance and immediately stopped drilling. The contractor extracted the auger bit and probed the area. The contractor then hand dug and visually found a 2 inch buried steel pipe about eighteen inches under grade. The pipe was not identified or marked on the ground or drawings. The proposed dig area was line painted on the ground to be imaged before digging. The status and contents within the pipe was unknown, but was assumed to be either an active or inactive hydrogen, air or nitrogen line. NASA requested the contractor submit a 1627 close call. Recorded NMIS (17-100422) pending closure.

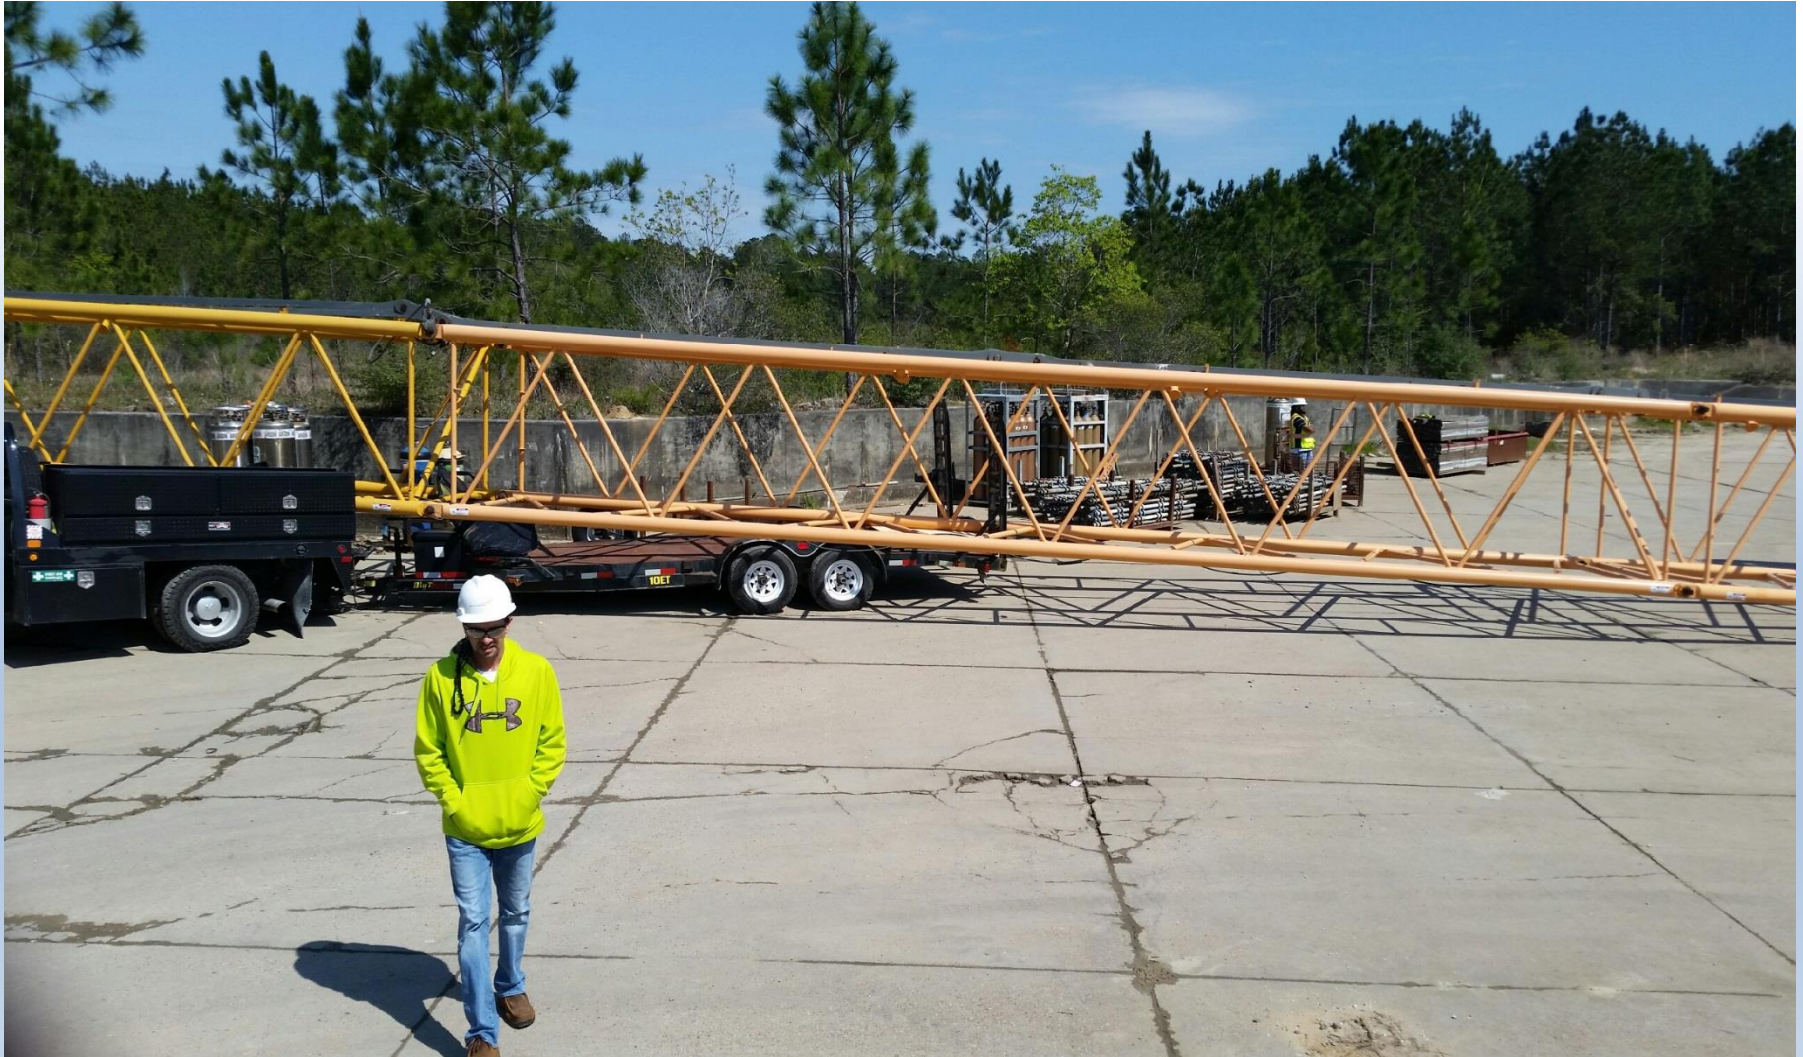
On 3/16/17 at approx. 2:05pm the Liebherr two section lattice boom crane behind the B-2 test stand was being lowered by an S-3 contracted operator for end of shift night storage. Normally, the boom rests in a inverted V position for storage. The operator was positioning the boom to ground when unexpectedly the entire lattice boom began to slowly fall to the ground landing on part of a contractor's truck and trailer. The crane tilted forward elevating its engine and counter weights. There were no injuries! This is a NMIS close call and is currently under investigation.

Top section of crane lattice boom

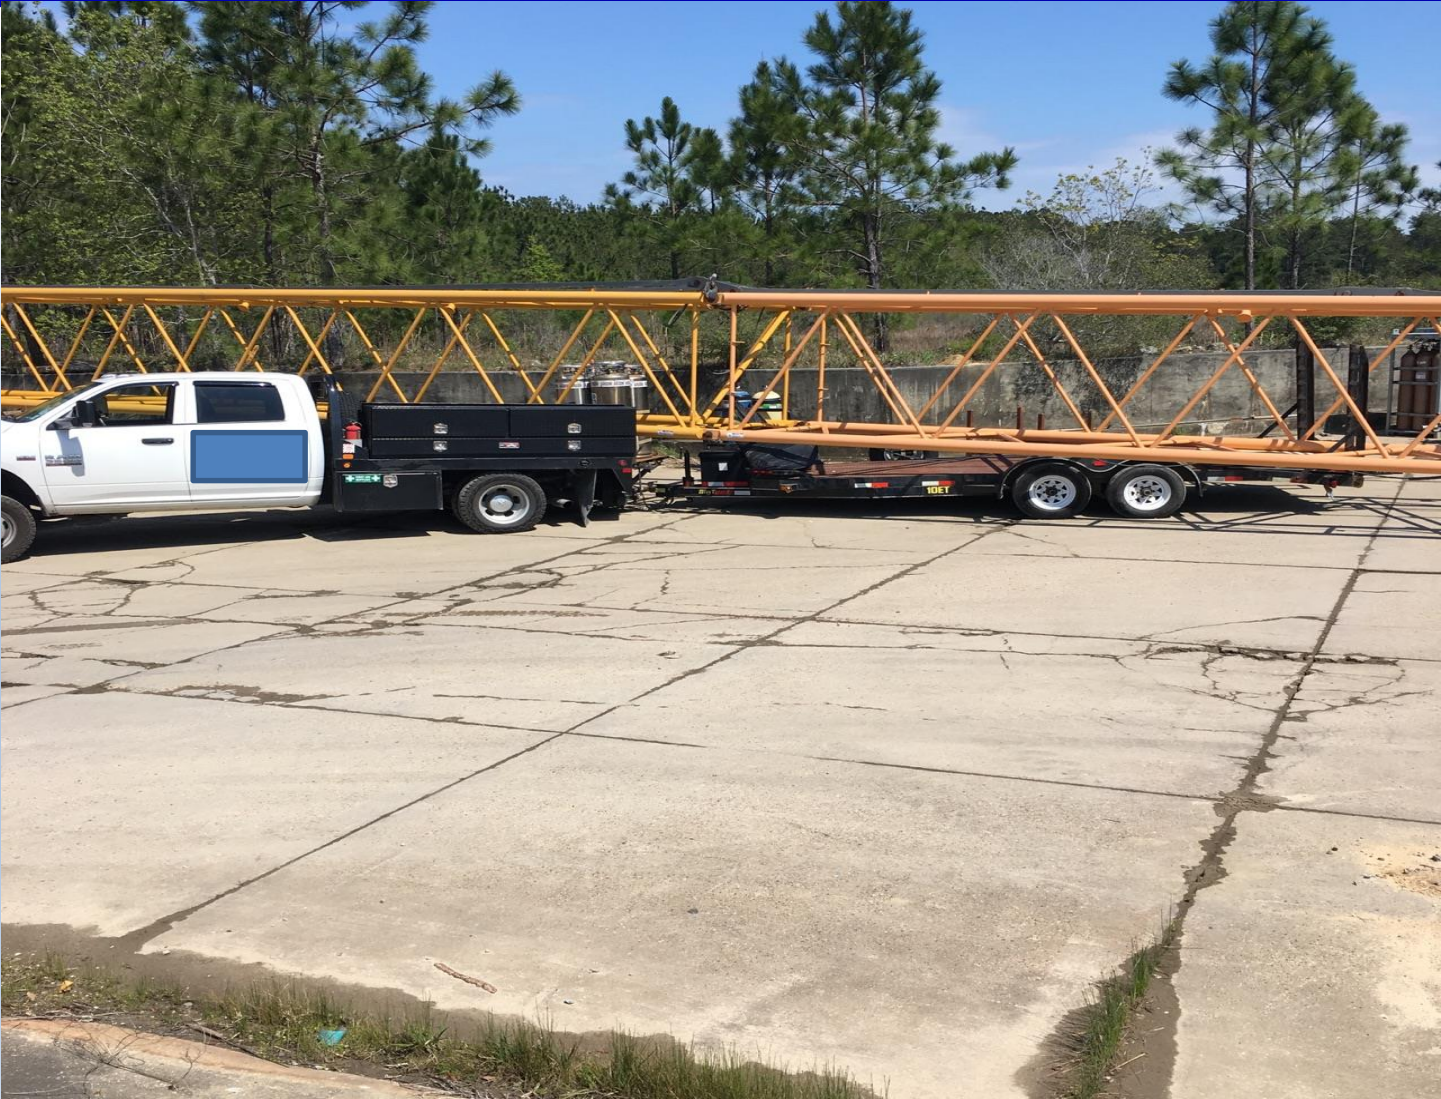
Contractor truck and trailer damage

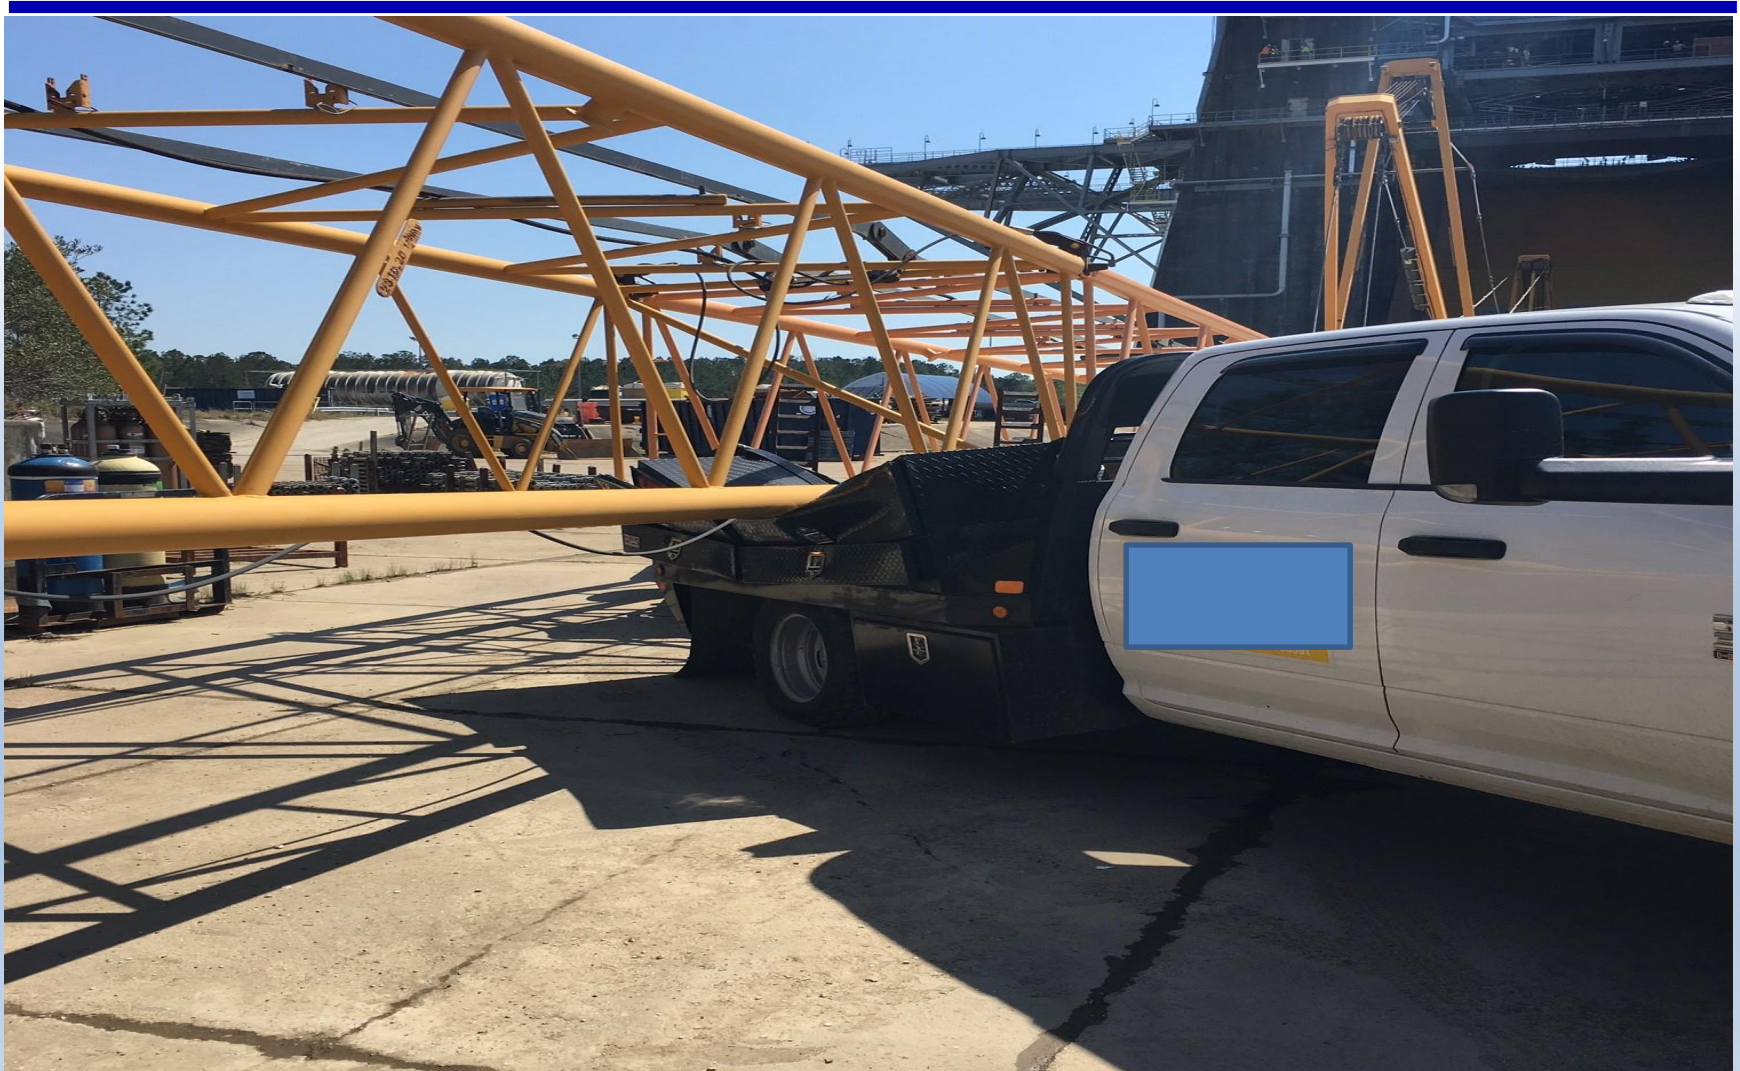
Lattice boom to cab and counter weights

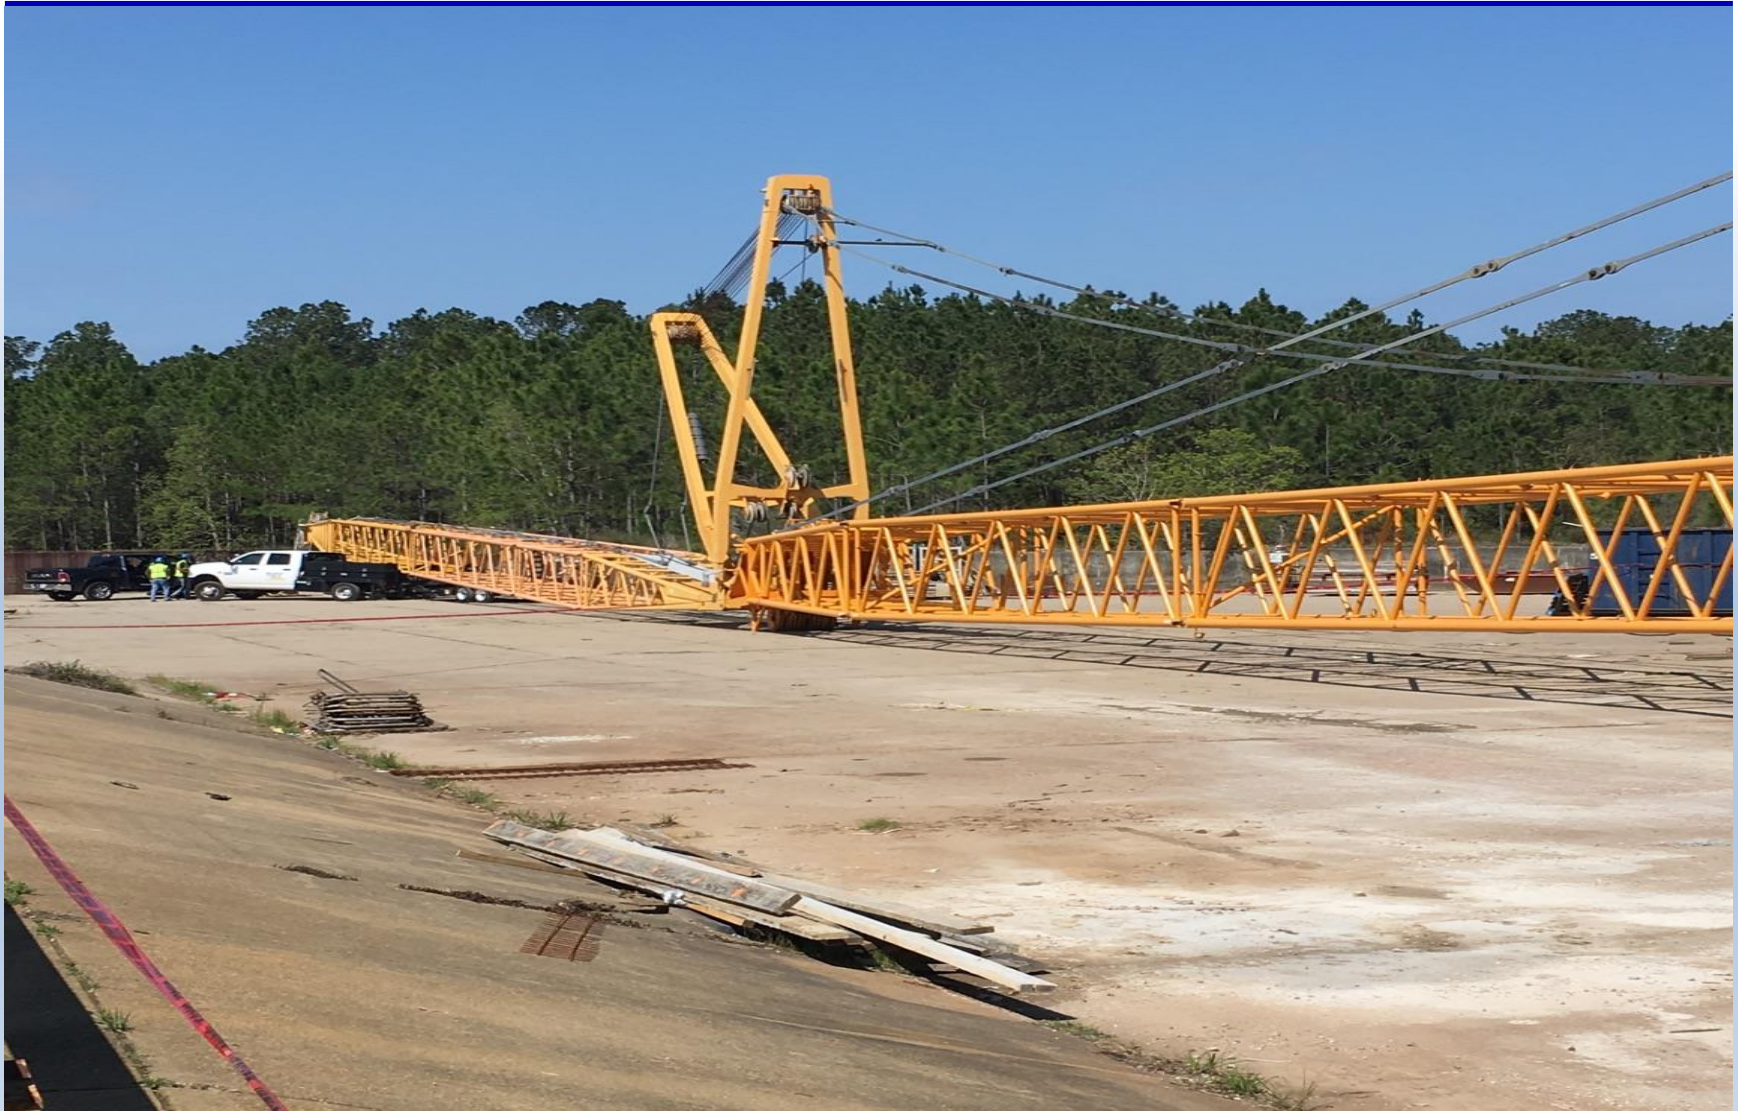
Lattice boom both sections

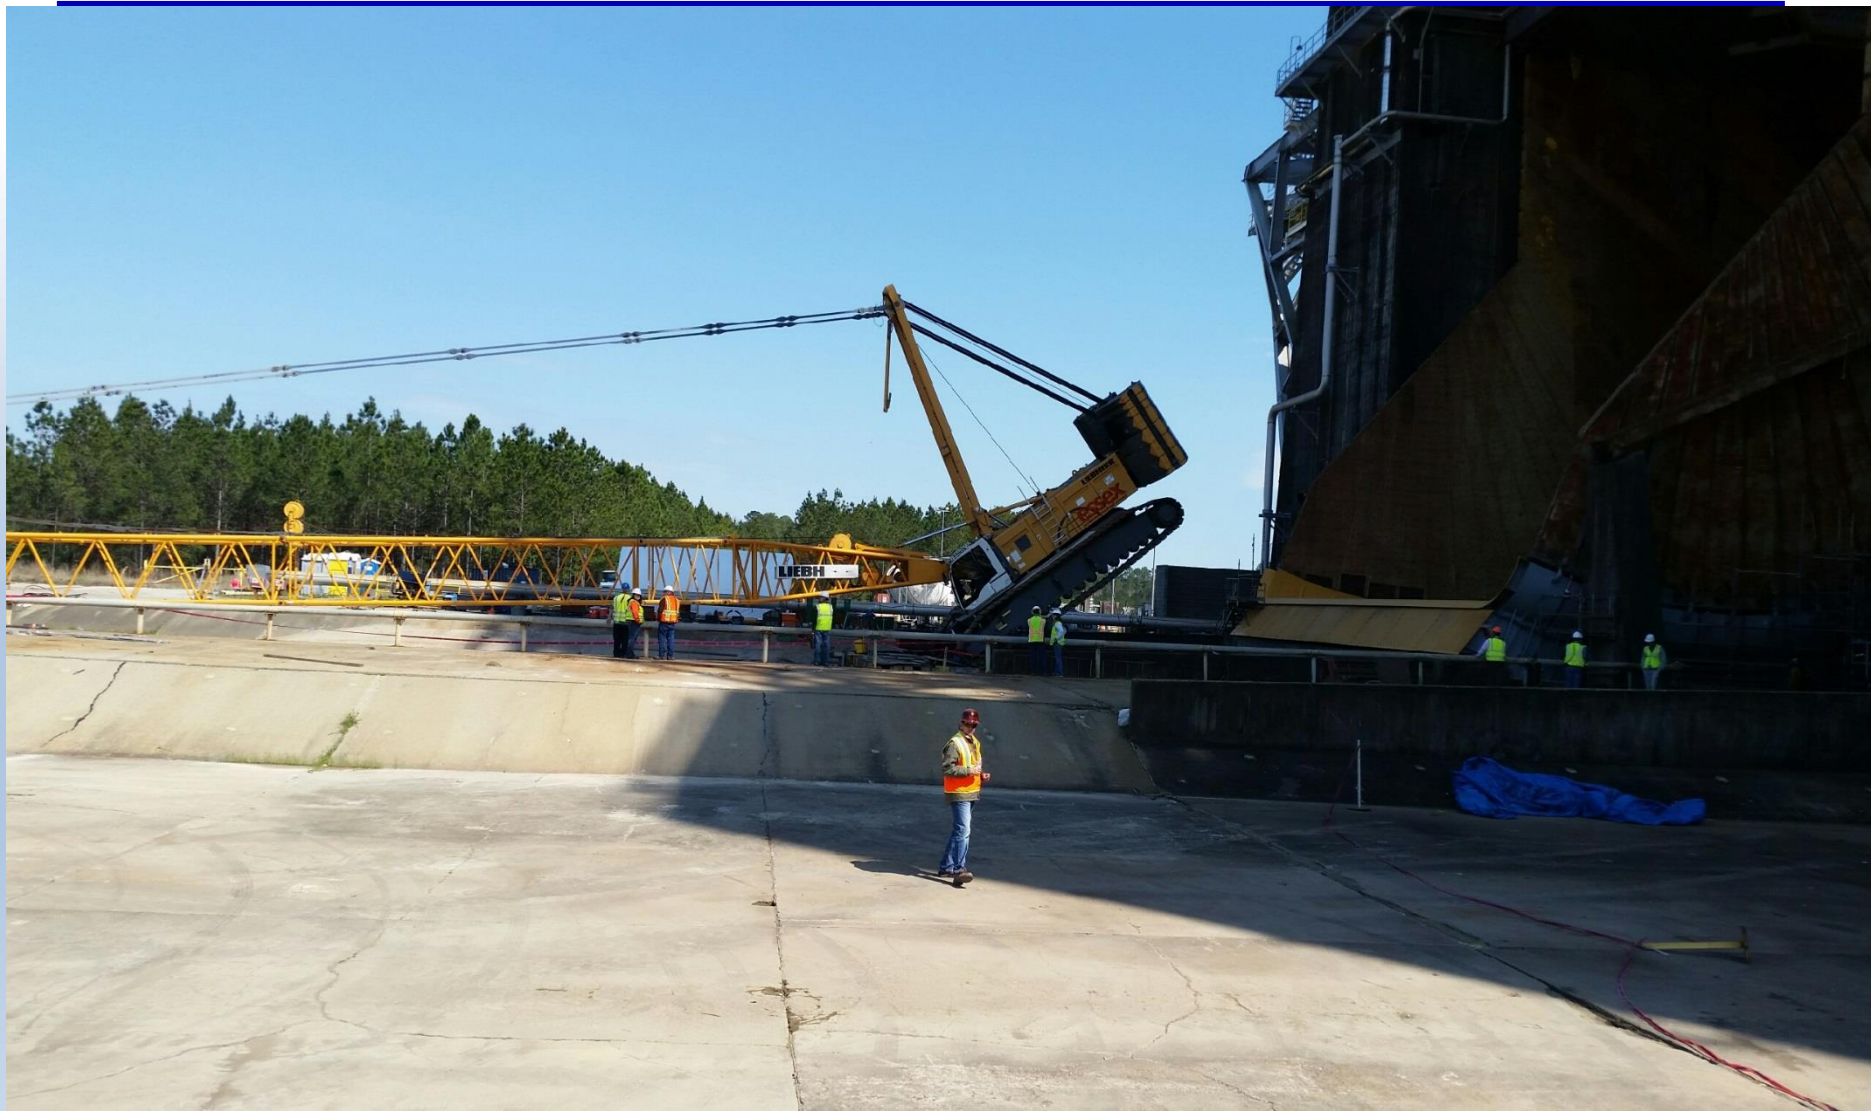
Lattice boom to cab and counter weights

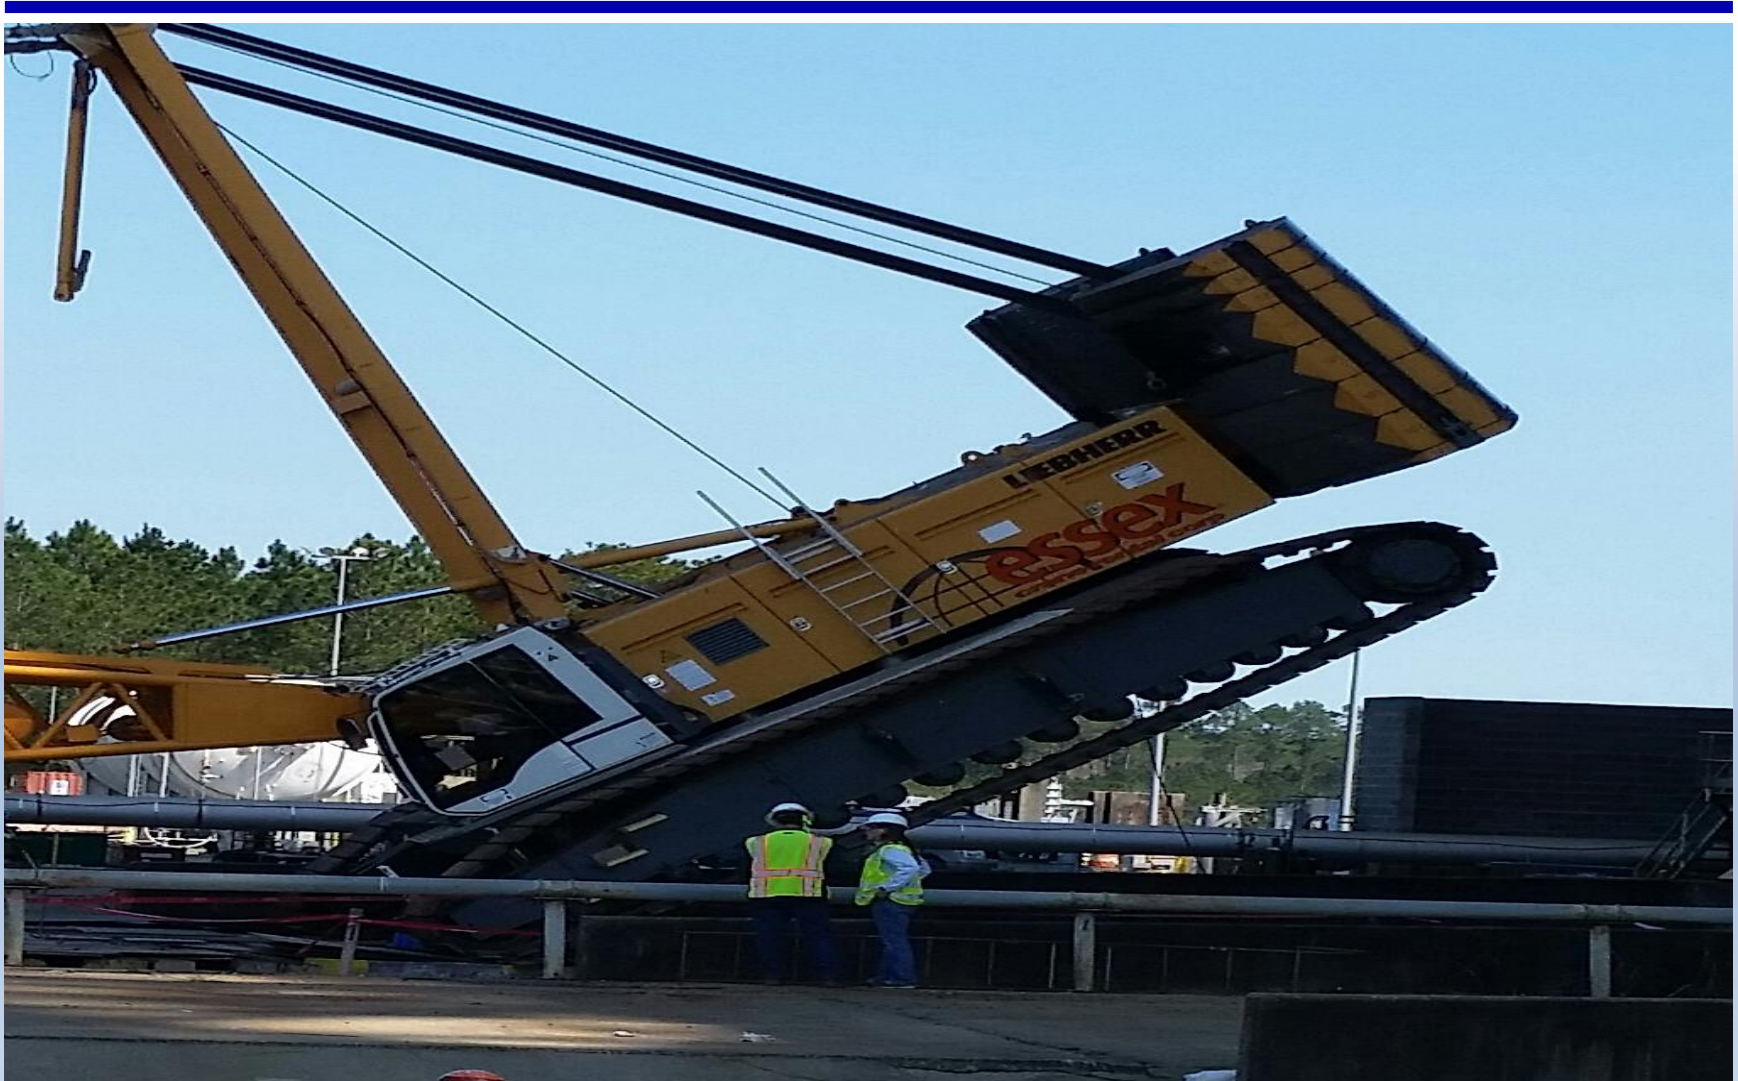
Lattice boom to cab and counter weights

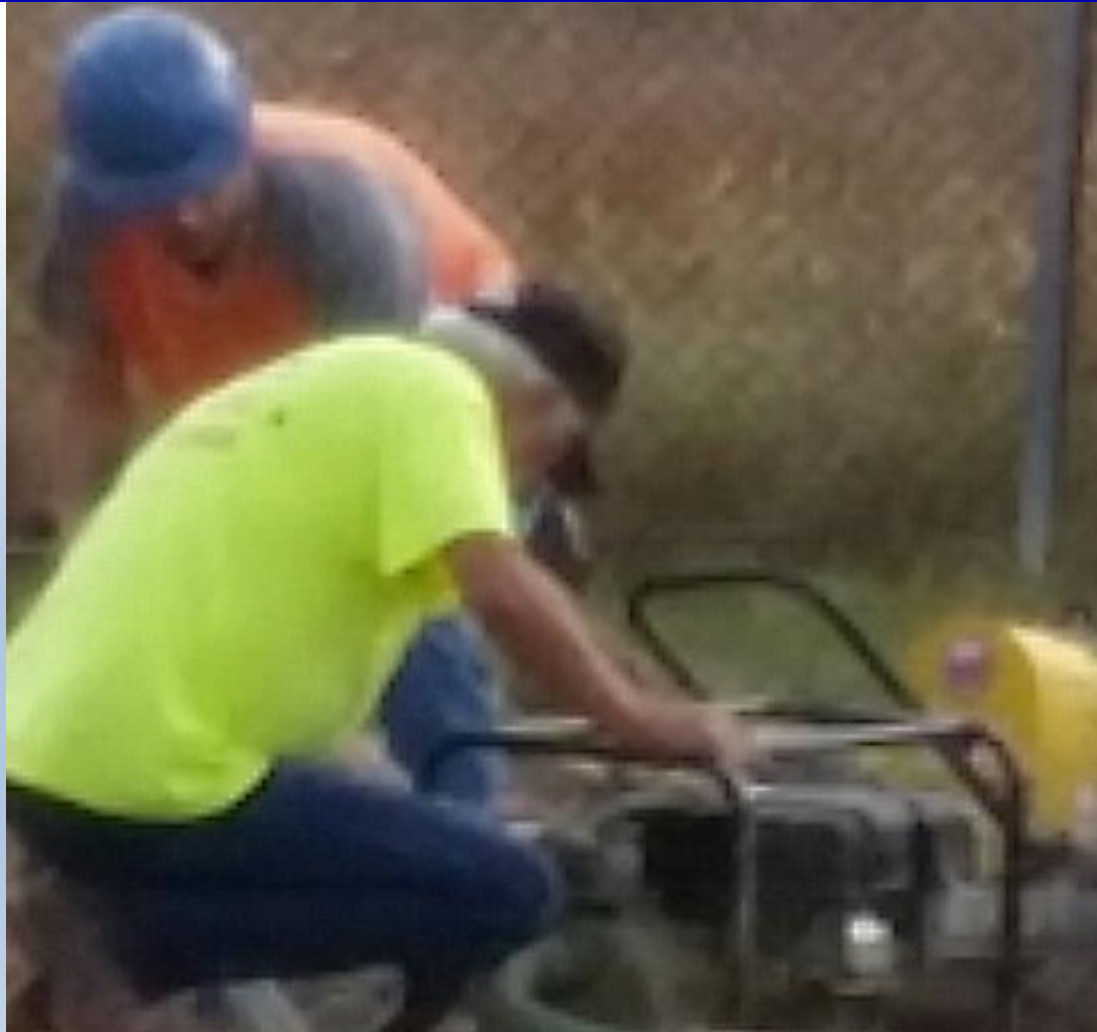
- **Demolition 1210,4302 and 4312:** A contractor was working in the demolition grounds area of building 4312 not wearing his required PPE. Corrected on the spot.
REF: SCWI-8715-0002 Page 12 Item 7.2 a SHEtrak Closed.
- **Demolition 1210,4302 and 4312:** A contractor failed to properly separate an oxygen and fuel gas (propane) cylinder by 20 feet when in storage as required by OSHA.
REF: 29CFR1910.253 b (4) iii SHEtrak Closed
