Construction Safety

SSC Construction Inspection
Safety Findings/Stats

February 2016

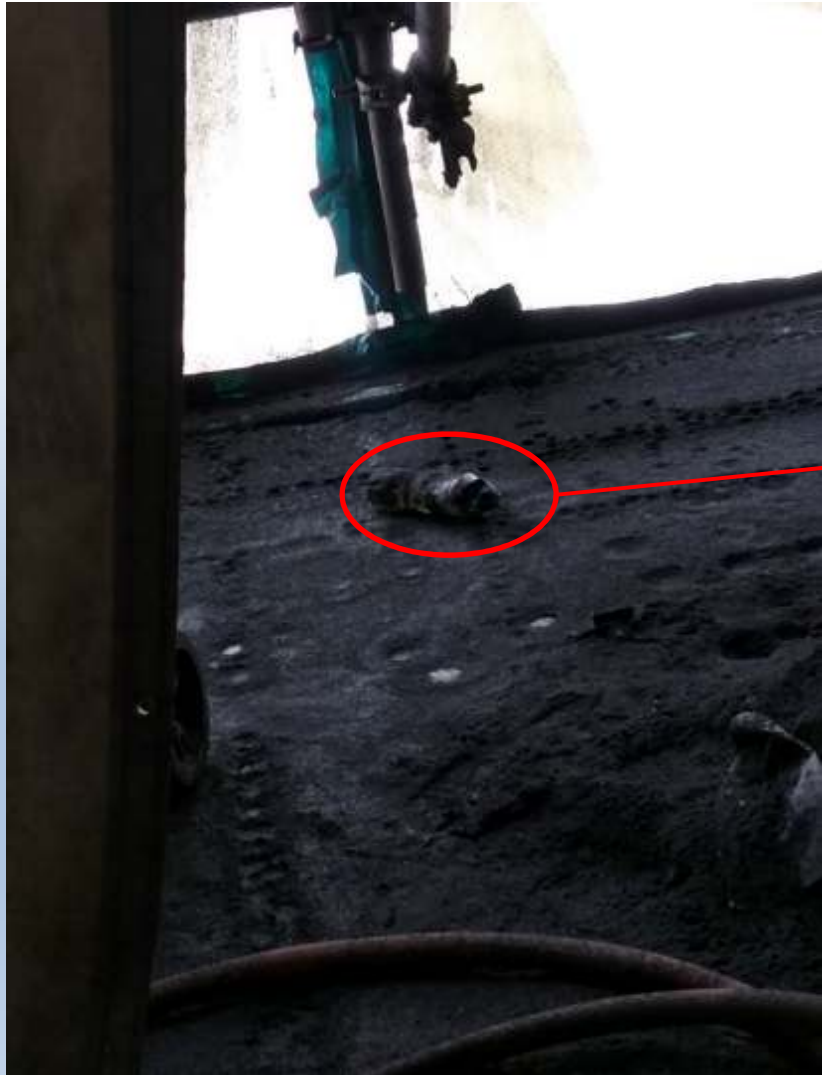
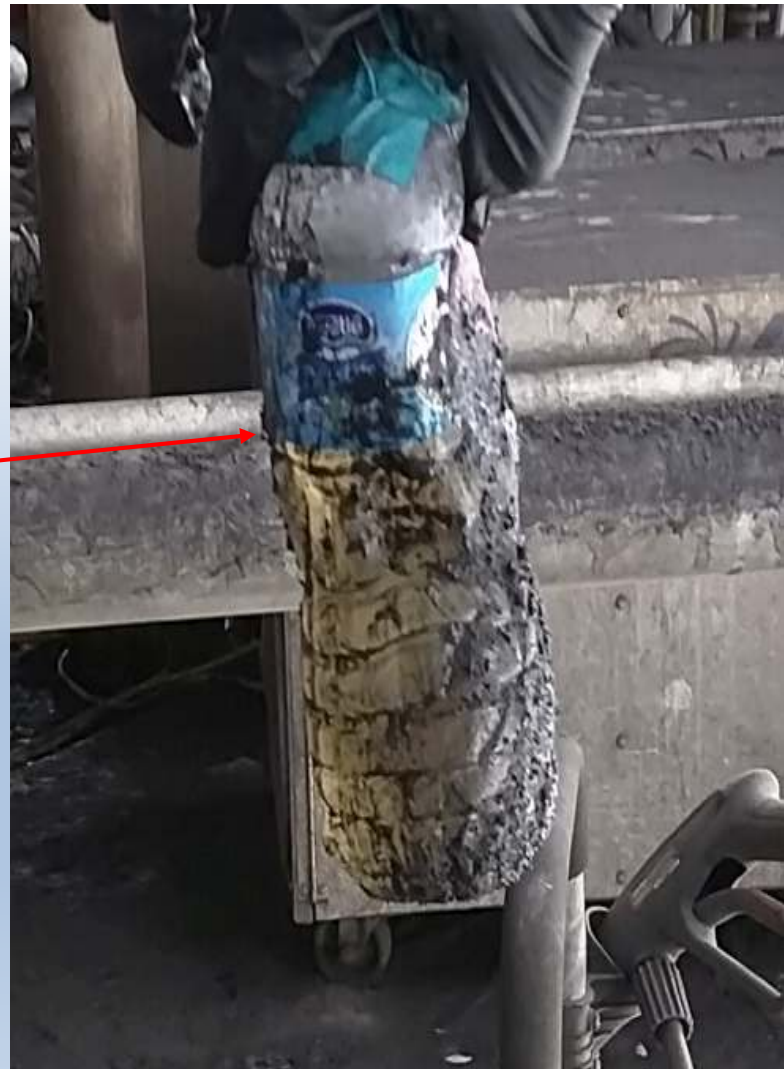
Urine stored in water bottle inside the lead containment:

- 1926.51(a)(3) Any container used to distribute drinking water shall be clearly marked as to the nature of its contents and not used for any other purpose.
- 1926.51(c)(2) Under temporary field conditions, provisions shall be made to assure not less than one toilet facility is available.
- 1926.62(e)(1) Engineering and work practice controls. The employer shall implement engineering and work practice controls, including administrative controls, to reduce and maintain employee exposure to lead to or below the permissible exposure limit ...
- 1910.1200(f)(10) The employer shall ensure that workplace labels or other forms of warning are legible, in English, and prominently displayed on the container

Urine (Inside the Containment/Work Area)

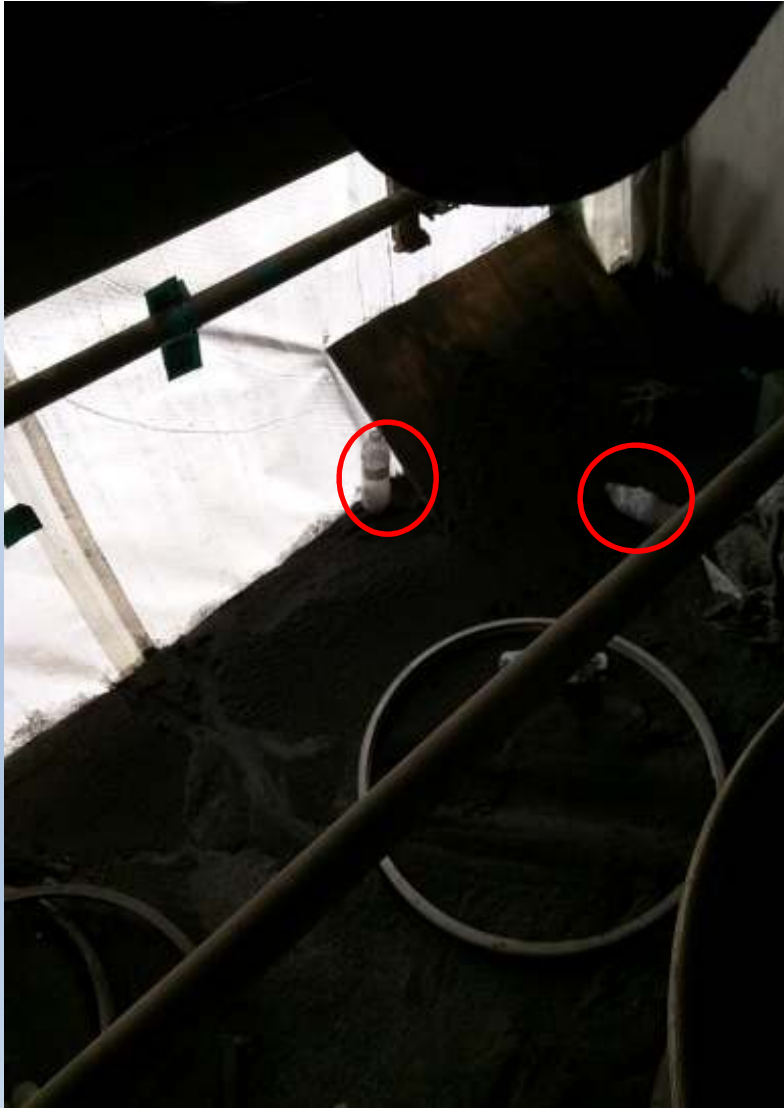
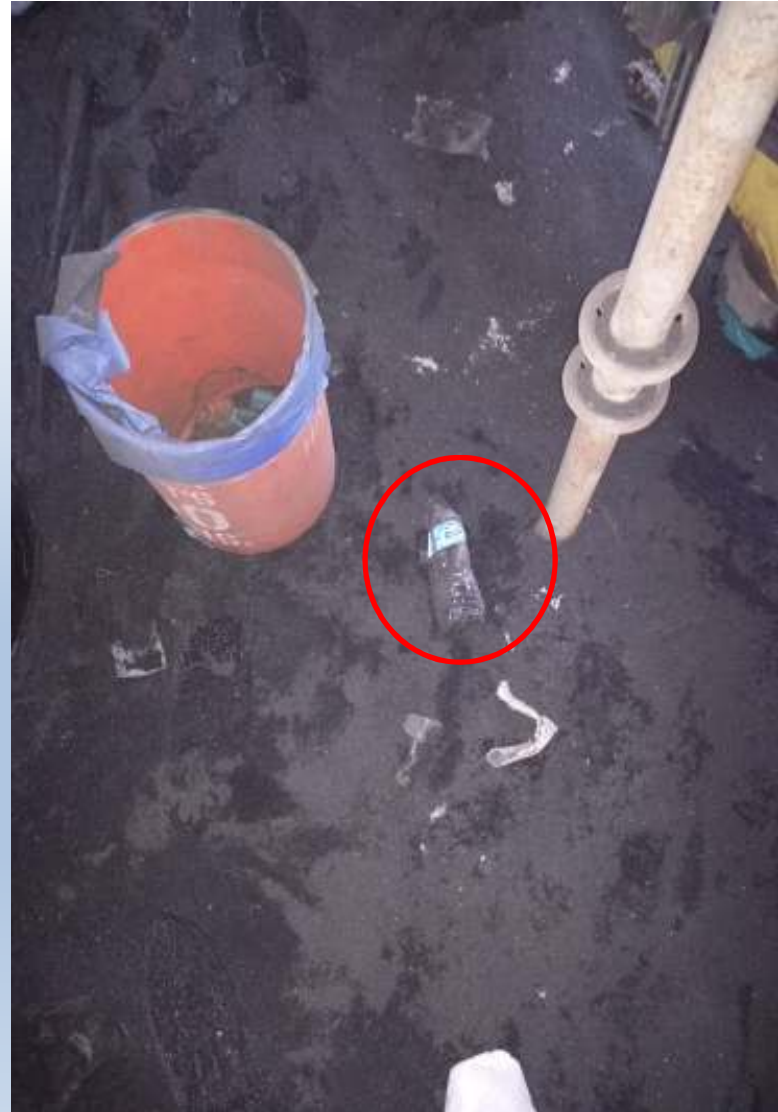
Drinking water bottles observed inside the containment:

- 1926.62(i)(1) The employer shall assure that in areas where employees are exposed to lead above the PEL without regard to the use of respirators, food or beverage is not present or consumed, tobacco products are not present or used, and cosmetics are not applied.

Water Bottles Inside Containment/Work Area

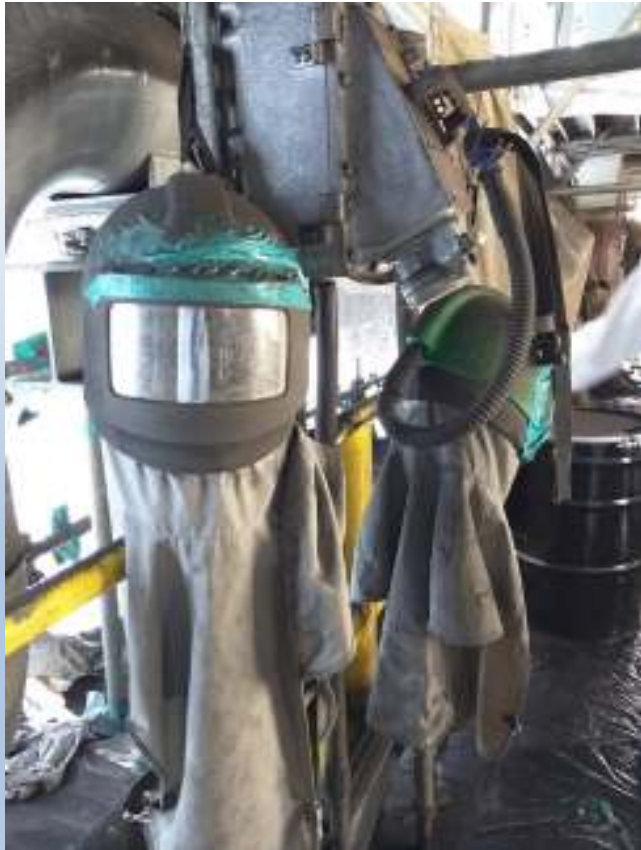
Contaminated blast helmet and shroud (respirator) stored in contaminated containment:

- 1926.62(g)(2)(v) The employer shall assure that contaminated protective clothing which is to be cleaned, laundered, or disposed of, is placed in a closed container in the change area which prevents dispersion of lead outside the container.

- 1926.62(g)(2)(iv) The employer shall assure that all protective clothing is removed at the completion of a work shift only in change areas provided for that purpose as prescribed in paragraph (i)(2) of this section

- 1926.62(i)(2)(ii) The employer shall assure that change areas are equipped with separate storage facilities for protective work clothing and equipment and for street clothes which prevent cross-contamination.

- 1926.103 and [1910.134\(h\)\(2\)](#) Storage. The employer shall ensure that respirators are stored as follows: All respirators shall be stored to protect them from damage, contamination, dust, sunlight, extreme temperatures, excessive moisture, and damaging chemicals.

Improper Storage
of PPE
(Inside the Containment/Work Area)

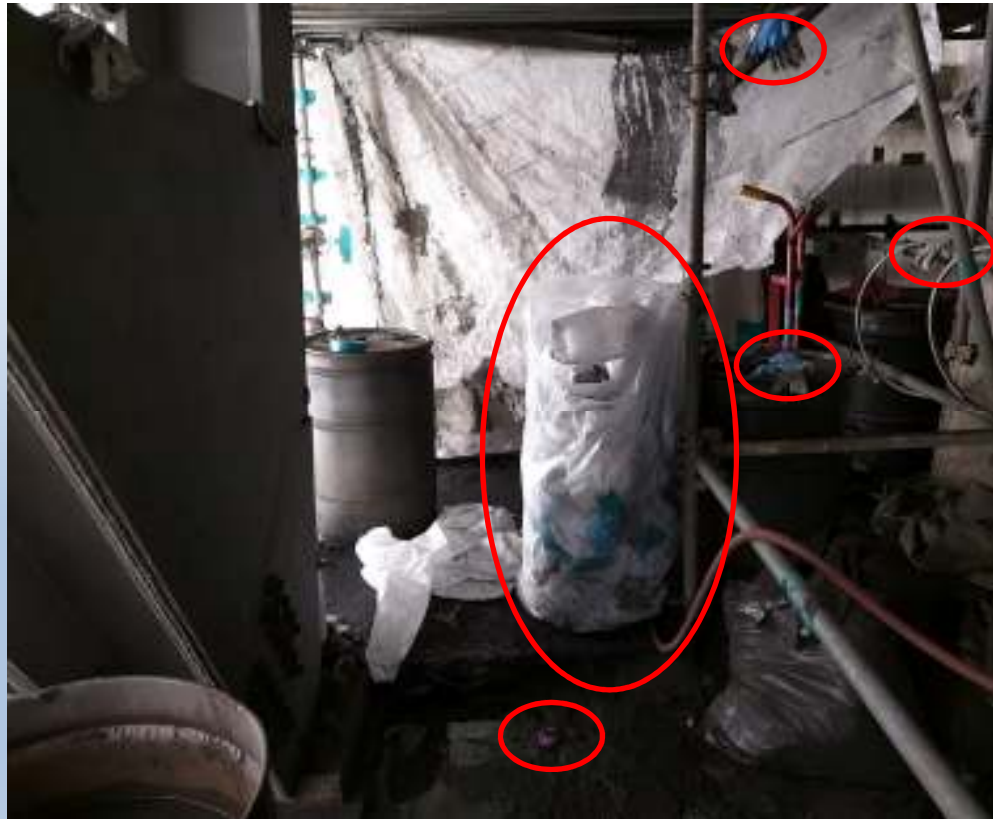
Improper Doffing of PPE
Bag should be located closer to the dirty room

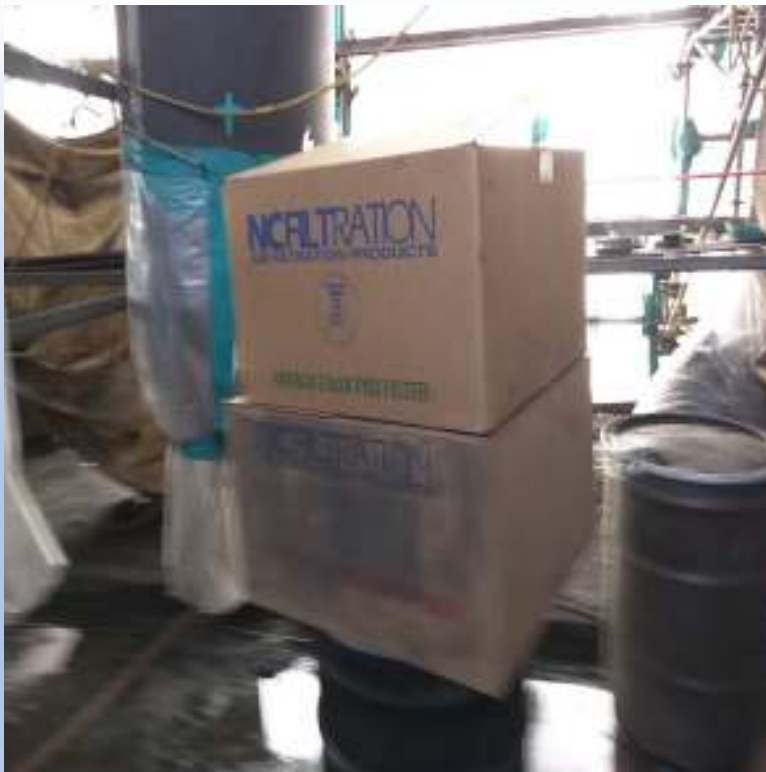
Storage of Negative Air Machine Filters
Inside the
Containment/Work Area

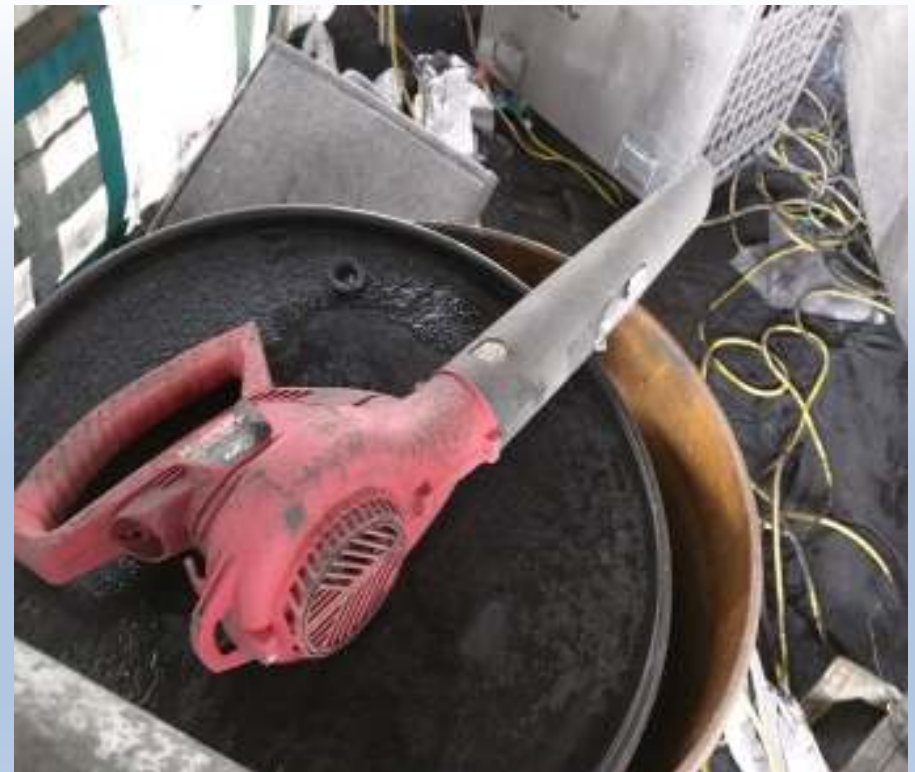
Leaf Blower Located Near the Dirty Room
