# Construction Safety

SSC Construction Inspection  
Safety Findings/Stats

# March 2014

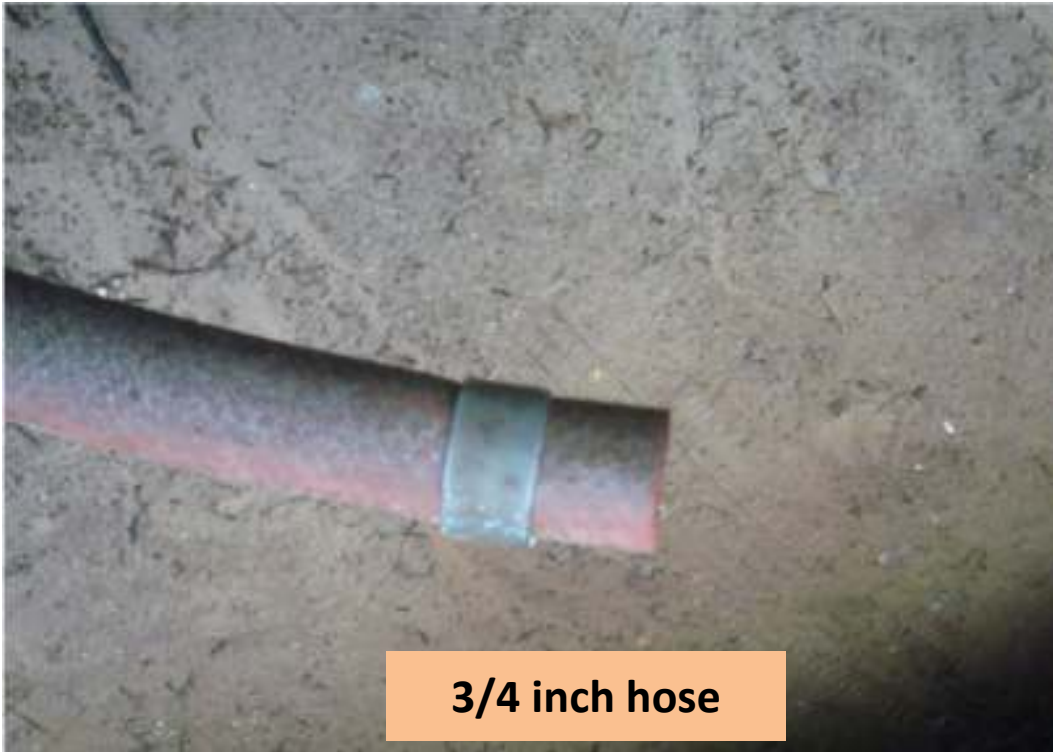
1. A worker was cleaning a catwalk on Level 9 when a 3/4 inch compressed air hose became disconnected from a nearby scaffold system. As a result, the vertically hanging air hose and clamp separated from a fitting, causing the hose to strike the employee on the head. Later in the shift, a contusion developed on the employee's head, at which point the contractor's safety officer made the decision to transport the injured worker to an offsite clinic. The worker was treated with prescription strength medication, and told to return to work the next day, making this a NASA Type D mishap. This case is still under investigation.

**3/4 inch hose**

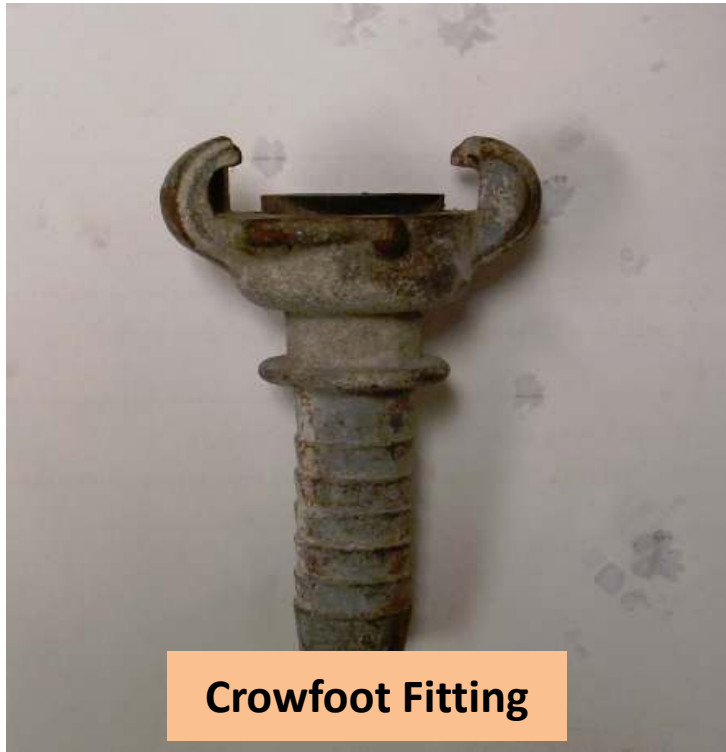
**Crowfoot Fitting**

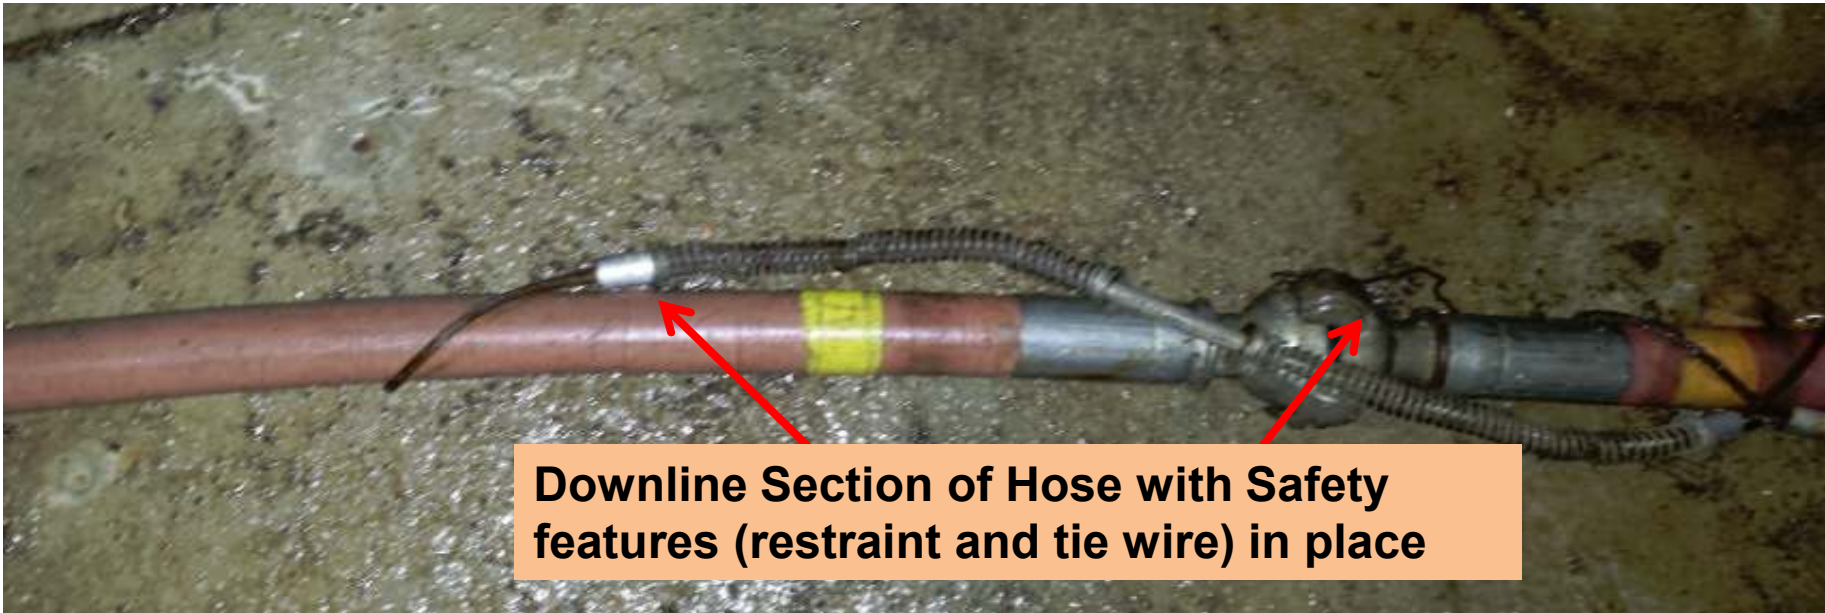
**Downline Section of Hose with Safety features (restraint and tie wire) in place**
