**Construction Safety**

### SSC Construction Inspection Safety Findings/Stats

# March 2012

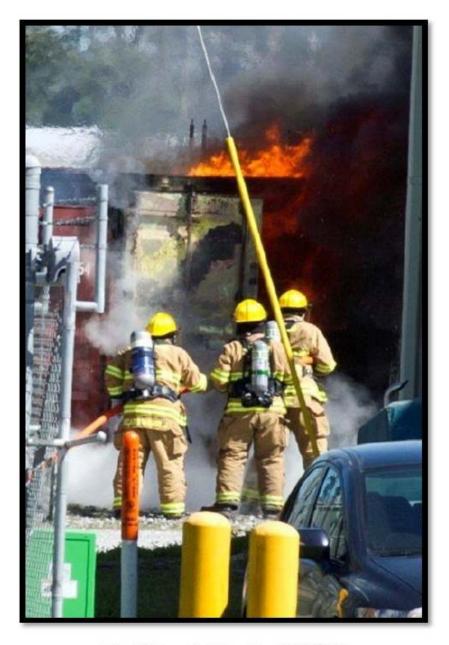
On March 5, 2012, SSC Firefighters responded to a fire in the area of Building 2418. Navy personnel were welding on the top of a Conex Box to repair small holes, when the contents of the box (new vehicle tires) caught fire. Two Firefighters received minor burn injuries while attempting to extinguish the fire.

Firefighters fighting the CONEX fire

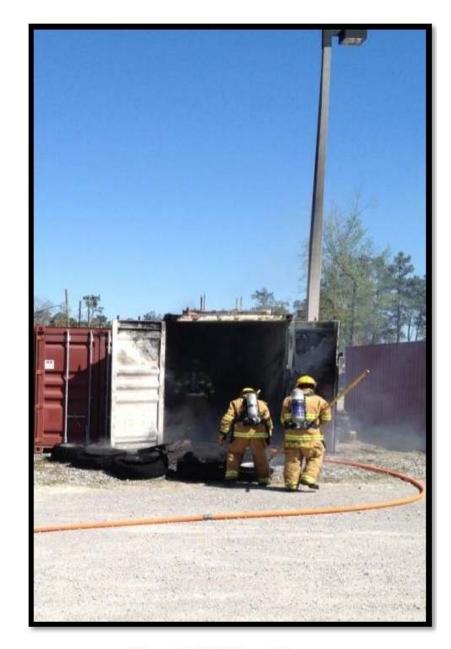
View of CONEX post fire

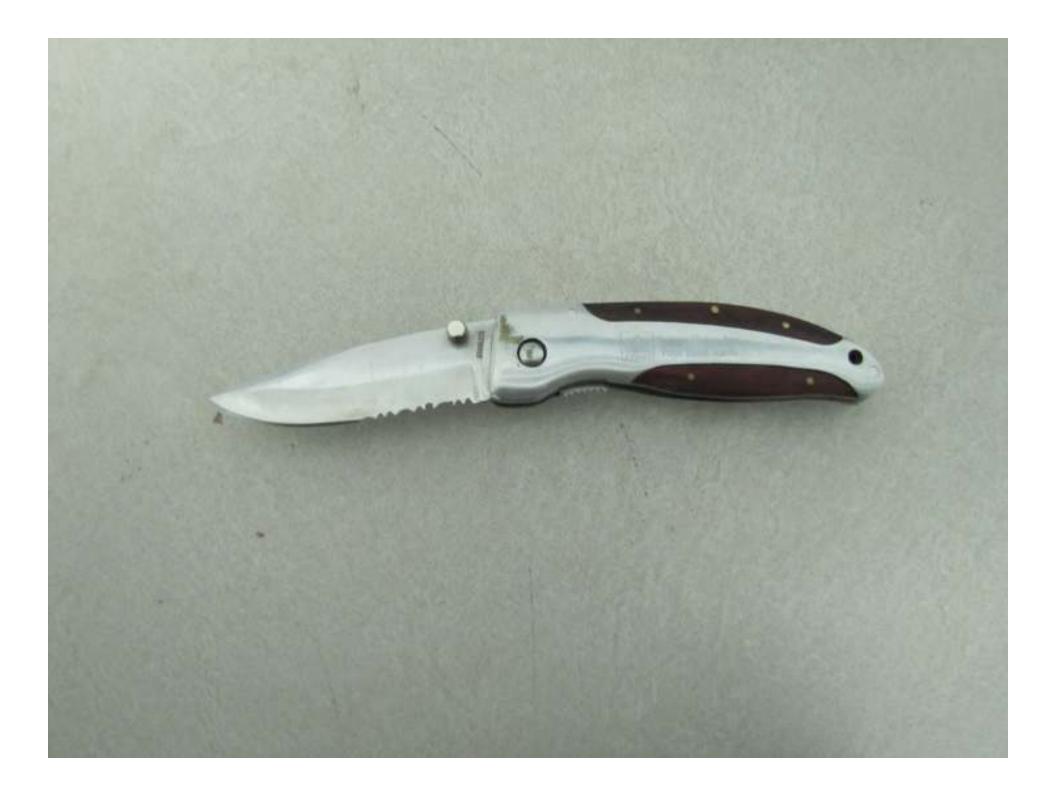
- 1. A scaffold worker on level 7 dropped his 3" pocket knife used to remove a section of "construction mesh". The open knife fell through the grating to level 6. <u>ACTIONS</u>: Work was stopped for a safety stand down. The prime directed the use of scissors for any future cuts to the mesh. Scissors will be tethered and/or held in a tool pouch. Alternate tools include dykes or utility knifes, both which may be tethered. The worker was sent home for two days without pay. The incident was shared with all contractor work crews. The incident was entered into IRIS.
- 2. An open pocket knife fell from an undisclosed location to directly in front of the test stand near the main entrance. The incident was entered into IRIS.
