Construction Safety

SSC Construction Inspection Safety Findings/Stats

May 2019

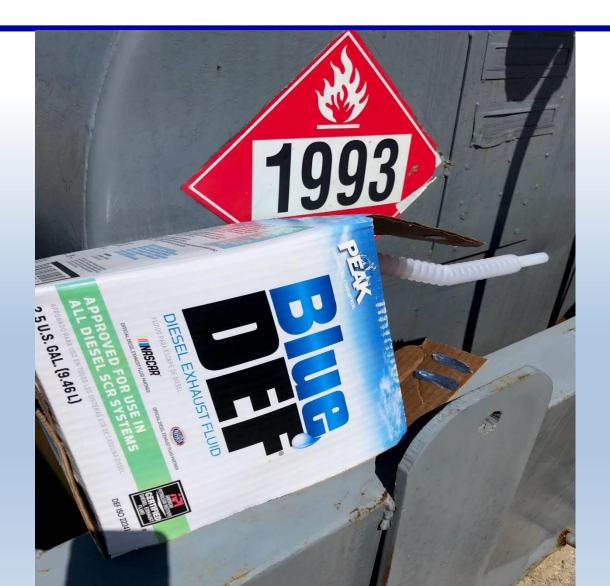
Weekly Safety Meeting

Project:	Sanitary Sewer Recap 80SSC018F0044
Location:	Stennis Space Center, Multiple Locations
Taula of the	Weeks SDS/Flamebles

Discussed the new to have all material used at Stennis documented and used properly. Items in company or personal vehicles are subject to some documentation requirements

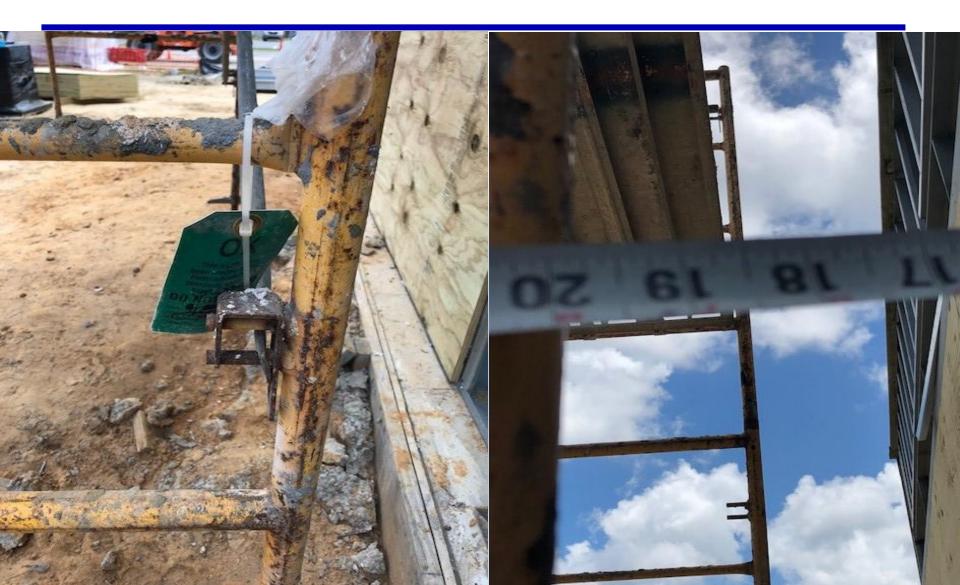
— Wellness Center Expansion Project: On May 24, an improperly tagged and poorly inspected scaffold was discovered during a jobsite inspection. The following deficiencies were noted: 1) Scaffold frame sections were not connected utilizing required pins. 2) The space from scaffold frame system to wall was over the 18" maximum allowable distance. 3) The top platform scaffold access opening for entry/exit was placed on the opposite side of the ladder. 4) Scaffold system work platforms above 10 feet were missing required toe boards. These deficiencies were only permissible if annotated on a yellow scaffold tag (for cautionary use), vs the green tag which was in place. Ref: 29CFR1926.454 (b) (2). SHEtrak # 103331 Closed

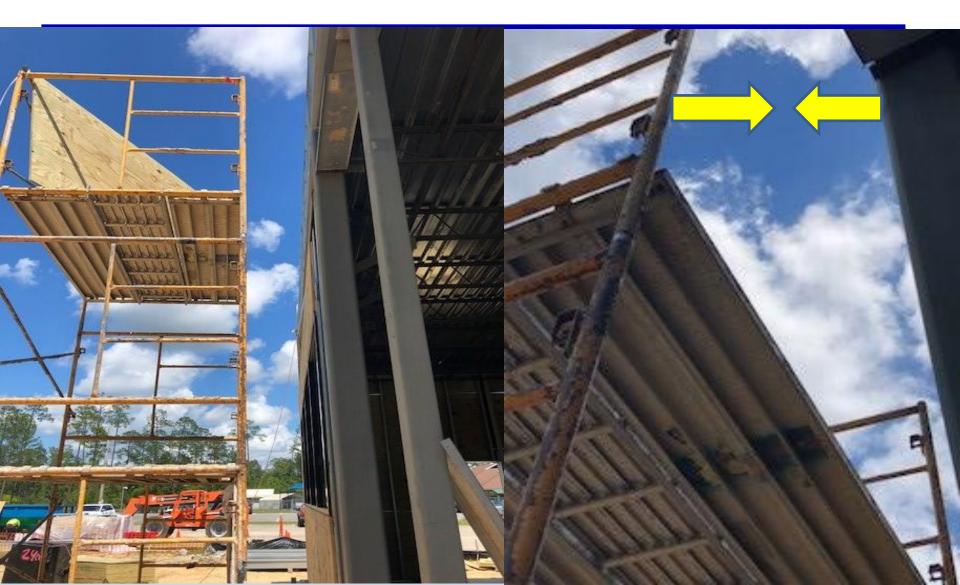
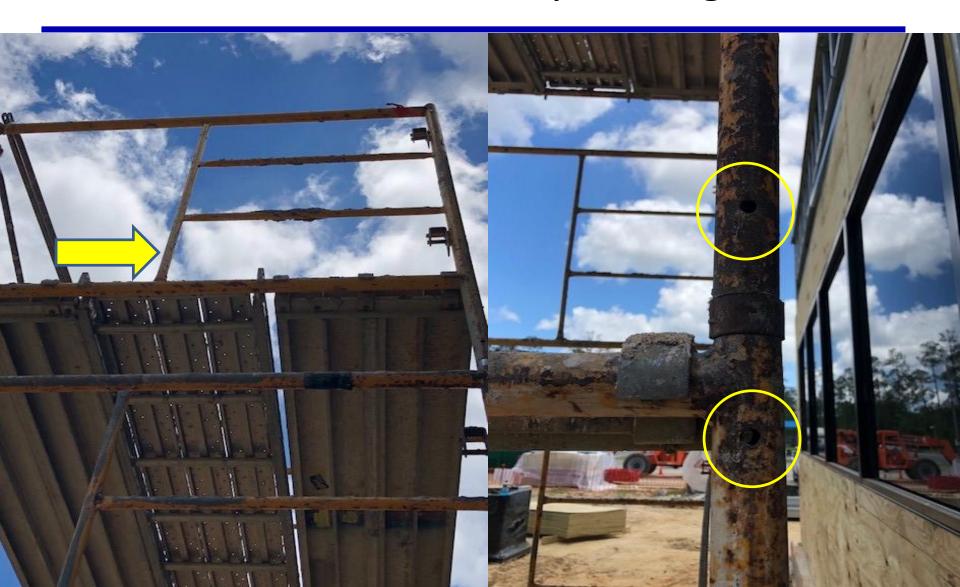
<u>-High Pressure Gas Phase II Project:</u> On May 30, the contractor failed to place a properly rated fire extinguisher (20-B or greater) not less than 25 feet and no more than 75 feet from the flammable liquid storage tank.

Ref: 29CFR1926.152 (d)(2). SHEtrak # 103372 Closed

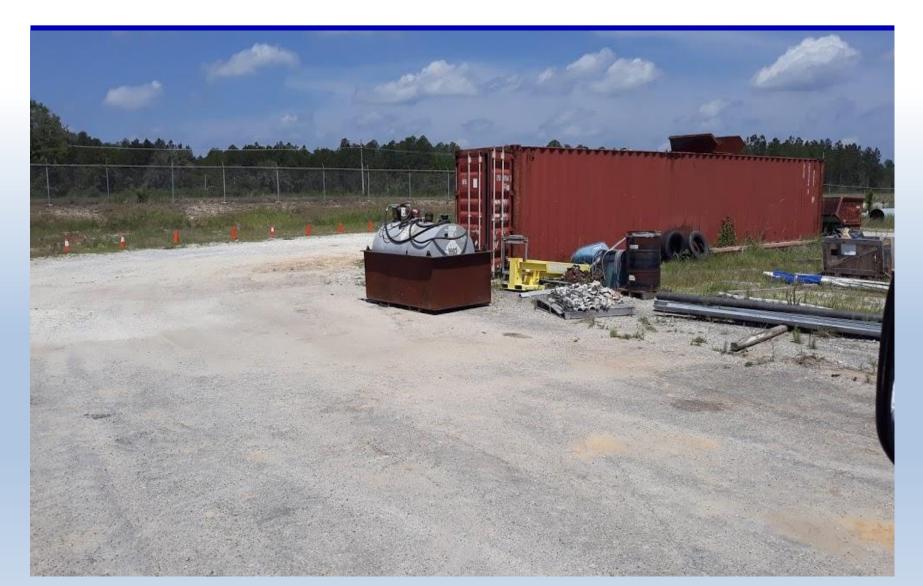
<u>-High Pressure Gas Phase II Project:</u> On May 30, The contractor failed to place a not less than 20-B rated fire extinguisher not less than 25 feet and no more than 75 feet from the flammable liquid storage tank.

Ref: 29CFR1926.152 (d)(2). SHEtrak # 103372 Closed
