Construction Safety

SSC Construction Inspection
Safety Findings/Stats

May 2018

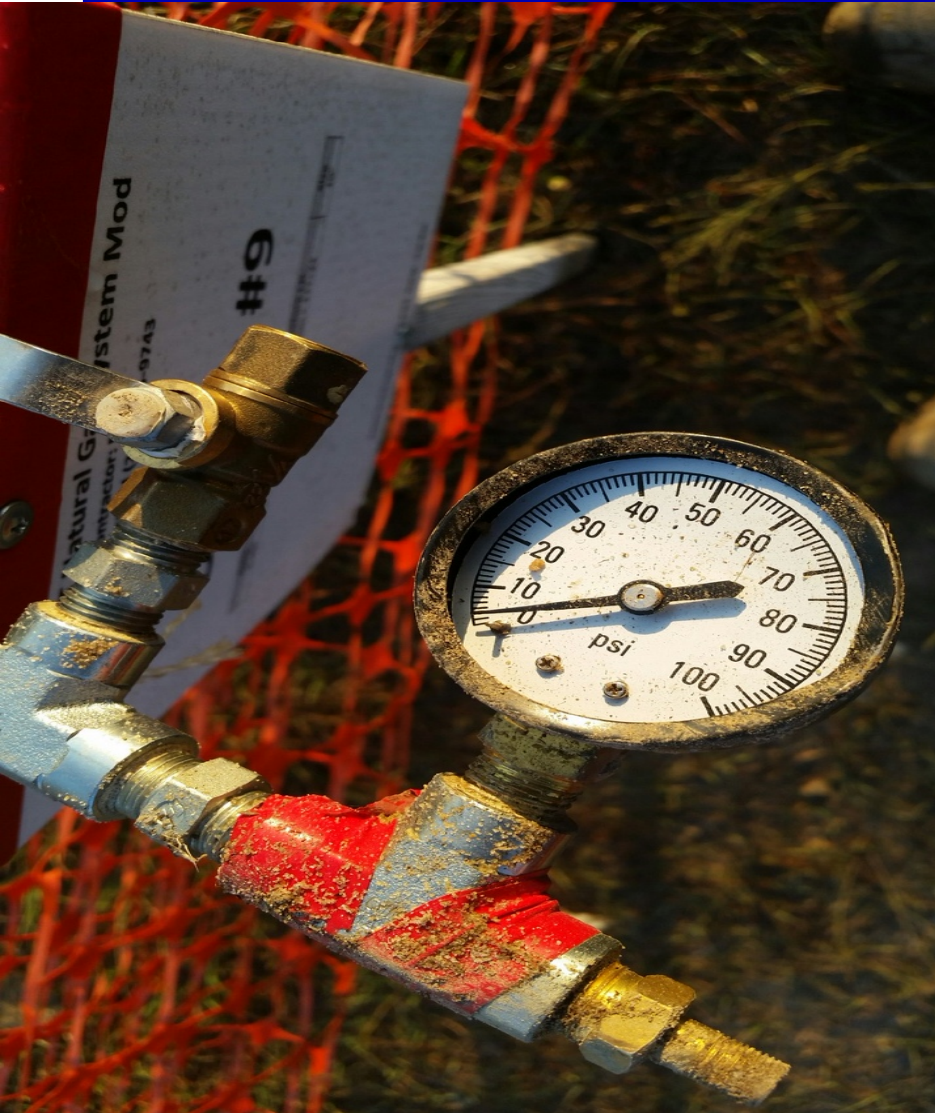
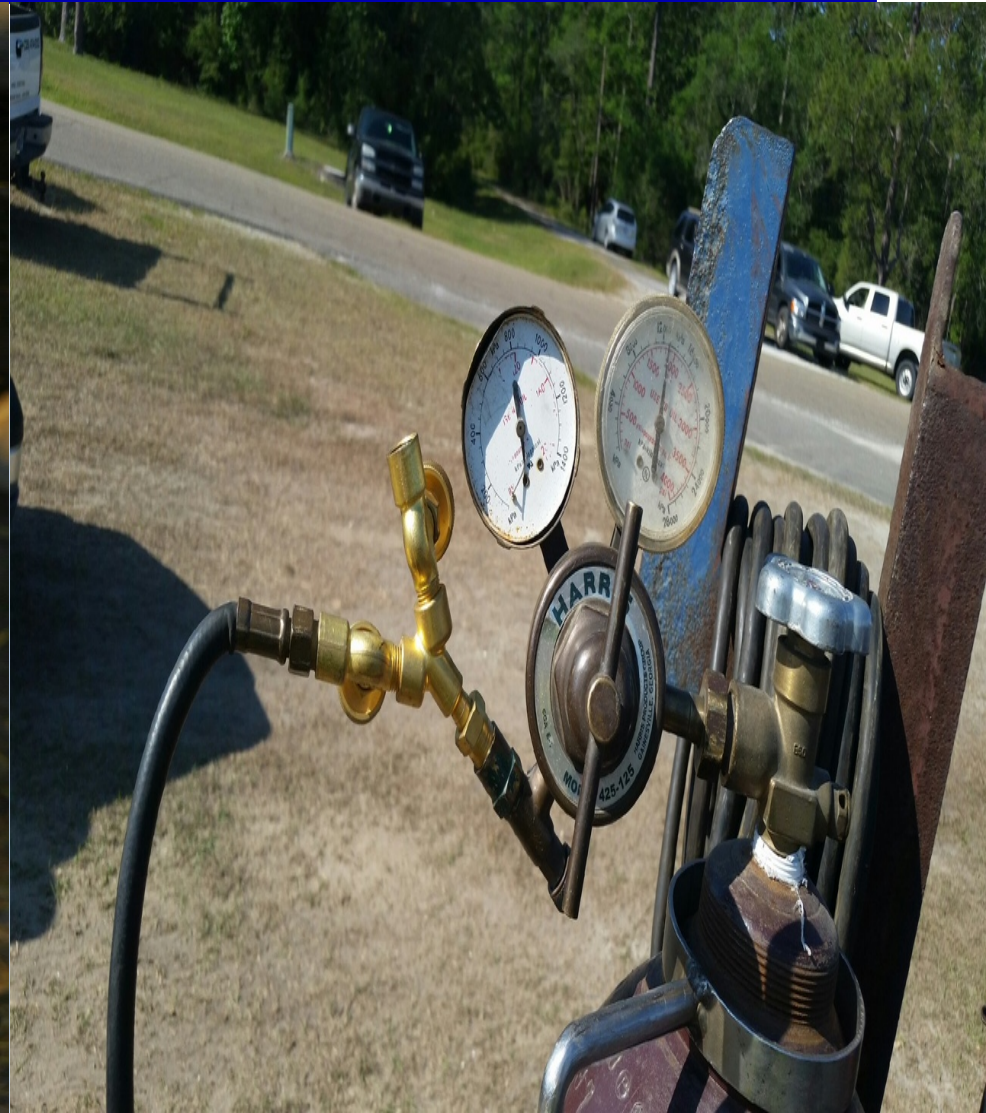
- **Natural Gas System Modification:** Two separate cylinder gauges had visible signs of damage i.e.(Bent damaged internal components and missing gauge protective face covers). Both gauge units were connected to separate connections. Ref: 29CFR1926.350 (h)
- **Natural Gas System Modification:** Contractor was using an extension cord with a missing ground pin on the plug end.
Ref: 29CFR1926.404 (b)(1)(iii)(C)
- **Natural Gas System Modification:** Contractor failed to properly secure two gas oxygen cylinders in an upright position at all times. Ref: 29CFR1926.350 (a) (9)
- **Natural Gas System Modification:** Contractor failed to wear hearing protection when using a power grinder to surface pipe ends. Ref: 29CFR1926.101 (a)

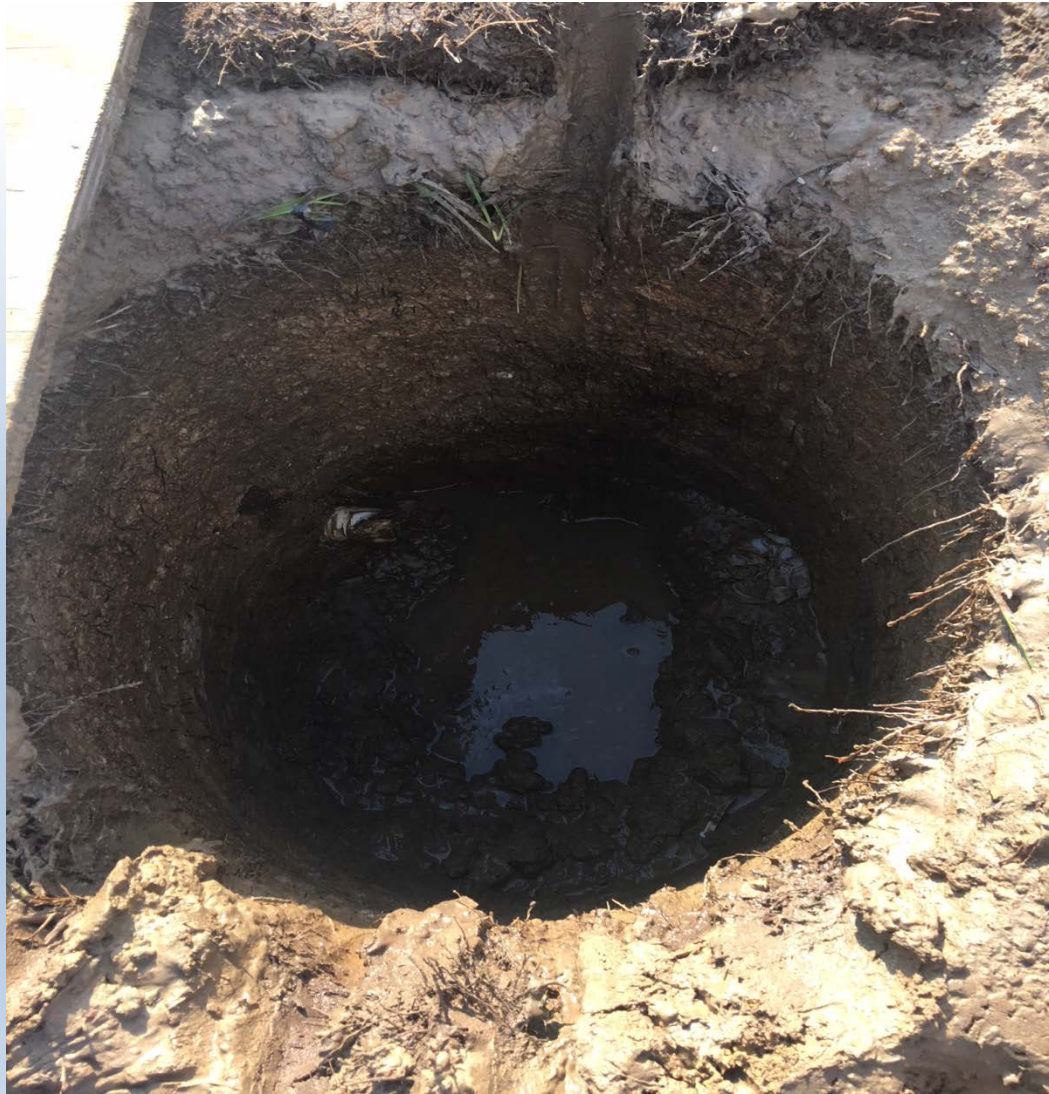
High Pressure Gas Phase II: On 5/17, at about 6:00 PM, the contractor was excavating around the A-3 T/S for the purposes of constructing a pipe support, and struck a 2" pvc lift station overflow line.

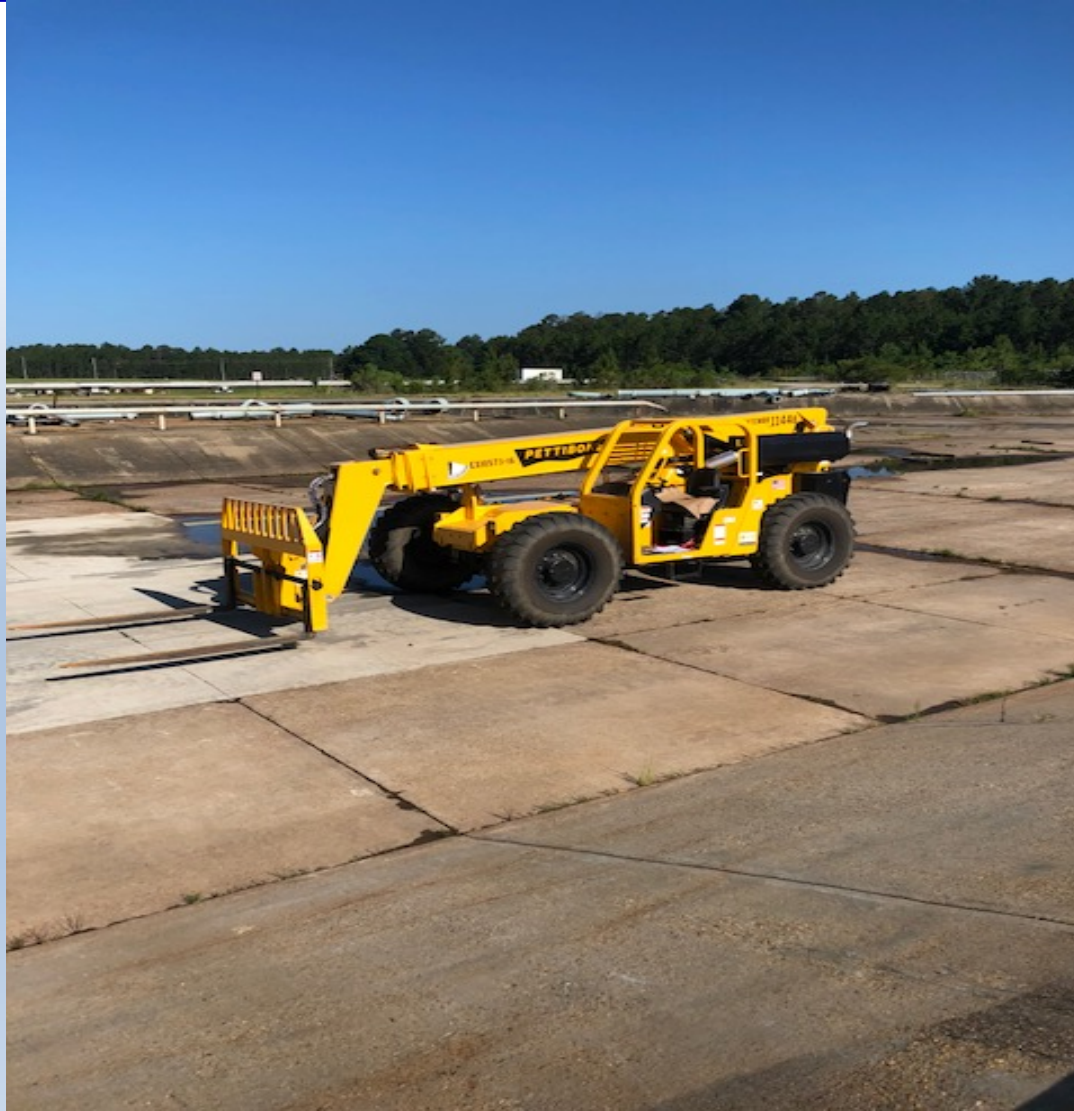
- B2 Fire X HPI Piping : Contractor failed to prepare a daily equipment inspection prior to starting work
Ref: SCWI-8715-0008 Section 6.8.3. SHEtrak Closed. ID# 86660

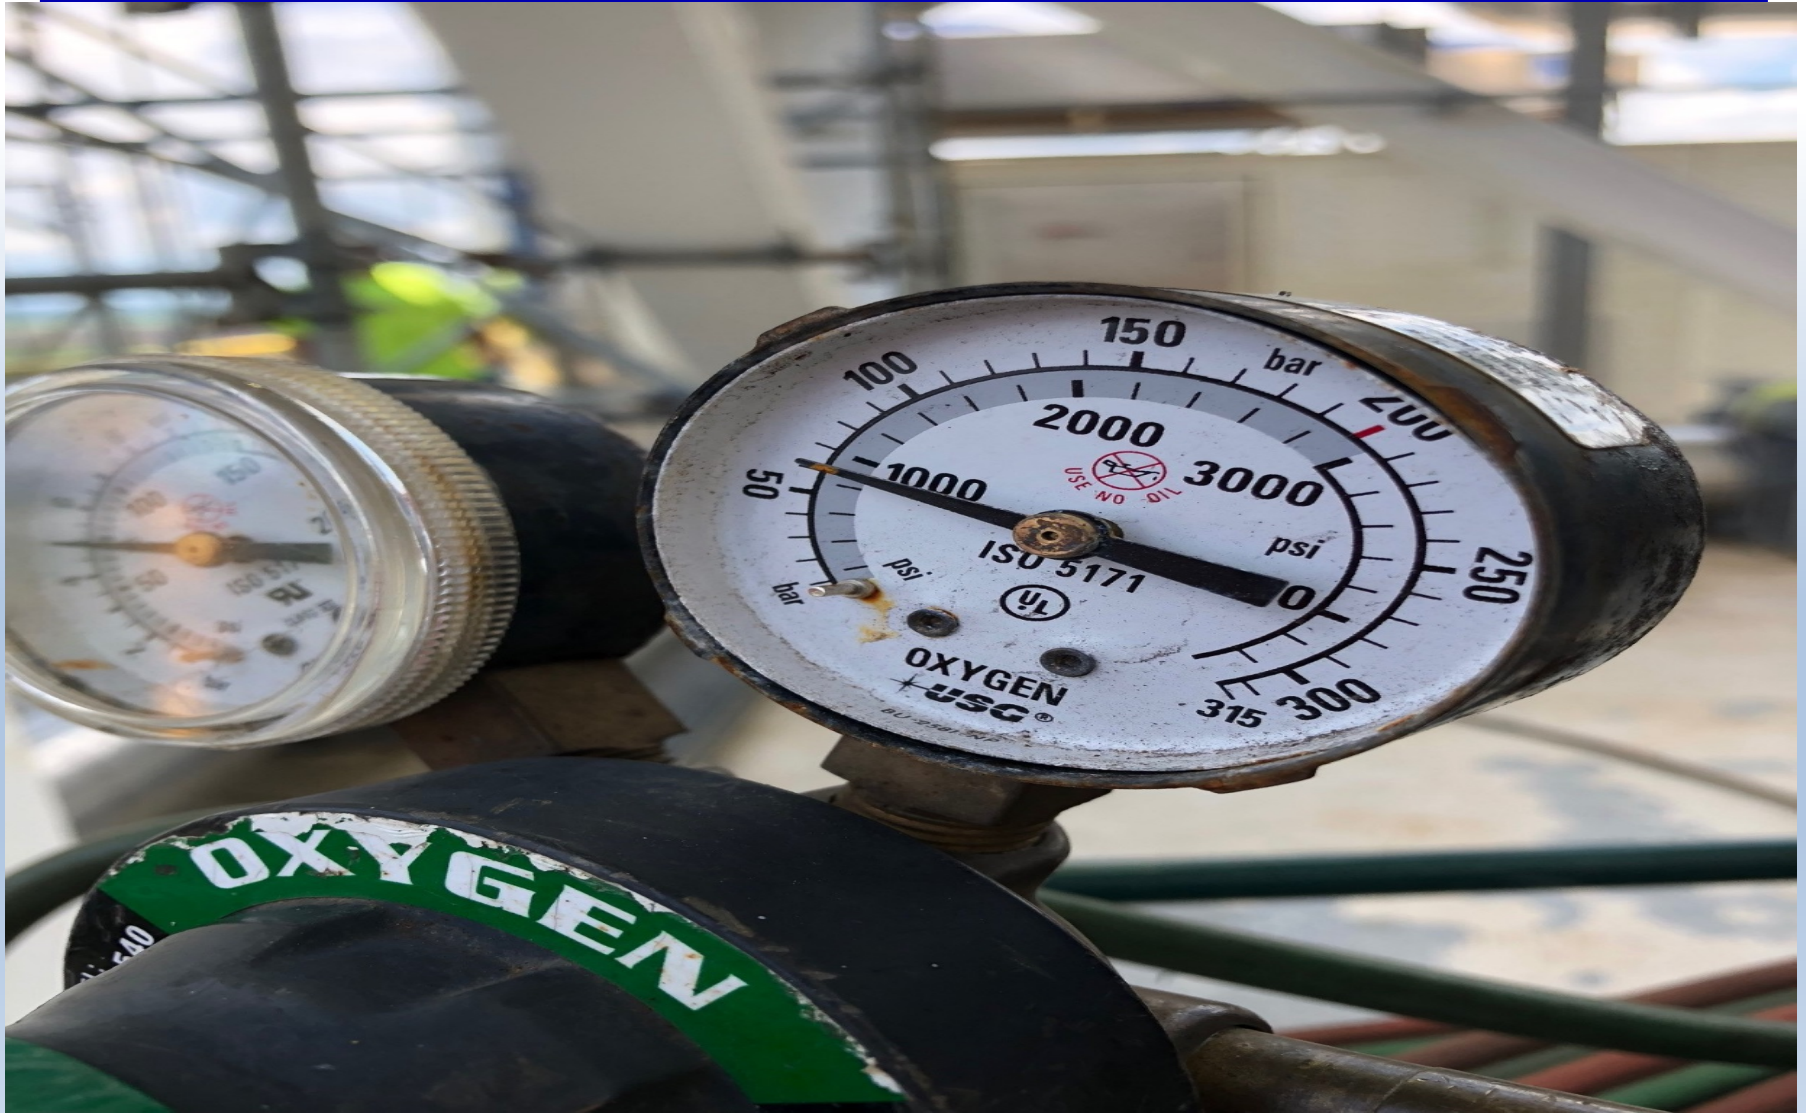
- **Fire X HPI Piping:** Contractor was using a set of cylinder gauges with a missing protective face cover.
Ref: 29CFR1926.350 (h) SHEtrak Closed. ID# 86766
