# SSC Construction Inspection Safety Findings/Stats

May 2016

# Construction Safety Findings: 02-06 May 2016

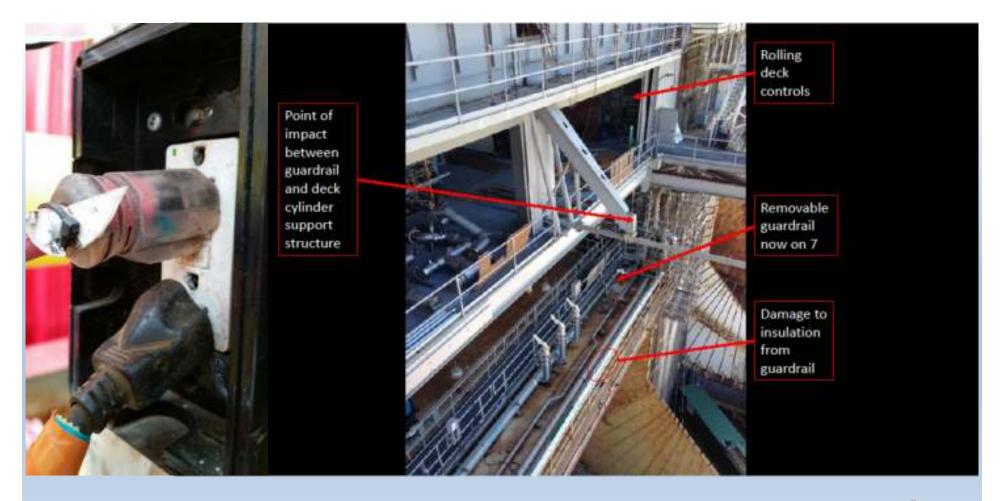
1. Inspector observed an electrical extension cord in use with the ground pin missing from the male end of the cord, 29 CFR 1926.404(b)(iii)(c).

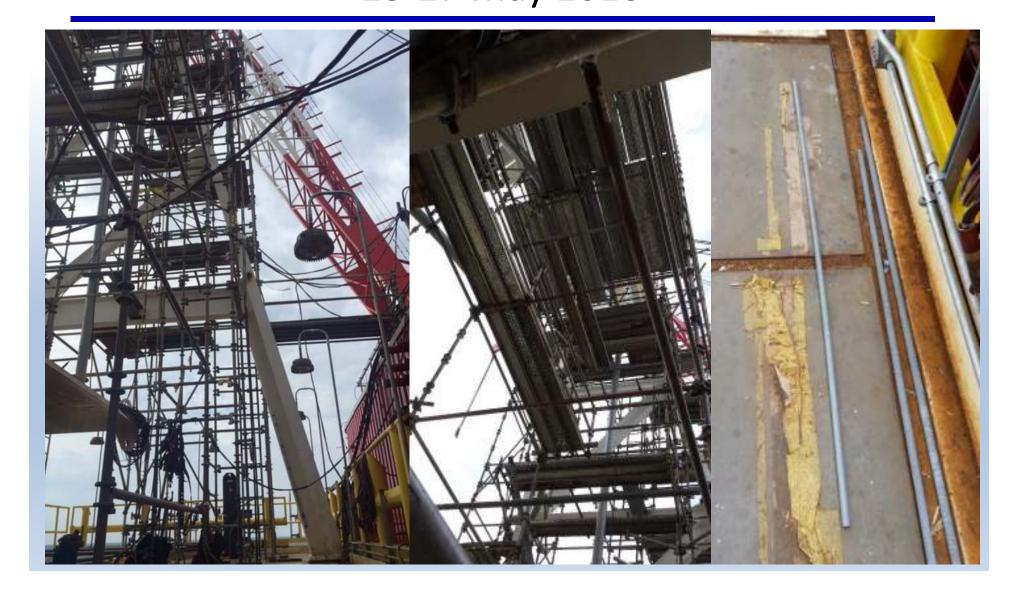
On 5/27, at about 8:30 AM, a 5' 3" x 3/4" piece of threaded rod (all-thread) fell approximately 30-40 feet from elevation 320' to level 18, where it struck a construction worker. The all-thread hit the worker on the bill of the hard hat, then struck them on the back, to the left of their spine at the base of the neck. As a welder, the injured party wore their hard hat with the bill toward the back, thus the hard hat took the brunt of the hit. A nearby worker called the supervisor, who notified emergency response. The worker had some bruising/swelling on the neck so the supervisor applied ice while waiting for the fire department, who subsequently transported them to the clinic where first aid was administered. The worker was then taken to a local hospital where the physician's orders required time off until a neurosurgeon could be consulted. (NMIS Close Call/16-100742)
