Construction Safety

SSC Construction Inspection Safety Findings/Stats

May 2015

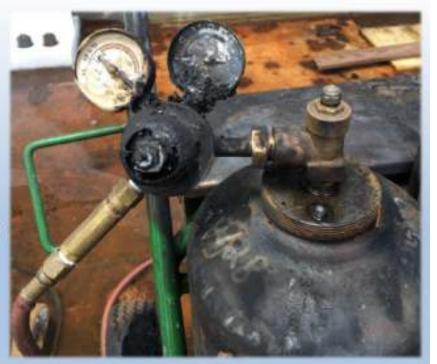
1. Components of an Oxygen-Acetylene welding cart in use by a subcontractor caught fire during superstructure modification activities on level 16 of the B-2 Test Stand.

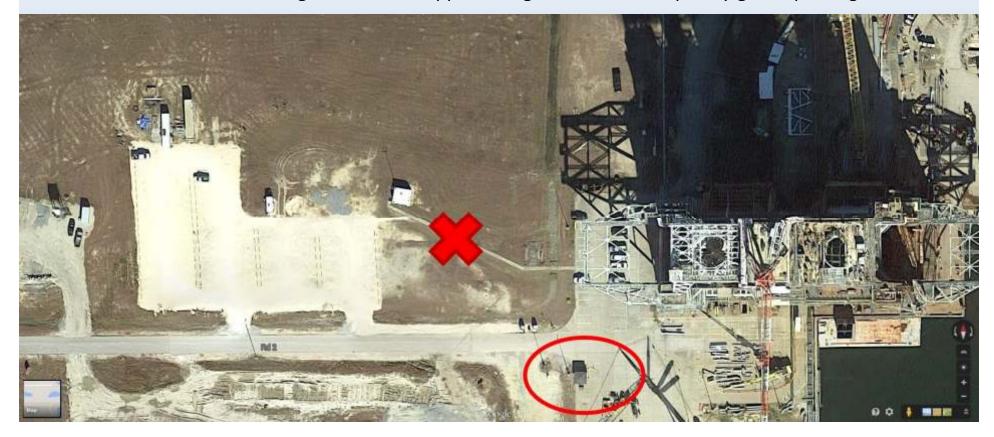
B-Test Stand: As a result of a fire on the B Test Stand, it was determined the marshalling area should be moved to a less congested area. The new marshalling area is to the west of the Test Stand, along the sidewalk approaching the Bunker/temporary gravel parking lot.
