Construction Safety

SSC Construction Inspection Safety Findings/Stats

June 2019

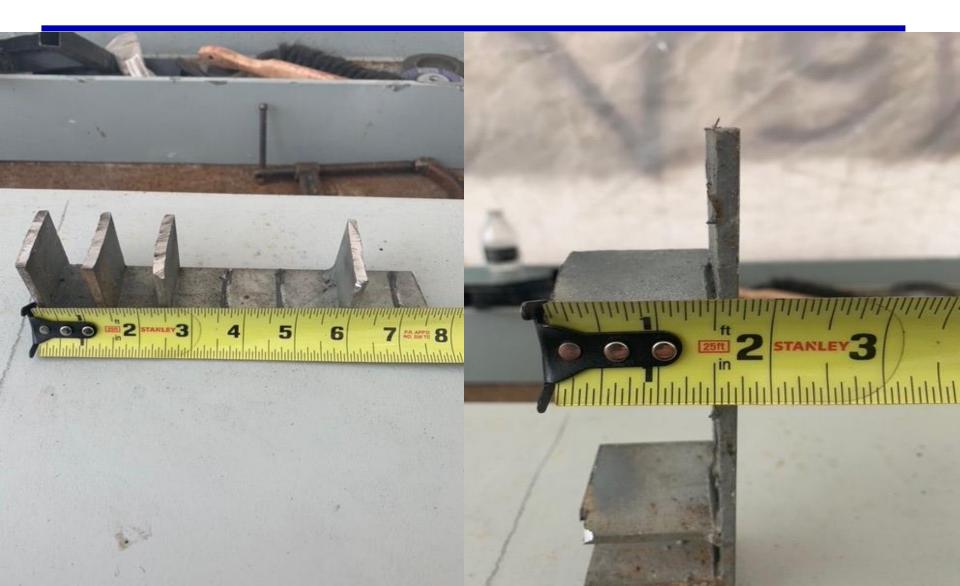
<u>-B2 Restoration Project</u>: On June 10, while cold cutting grating to move a light support on level 23, a section of grating (1.75"x 7.5") vibrated loose from a vice grip's grasp and fell to the next level, level 19.

- The construction contractor verbally informed two NASA prime contractor personnel working on level 19, that they were going to cut a small section of grating on level 23. These prime contractor personnel were brought up to level 23 where the cut was to be made to view the anticipated work and then go back to level 19. The construction contractor cutting the grating could clearly see level 19 from their location on level 23, and as a precautionary measure asked the two personnel working on level 19 to remain working on the south side while the cut was being made on the north side of level 23. During cutting, the grating which was being held by a pair of vice grips vibrated fell loose from the tool's grasp to level 19.

- The construction contractor has now instituted additional protective measures including the following:
 - Affixing the material pieces being freed from the larger sections via tie-wire to the larger

- Stationing a falling object watch at the lower level(s)
 - Barricading the lower level(s)

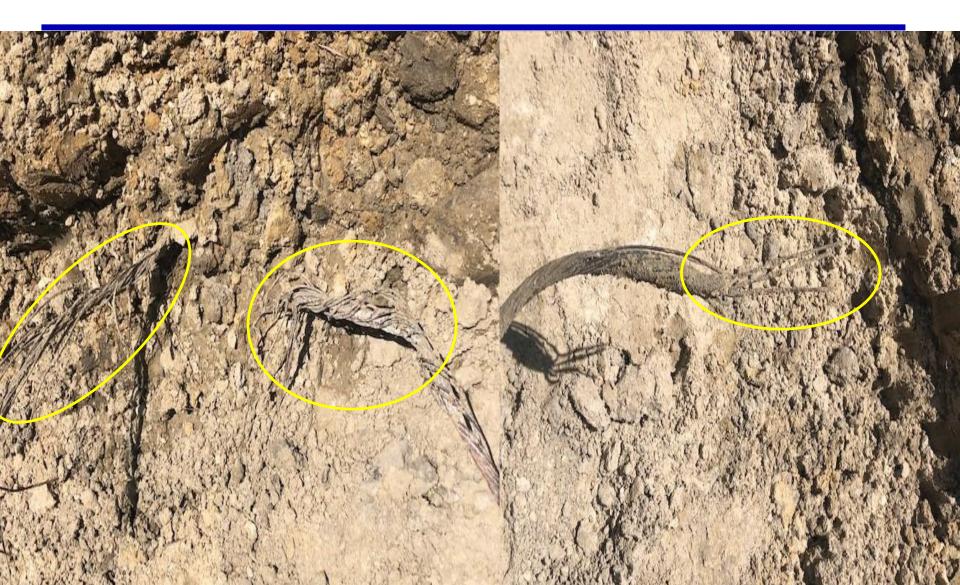
Building 4400 HPIW Facility: On June 27, At Approximately 3 pm, a contractor struck and damaged a 5' section of grounding wire with an excavator while excavating for a concrete pad. SSC Form 1627 was completed and the incident was entered into NMIS # 19-100885. The wire was repaired by cad weld.
