# Construction Safety

SSC Construction Inspection  
Safety Findings/Stats

June 2018

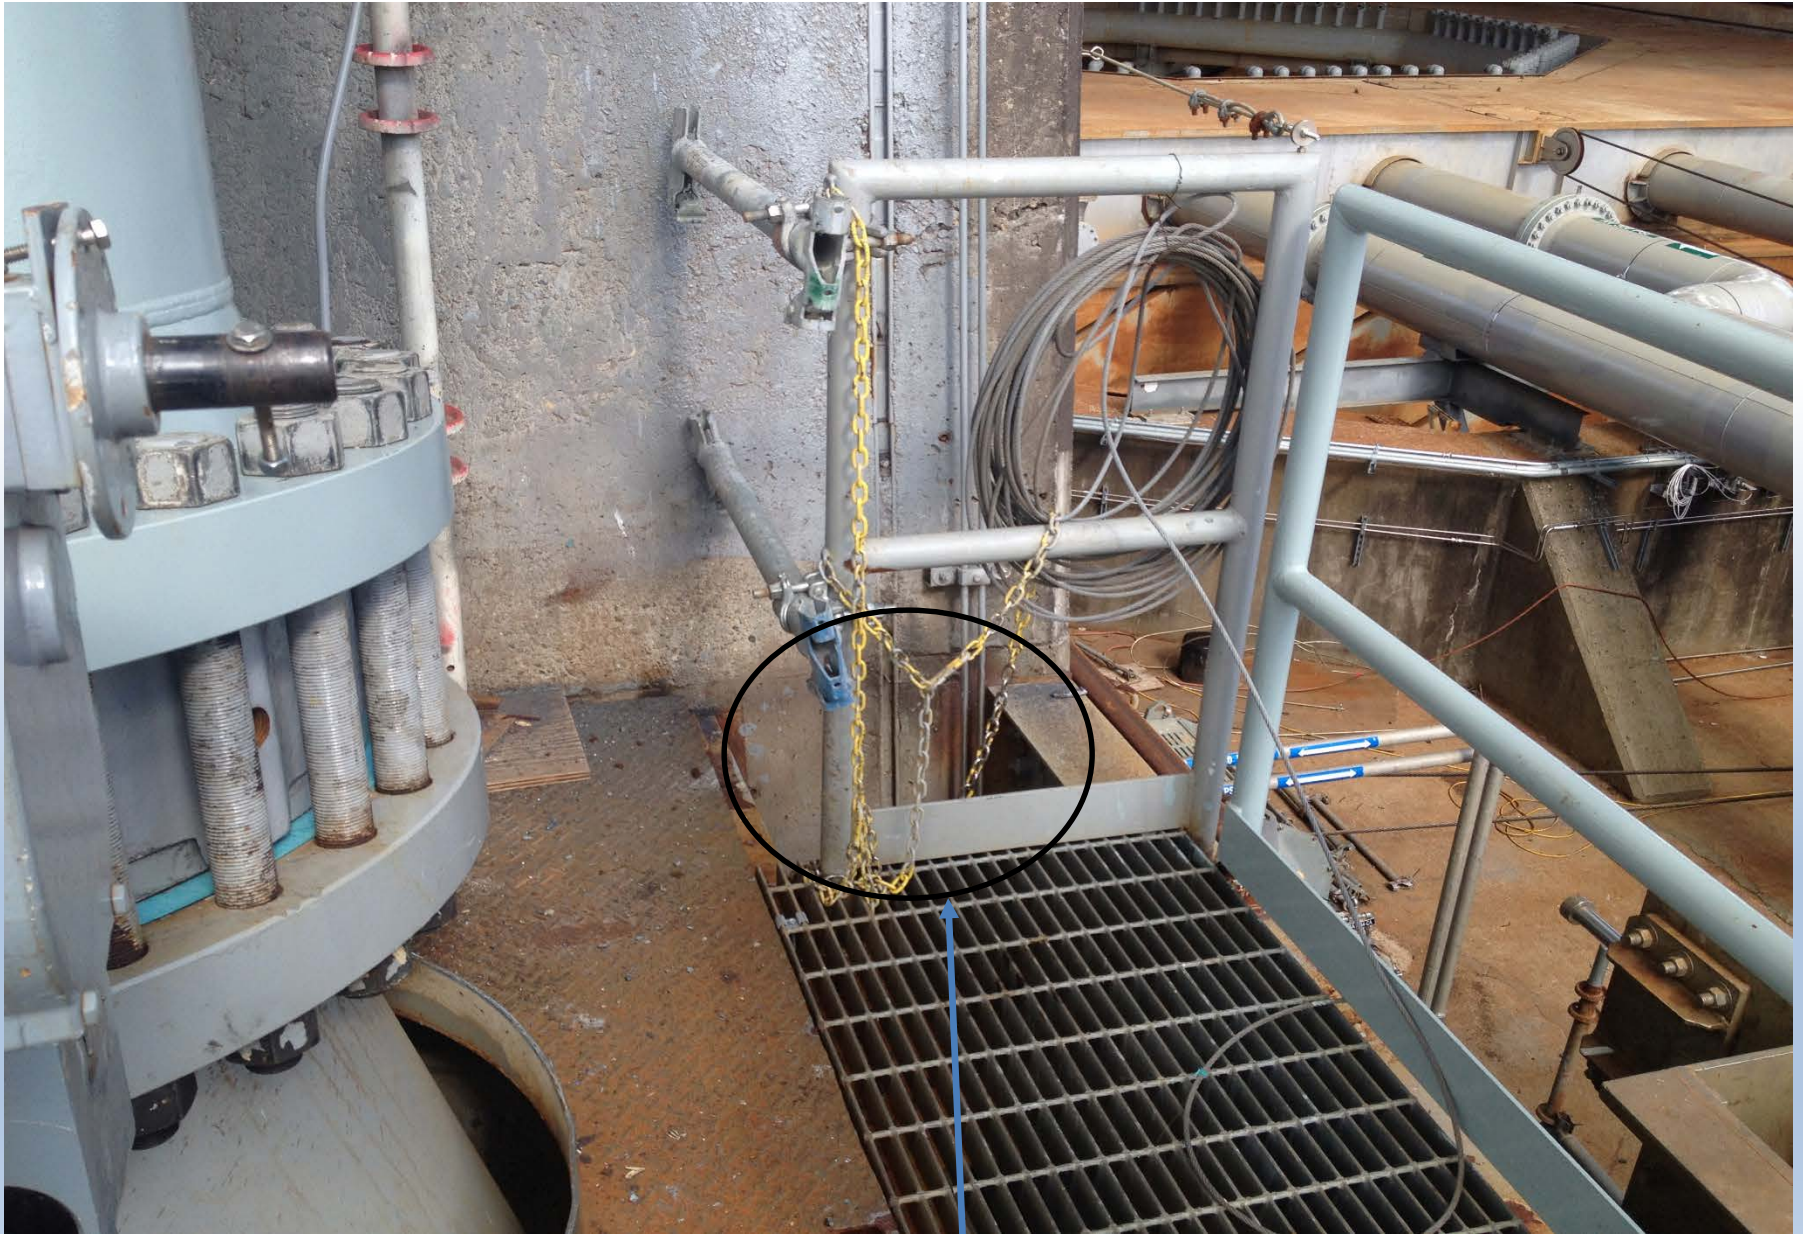
**B-2 Fire-X/HPIW Restoration:** A section of 48" HPIW piping was being delivered via the B2 derrick crane. Workers were on the southeast platform to install the pipe. There is a hole in the grating of sufficient size for a person to fall in the immediate vicinity of the pipe being installed. In addition, this hole is adjacent to an opening without handrails that leads to a substantial drop. Neither the hole nor the opening had protective measures against falls. Hazardous condition: Several of the personnel working within a few feet of this opening were not using fall protection. A fall into the hole or through the opening would likely have resulted in a serious injury. (CCRS 18-037)

Previously unprotected area
