Construction Safety

SSC Construction Inspection
Safety Findings/Stats

June 2015

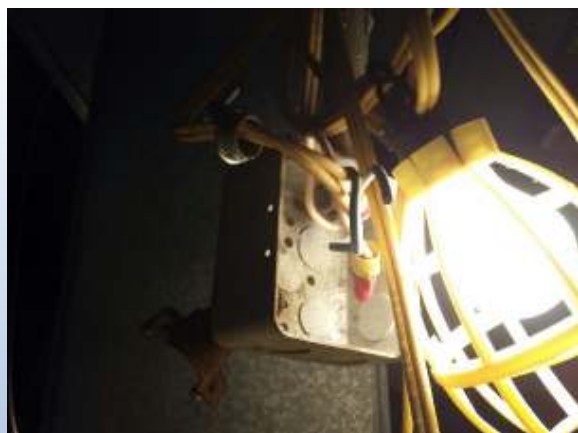
BEFORE

1. Electrical junction box missing the required cover and wires not secured, 29CFR1926.405 (b)(2). Corrected on-the-spot.

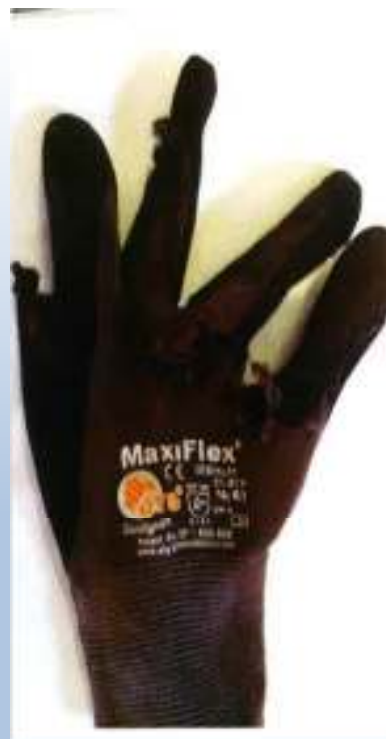
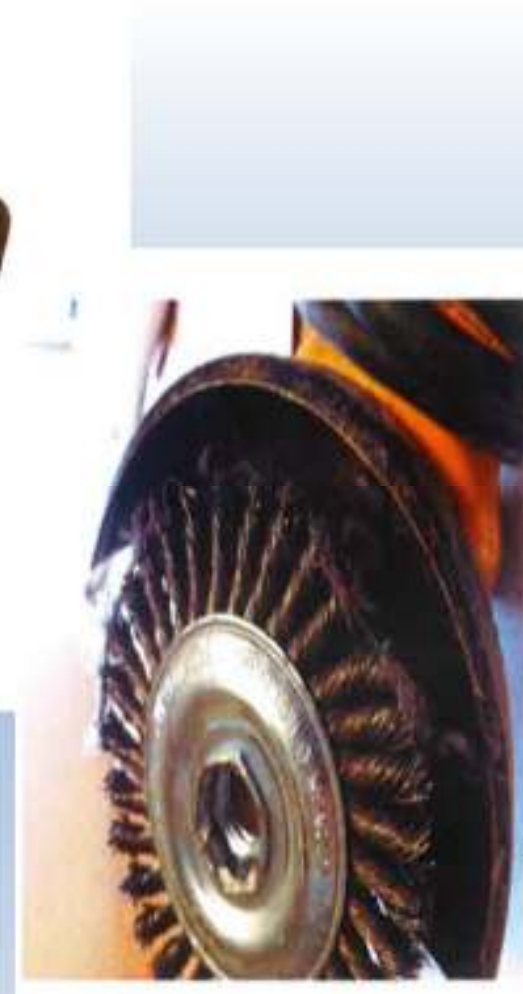
1. A worker was operating a grinder with a wire brush attachment, when the glove on the left hand became entangled in the moving wheel. The wheel cut through the glove, contacting the skin near the knuckle of the left index finger. (First Aid)

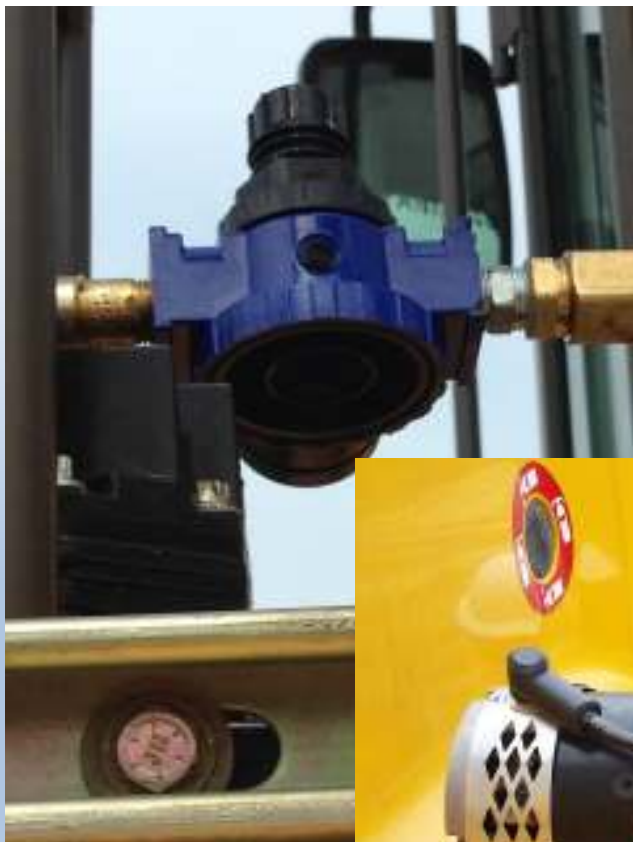
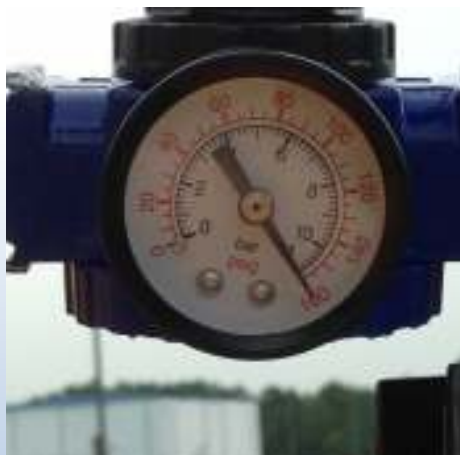
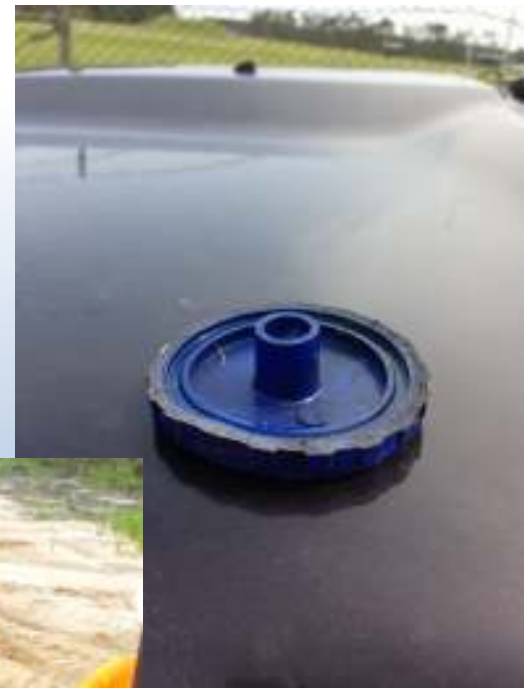
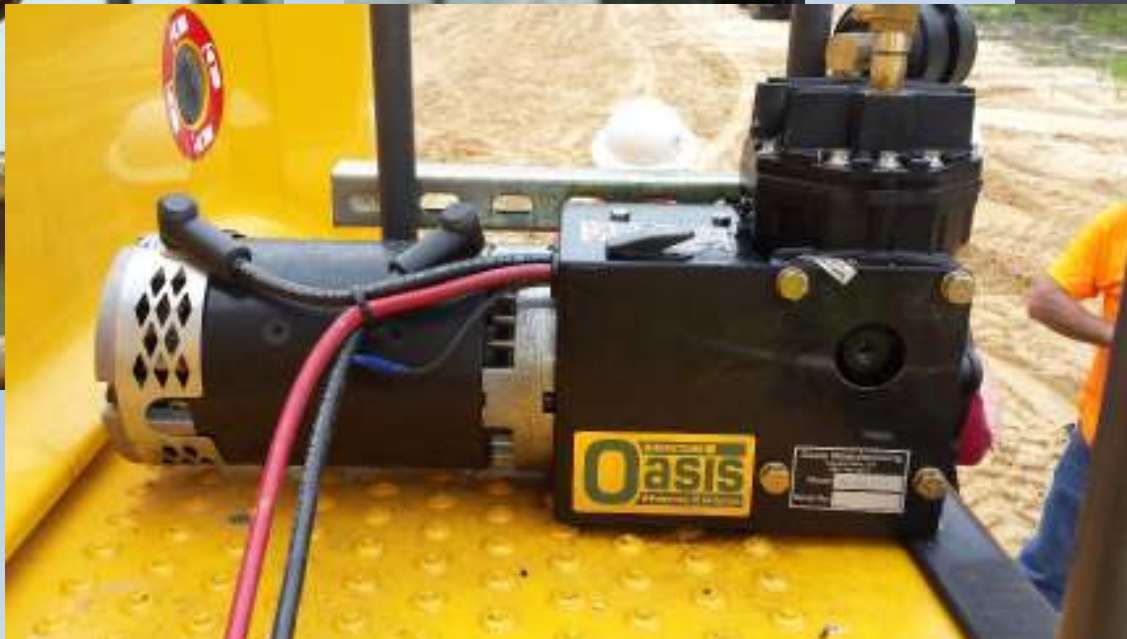
Construction Safety Findings: 22-26 June 2015

1. On June 23, 2015, workers noticed the pressure regulator on an air compressor on the job site was failing to regulate pressure down to the needed 90 PSI. They replaced it with a new pressure regulator. On June 24, 2015 at approximately 0900, a worker turned on the compressor and the regulator almost immediately exploded, with parts contacting the worker's left index and middle fingers. The incident caused a deep laceration and fractured bones to the worker's left index finger. The worker received first aid on-site and was transported to the SSC Clinic. The worker was then transported to Ochsner Medical Center-Northshore in Slidell. The worker received stitches and two perscription medications, along with a confirmation of broken bones, making this an OSHA Recordable or NASA Type D Mishap.
