SSC Construction Inspection  
Safety Findings/Stats

June 2016

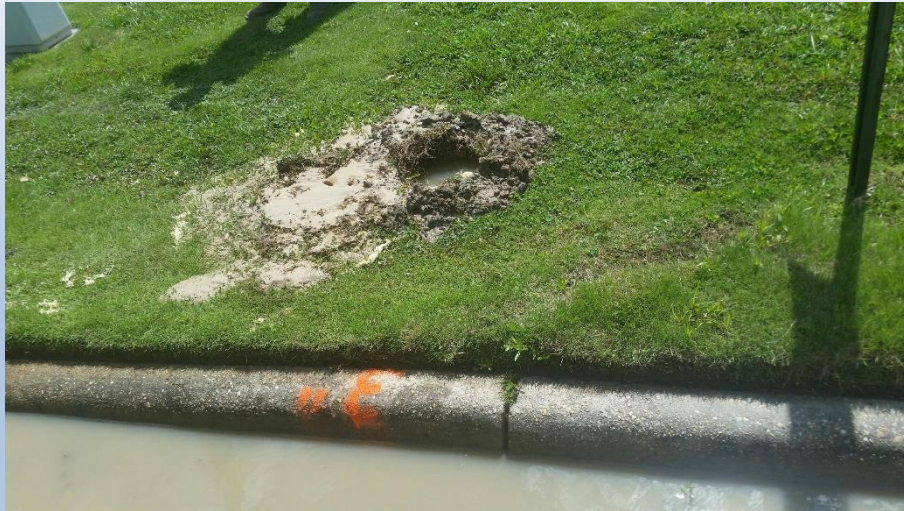
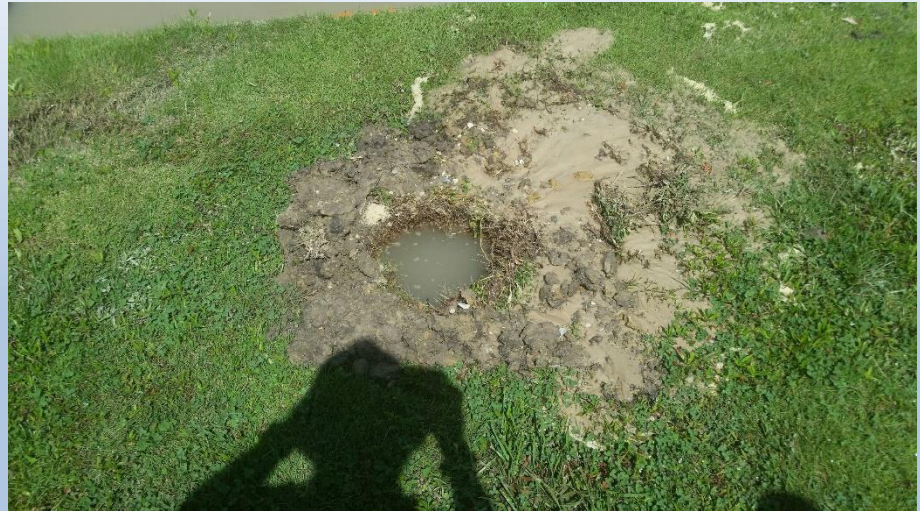
- WP#3: A worker was using a grinder w/o hearing protection.
- WP#3: Two extension cords were found passing through a doorway without pinch point protection.

1. Highway 607 Standardization: Close Call (NMIS) 16-100754: on June 2, at about 10:30 AM, a construction contractor in the process of installing road signs on Trent Lott Parkway struck a buried water line near the south gate guard shack.

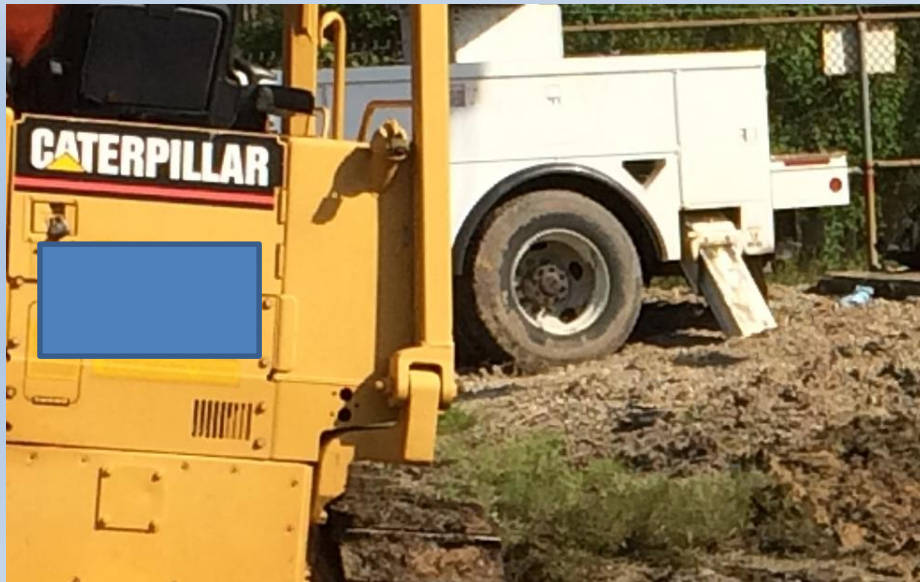
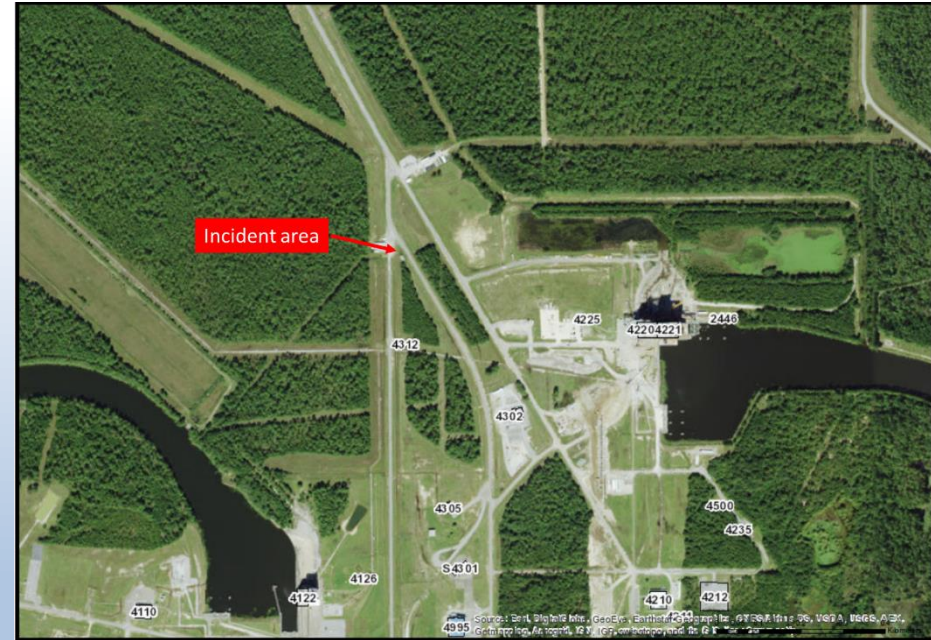
- WP#3: The contractor neglected to perform the required load test of the crane following relacing of the boom.

**“When the adjustment, repair, disassembly, or replacement of a load bearing part, load controlling part, or operational safety device requires a load test for verification of satisfactory work performed, recertification is required. If load components or safety are not compromised, recertification is not required. If the certifying official and test personnel cannot reach agreement whether components have been compromised, the SSC LDE Manager or designee shall have final determination.”**

**“Modifications. Cranes may be modified and rerated provided such modifications and the supporting structure are checked thoroughly for the new rated load by a qualified engineer or the equipment manufacturer. The crane shall be tested in accordance with paragraph (k) (2) of this section. New rated load shall be displayed in accordance with subparagraph (5) of this paragraph.”**

**“Rated load test. Test loads shall not be more than 125 percent of the rated load unless otherwise recommended by the manufacturer. The test reports shall be placed on file where readily available to appointed personnel.”**

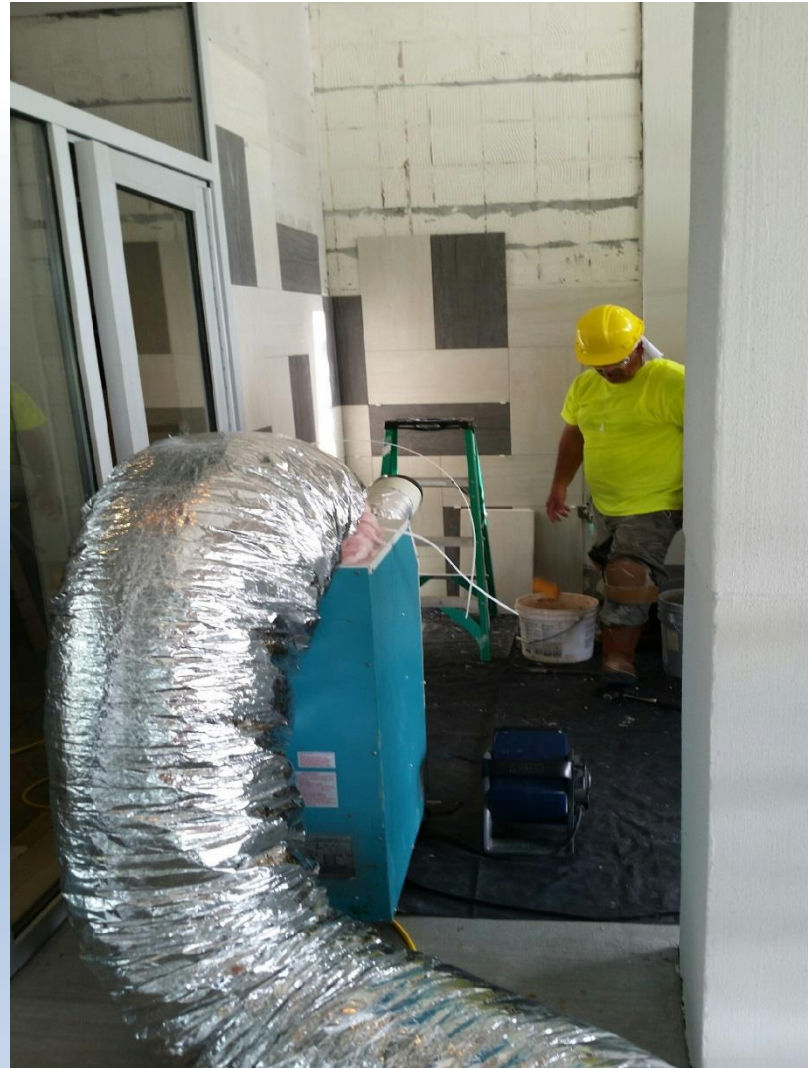
- Greening of Building 1100: Tile setter at the 1100 front entrance was hot, so the contractor brought in a portable AC unit to address the issue.

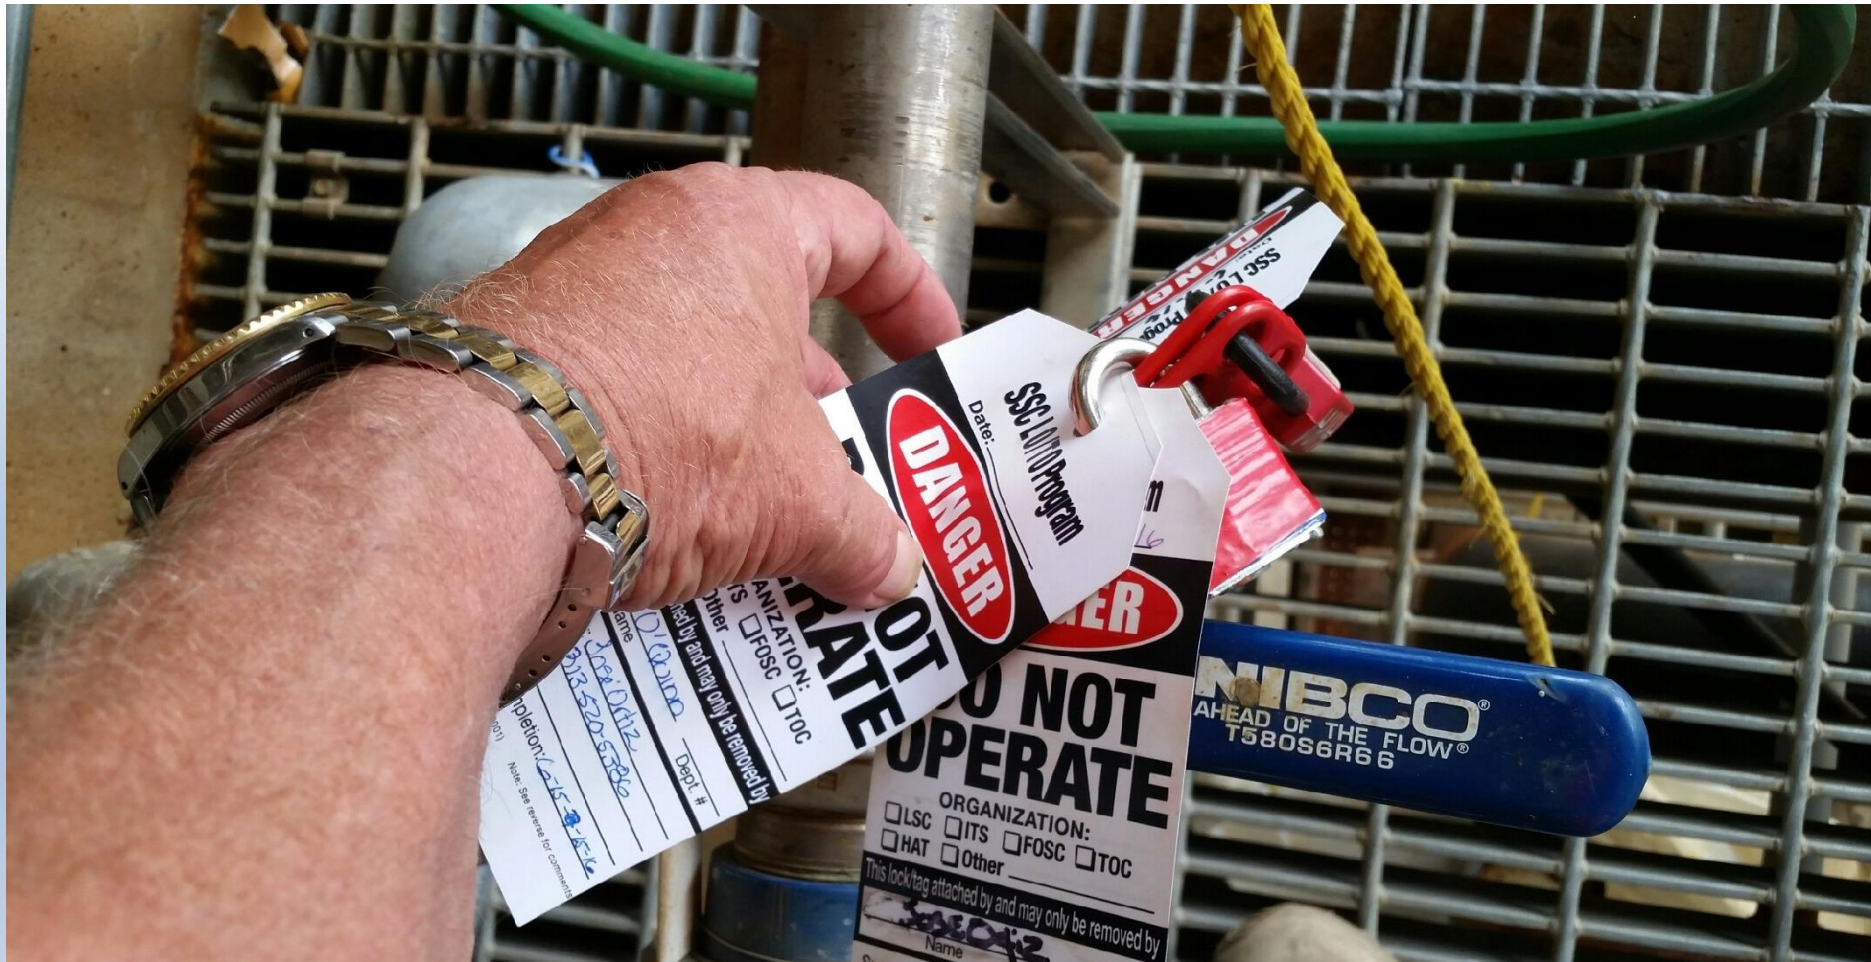
•B-2 WP 3: Two employees using their individual tags on a single lock. One lock and tag per person is required. 29CFR1910.147(f)(3)(ii)D

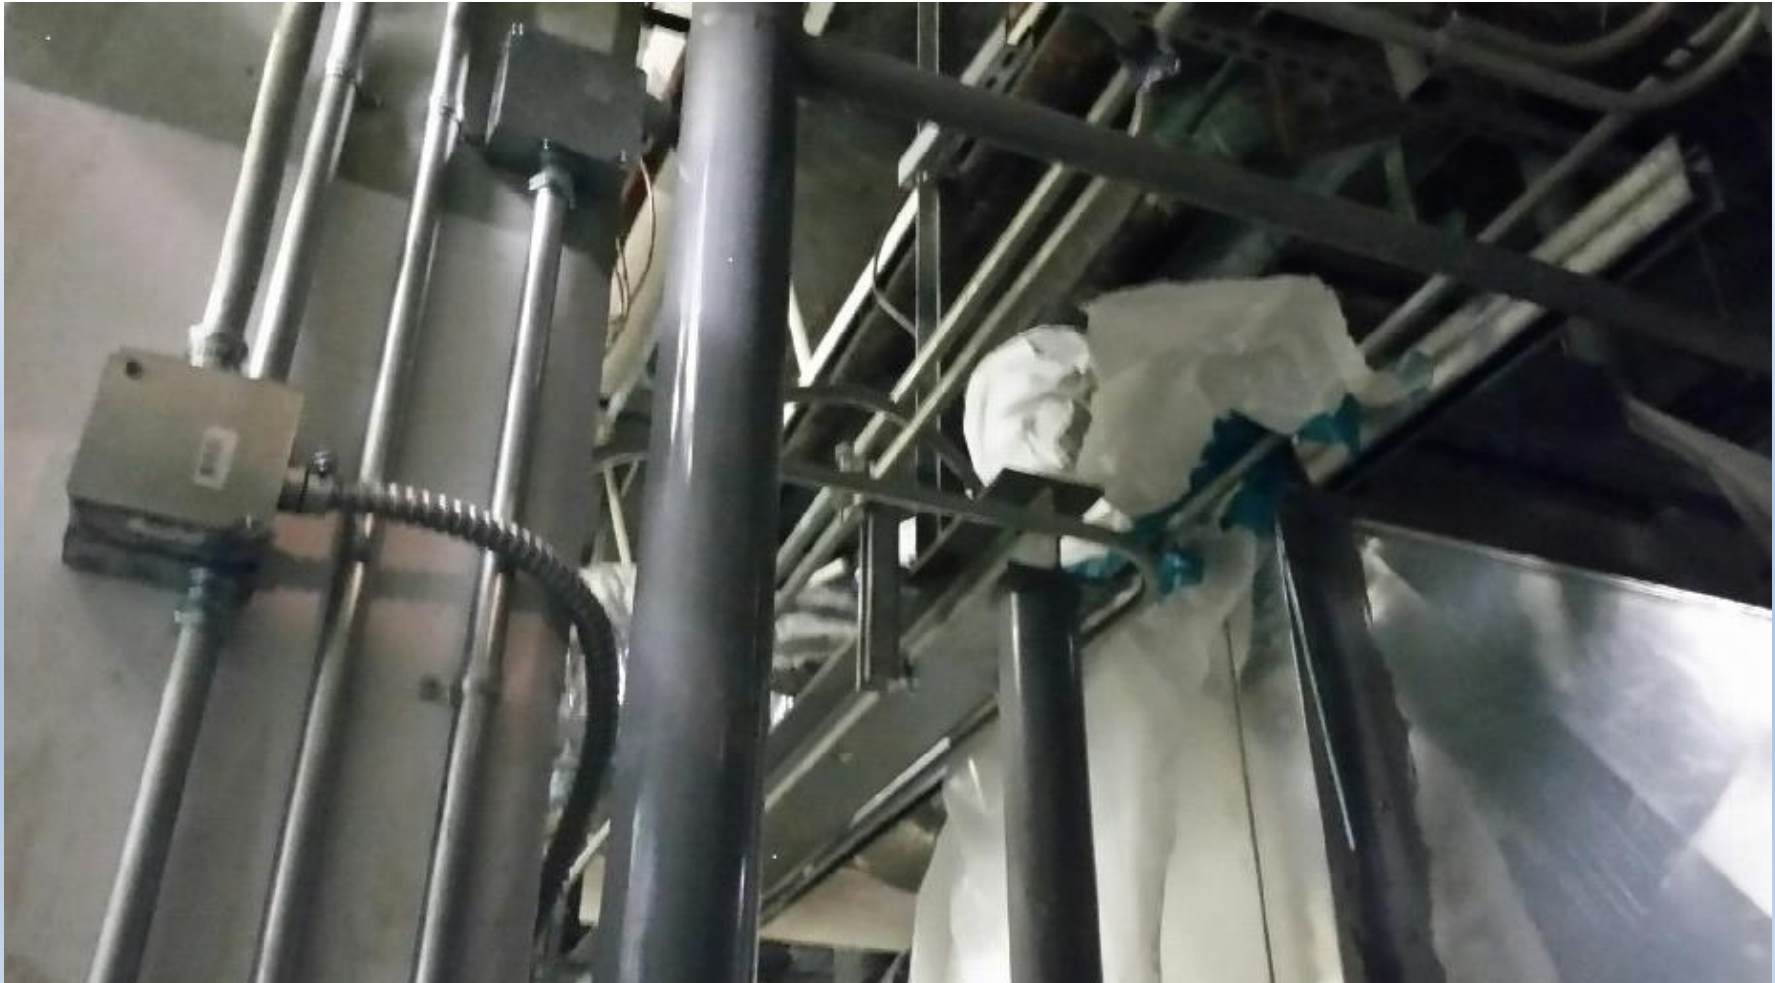
- B2 WP3: B2 Level 11 South, Contractor was using a product that is not SSC approved. (Dichloromethane). SCWI - 8715-0008 Sec 9.0 paragraph 9.12 (1)
- A-TCC HVAC Refurb: Inspector observed an employee in an elevated area well over 10 feet not wearing fall protection. 29CFR1926.501 (b) (1)
