Construction Safety

SSC Construction Inspection
Safety Findings/Stats

July 2014

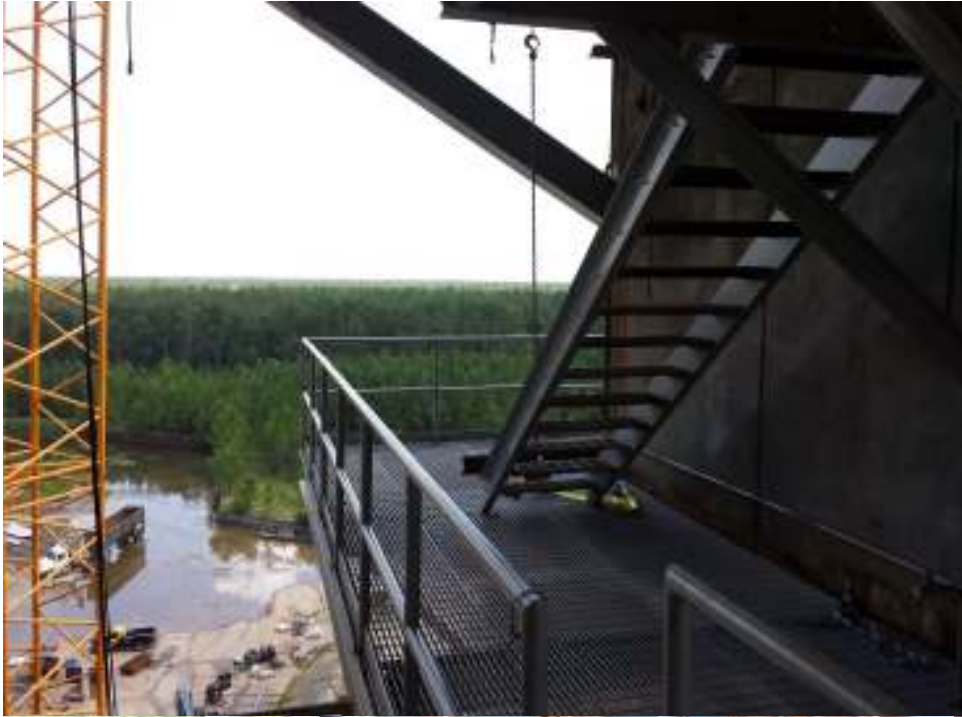
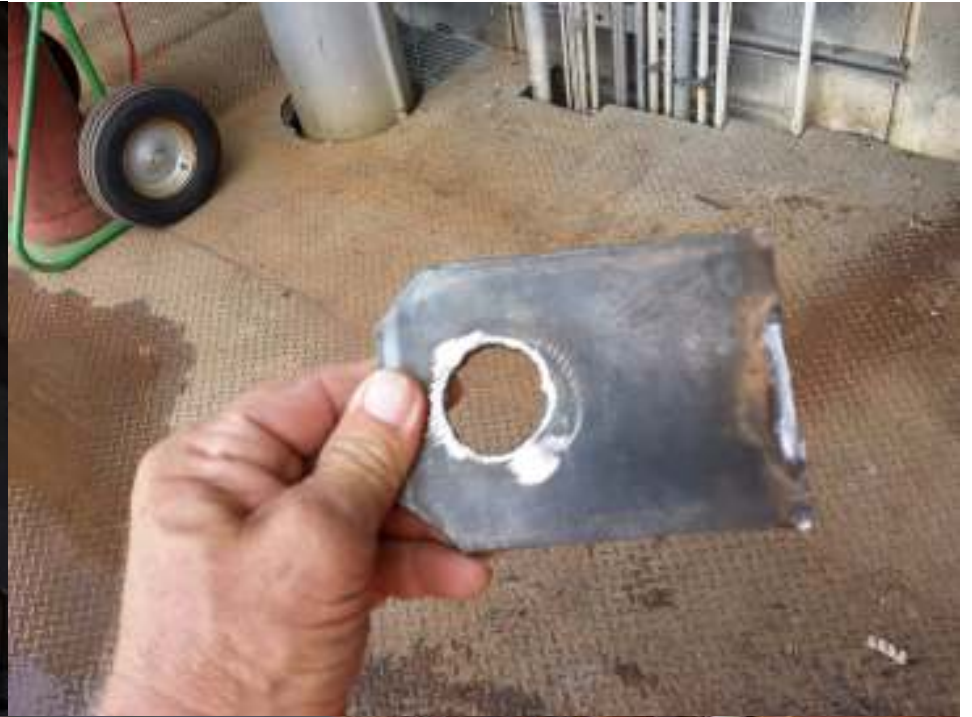
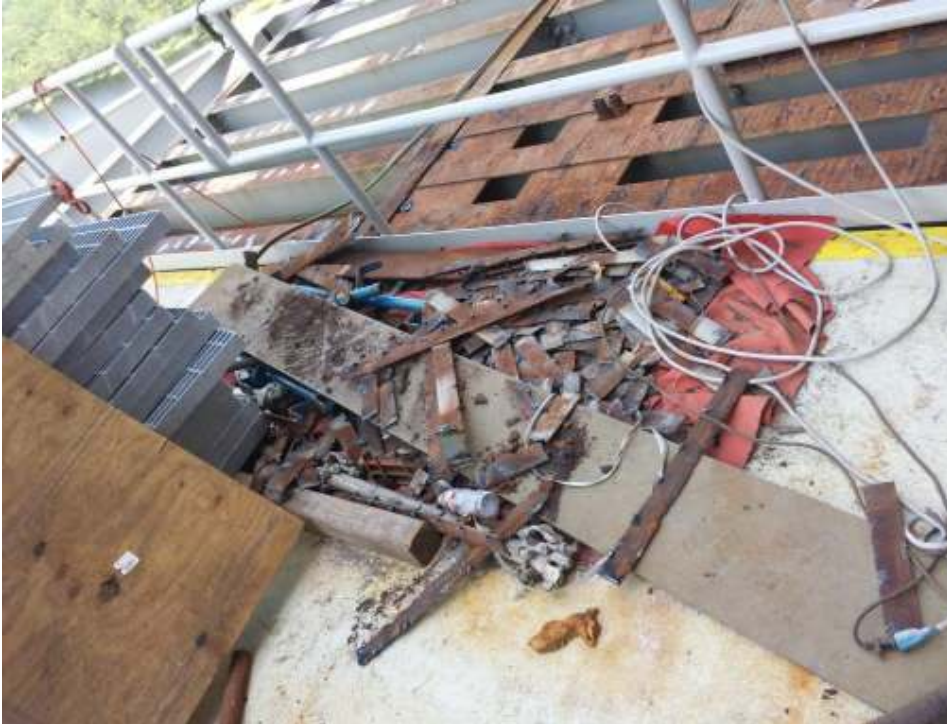
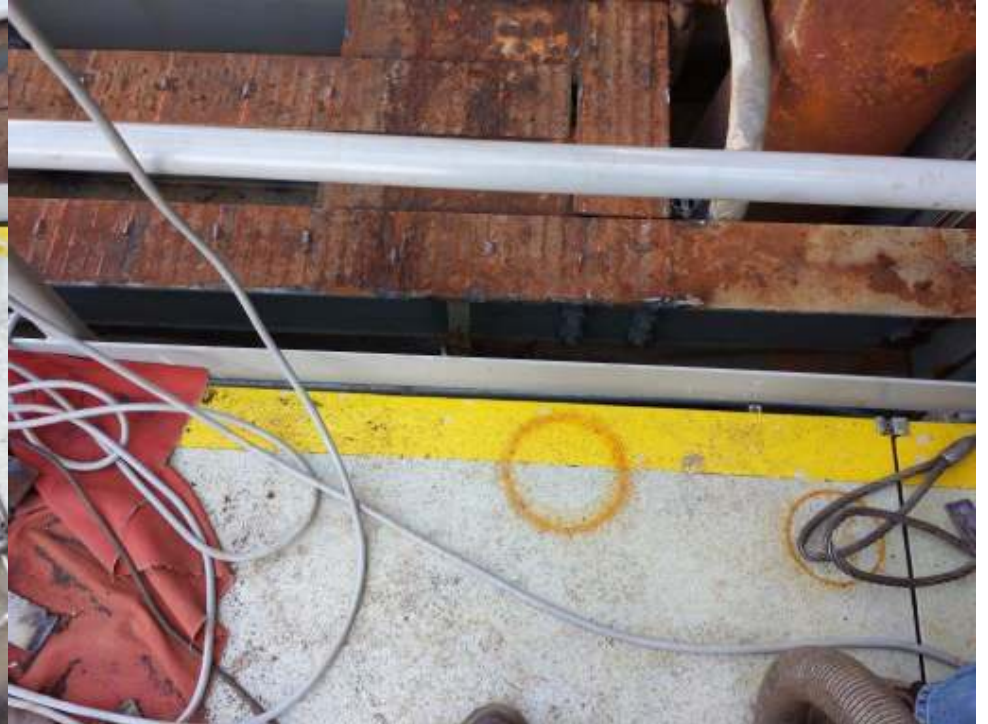
1. Subcontractor employee installing stair risers on a Level 7 platform elevated above the guard rail system without adequate fall protection. 29CFR1926.501(b)(1)

1. A welding supervisor accidentally dropped a steel lifting pad eye from Level 8 of the B-2 test stand. The pad eye fell through an opening by the wall and free fell to the ground landing about two feet from the stand wall. No injuries or damages noted.
2. One piece of removed scrap debris metal fell through level 7 toe-board to ground. The debris pile was close to rolling deck toe-board where a half inch gap exists. No injuries or damages noted. The area was cleaned up and metal pile was removed.
3. A flatbed truck driver misjudged the turn into the staging area and the right rear wheels of the flatbed became stuck in the adjacent ditch. No injuries occurred and there was no damage to the truck or the cargo.

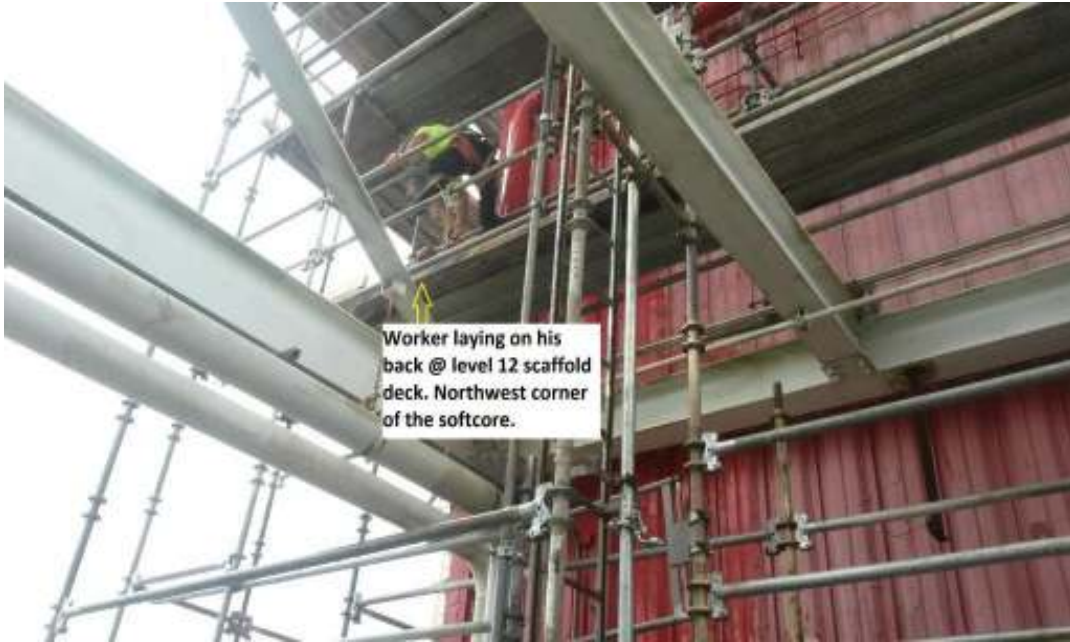
1. A scaffold erector employee tripped over a scaffold pole placed on the deck being worked and fell onto the same deck, resulting in a back injury. The SSC Fire Department responded and had to remove the employee from the Level 12 scaffold and transport to the SSC Clinic. The employee was transferred to the Ochsner Medical Center for evaluation. The employee was released with no medical treatment and issued prescription pain medication, making this an OSHA Recordable/NASA Type D Mishap at this time.

Worker laying on his back @ level 12 scaffold deck. Northwest corner of the softcore.

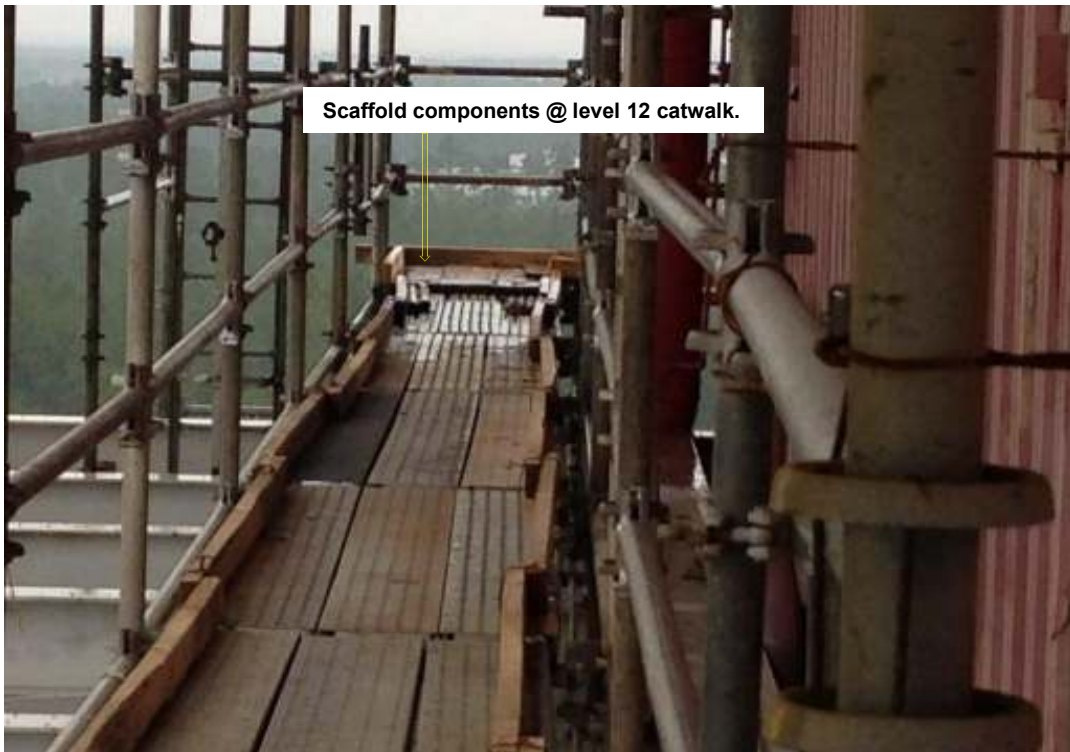
Scaffold components @ level 12 catwalk.

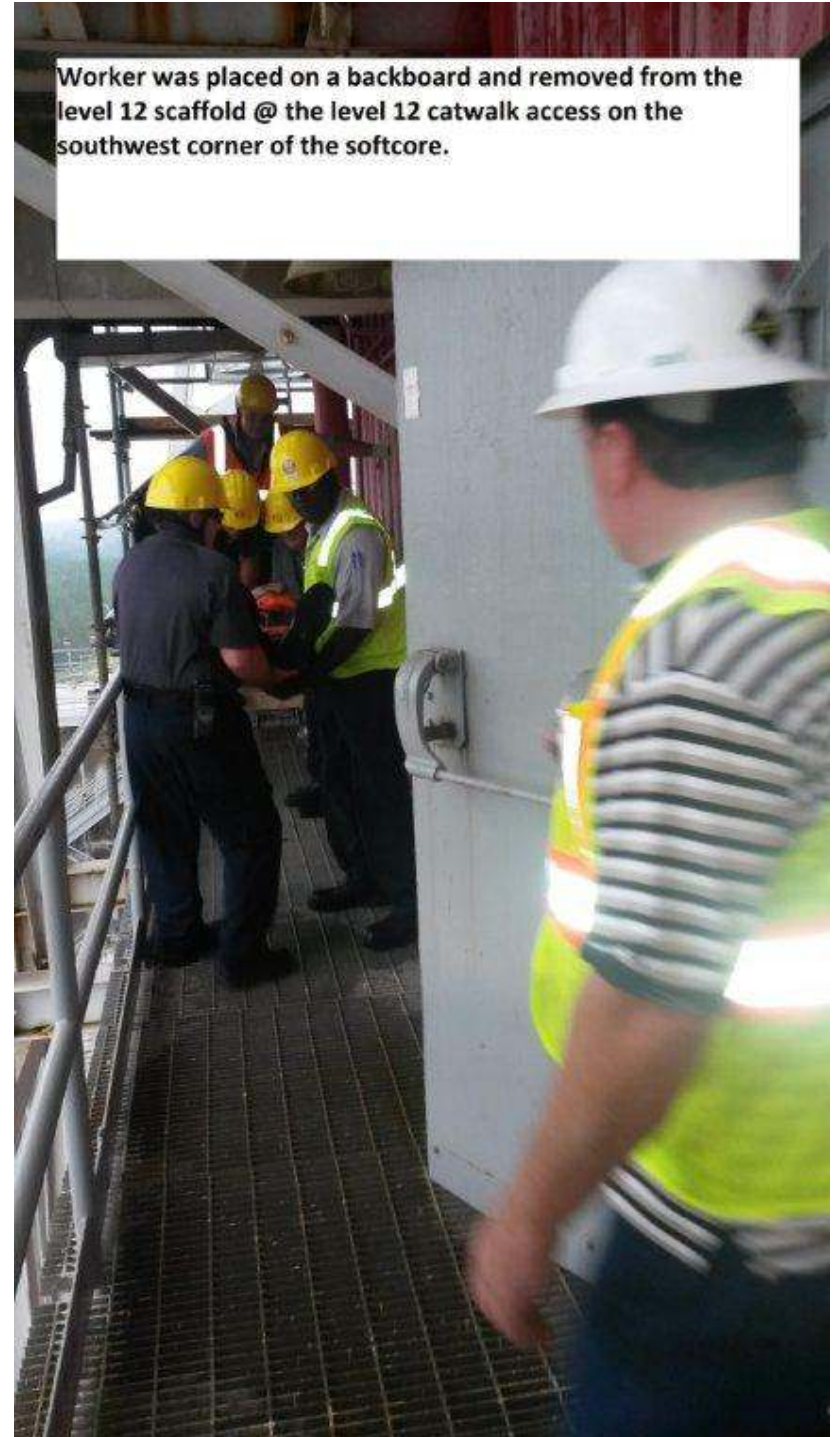
Worker was placed on a backboard and removed from the level 12 scaffold @ the level 12 catwalk access on the southwest corner of the softcore.

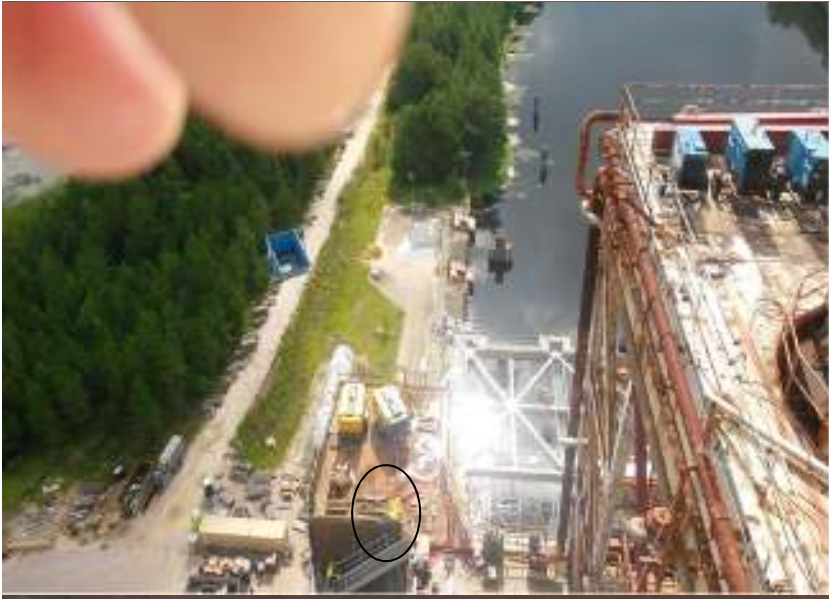
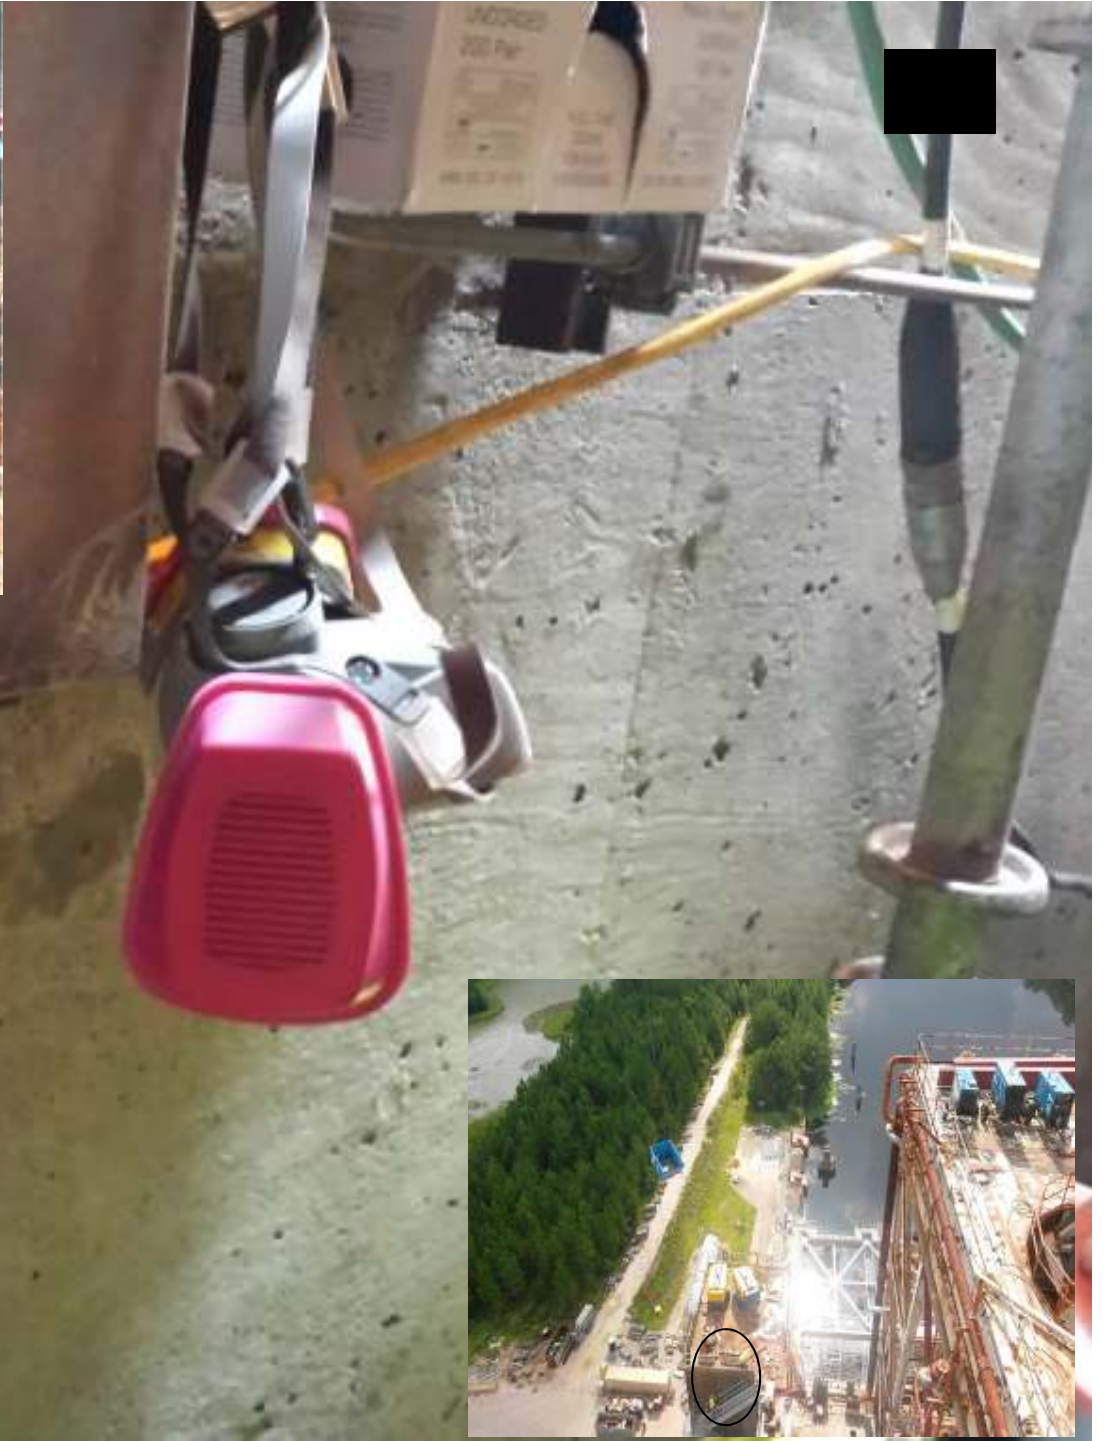
1. Subcontractor employee not wearing personal fall arrest gear climbed into an elevated skid pan not designed for human occupancy, being exposed to a life threatening fall on Work Package #3 project. 29CFR1926.501 (b)(1)
2. Subcontractor employees exposed themselves to a fall to the next level by climbing over a hand rail on Work Package #3 project. 29CFR1926.501 (b)(1).

1. Three subcontractor employees performing construction work in a designated construction area without safety glasses. SCWI-8715-0008 section 9.3
2. Improper storage of respirator mask. 29CFR1910.134(c)(1)(v)

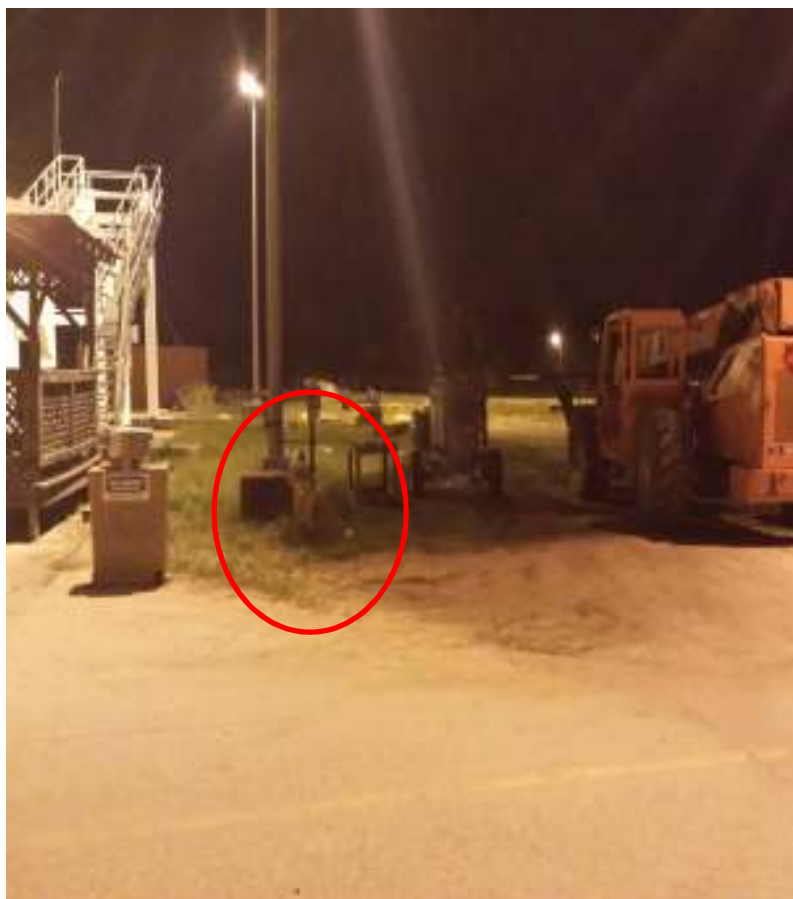
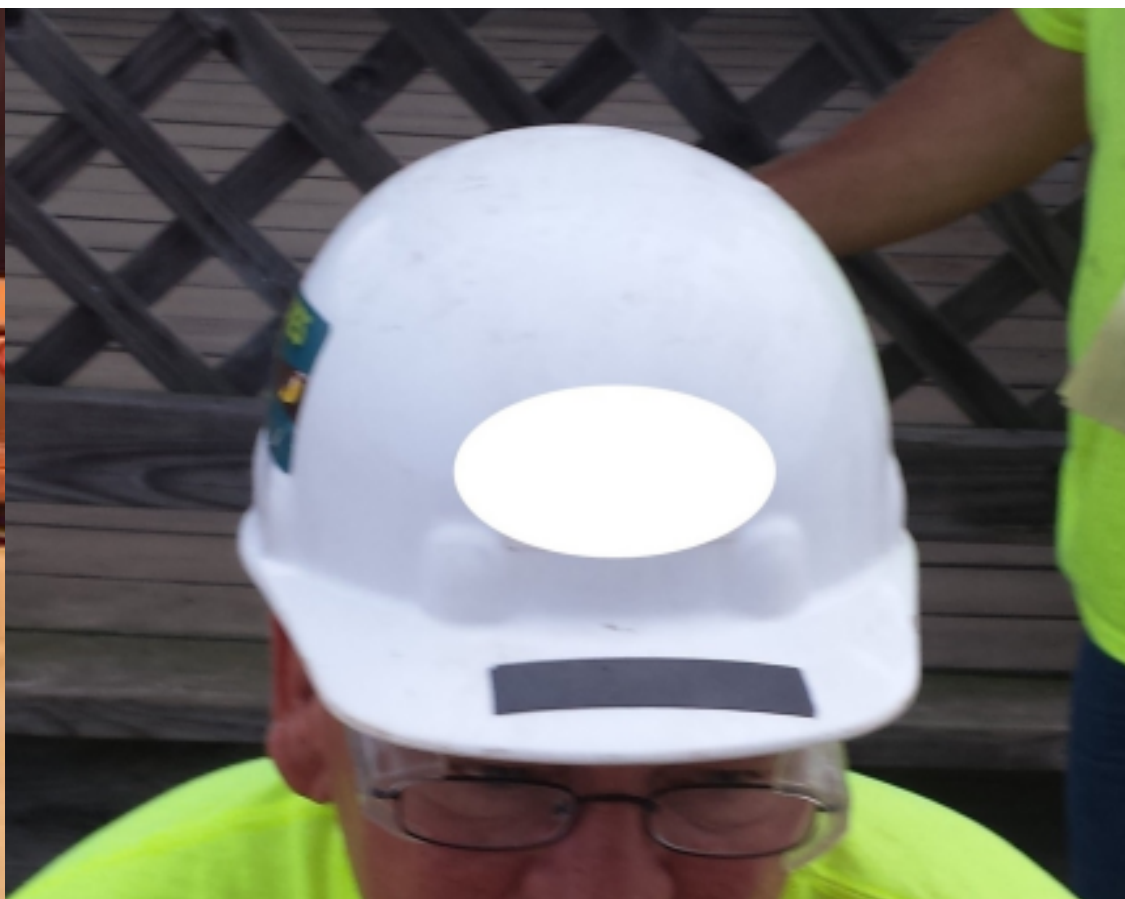
Construction Safety Findings: 28 July-01 August 2014

1. Contractor employees continue to place items and park equipment near the fire hydrant at the B Test Stand, obstructing it from being conspicuously located. 29CFR1926.150(a)(3)

B-2 Test Stand: The construction contractors have agreed to purchase and provide magnetic strips for employee hard hats in an effort to reduce the chances of additional eye injuries from metal shavings or dust particles on the stand. Employees have reported the strips appear to be working as noted by several instances of items found attached to the strips.
