Construction Safety

SSC Construction Inspection
Safety Findings/Stats

August 2018

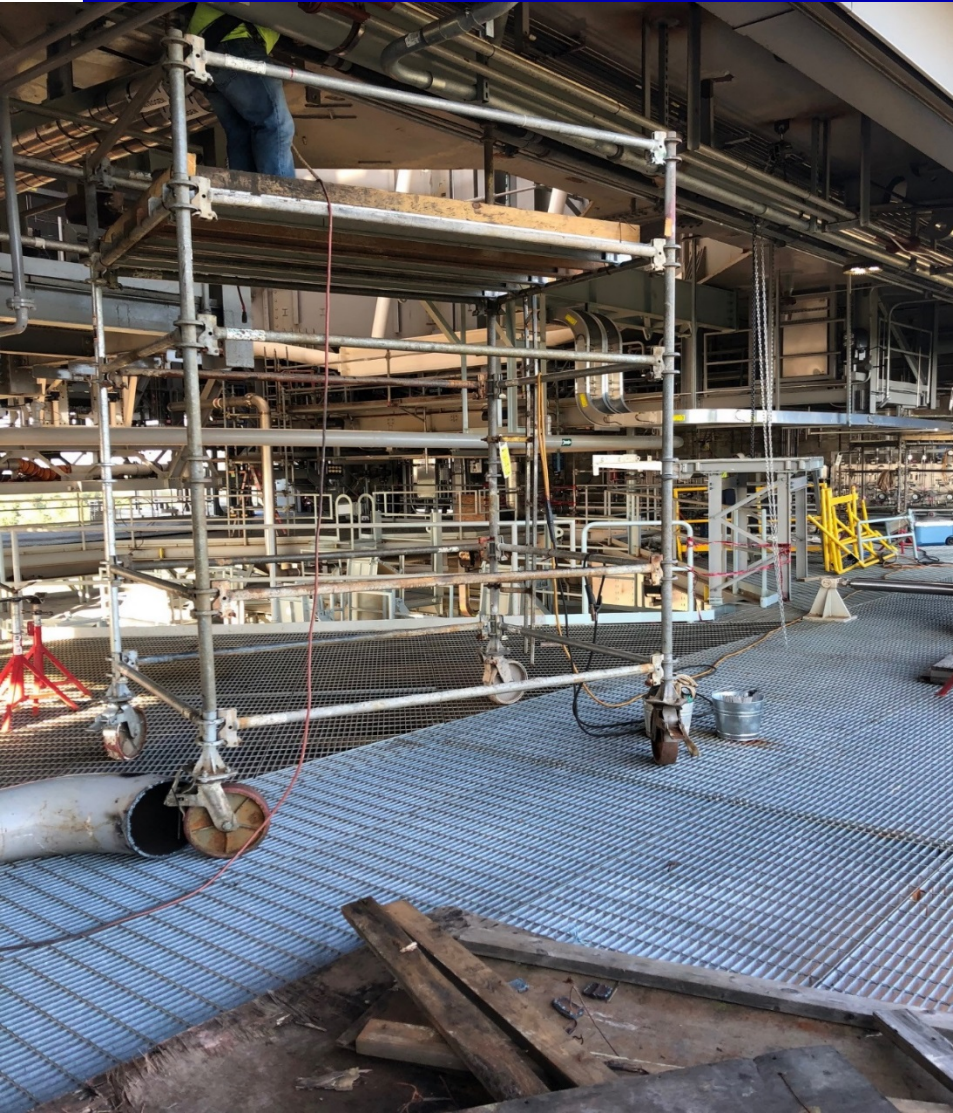
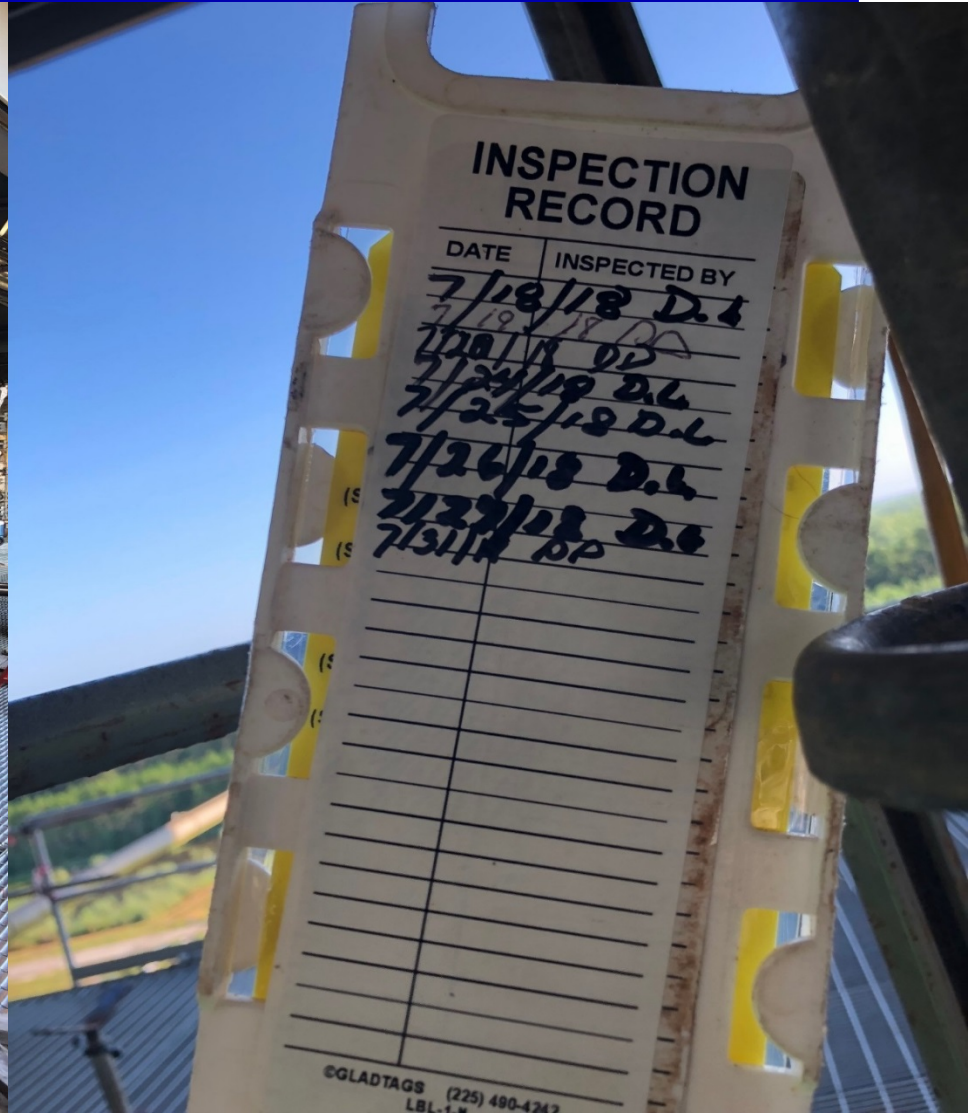
B-2 Fire-X/HPIW Restoration: On August 3, a contractor on B2 Test Stand was observed utilizing a rolling scaffolding without the required pre-use inspection and tag sign off. Ref: SCWI-8715-0008 Sec 6.8.3. ID # 88363. SHEtrak Closed

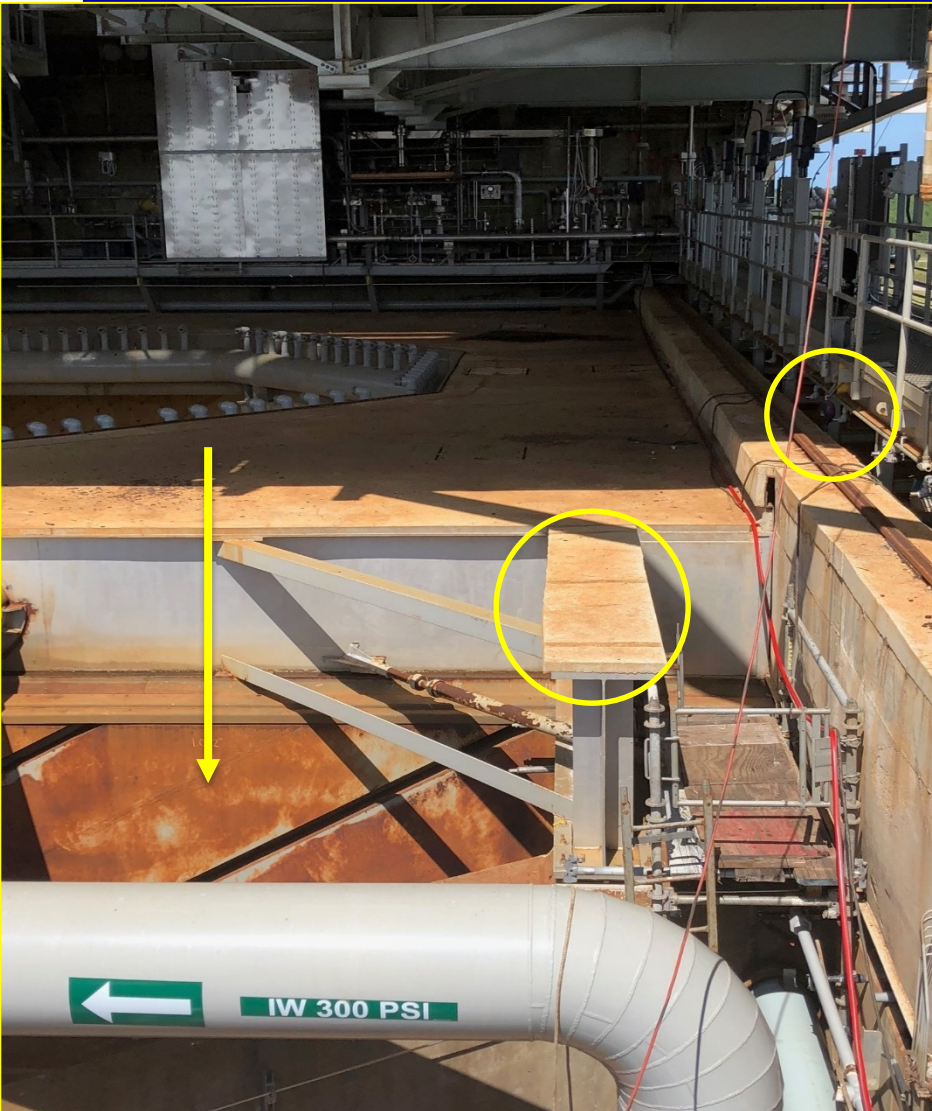
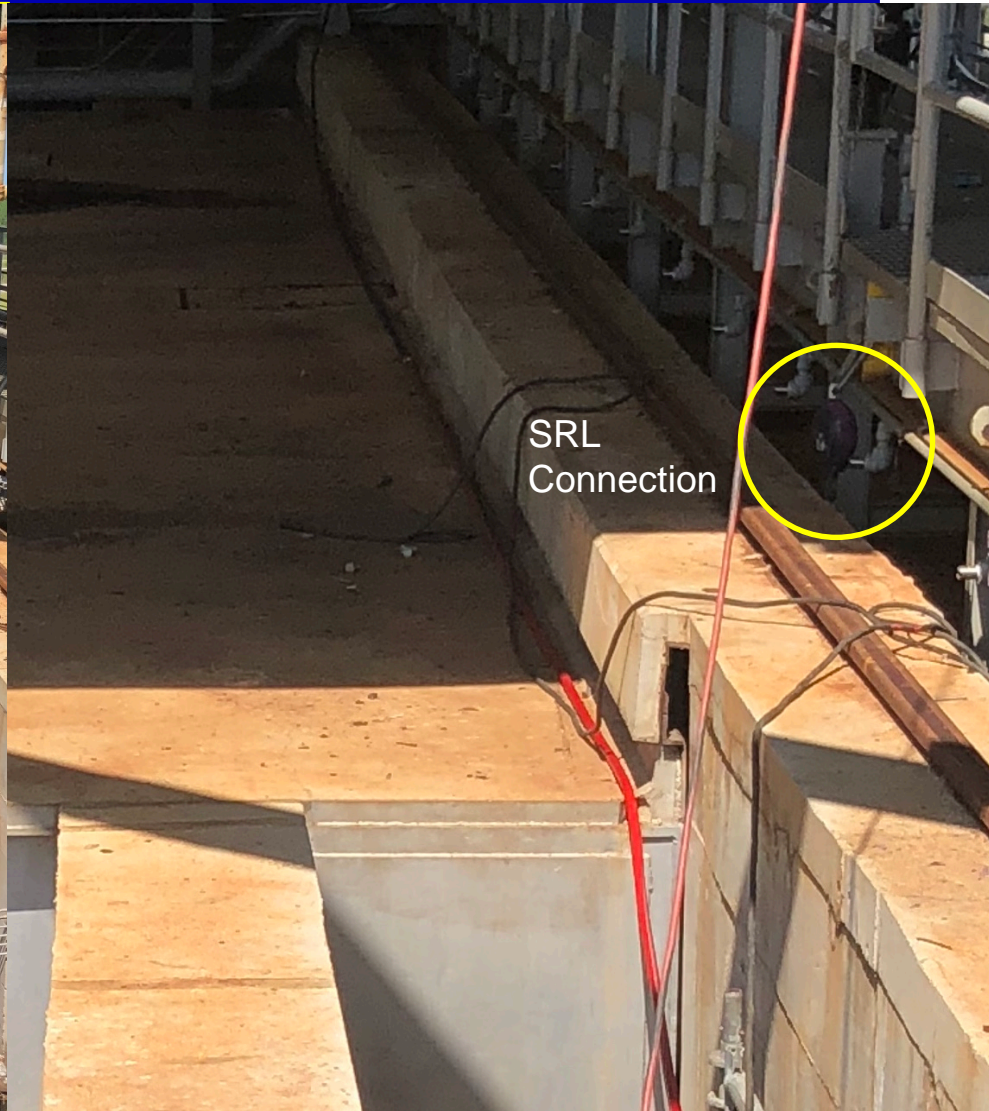
B-2 Fire-X/HPIW Restoration: On August 2, on the B-2 test Stand, a NASA Direct Construction contractor suited up with a personal fall arrest system gear (Full body harness, lanyard) walked out onto a level seven I-beam without the benefit of being tied off to an available anchorage. The employee was exposed to a potential fall of approximately 100'. Ref: SCWI-8715-0003 6.1 (i). NIMIS # 18-101252

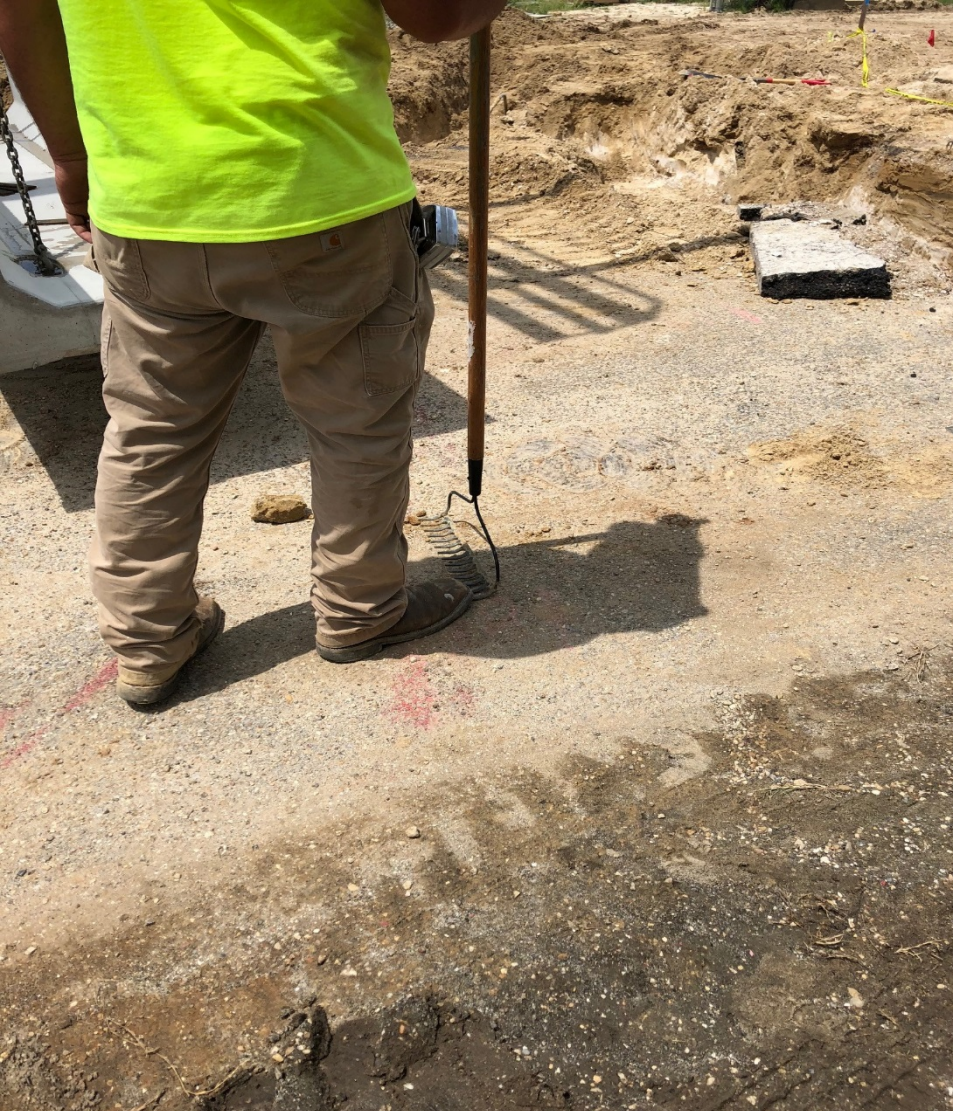
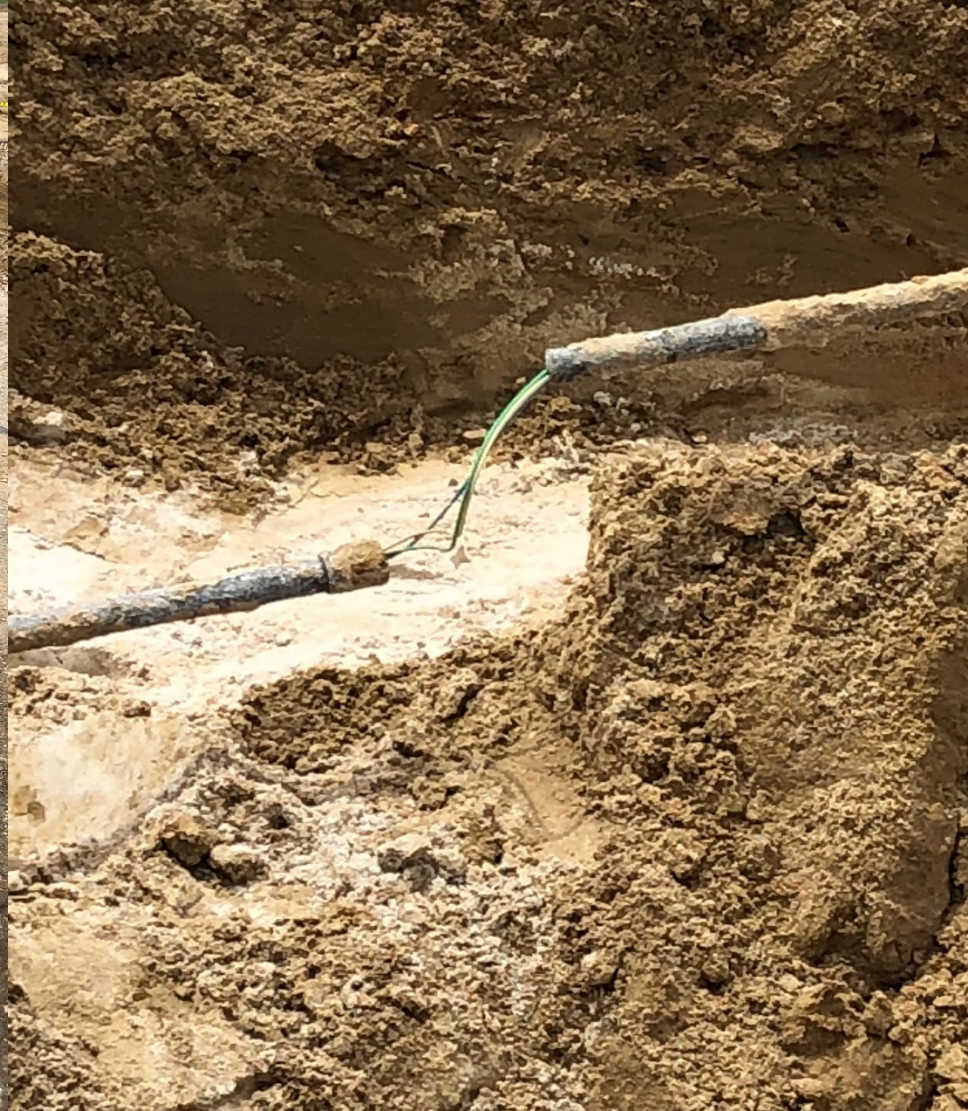
HPG Phase II: A contractor struck an underground electrical line. The line was identified and marked on the ground. S-3 shops responded to safety the electrical line and make necessary repairs. Mechanical excavation was being done north of Building 4400 looking for the water supply line to the fire hydrant. Notifications made and a 1627 was generated.

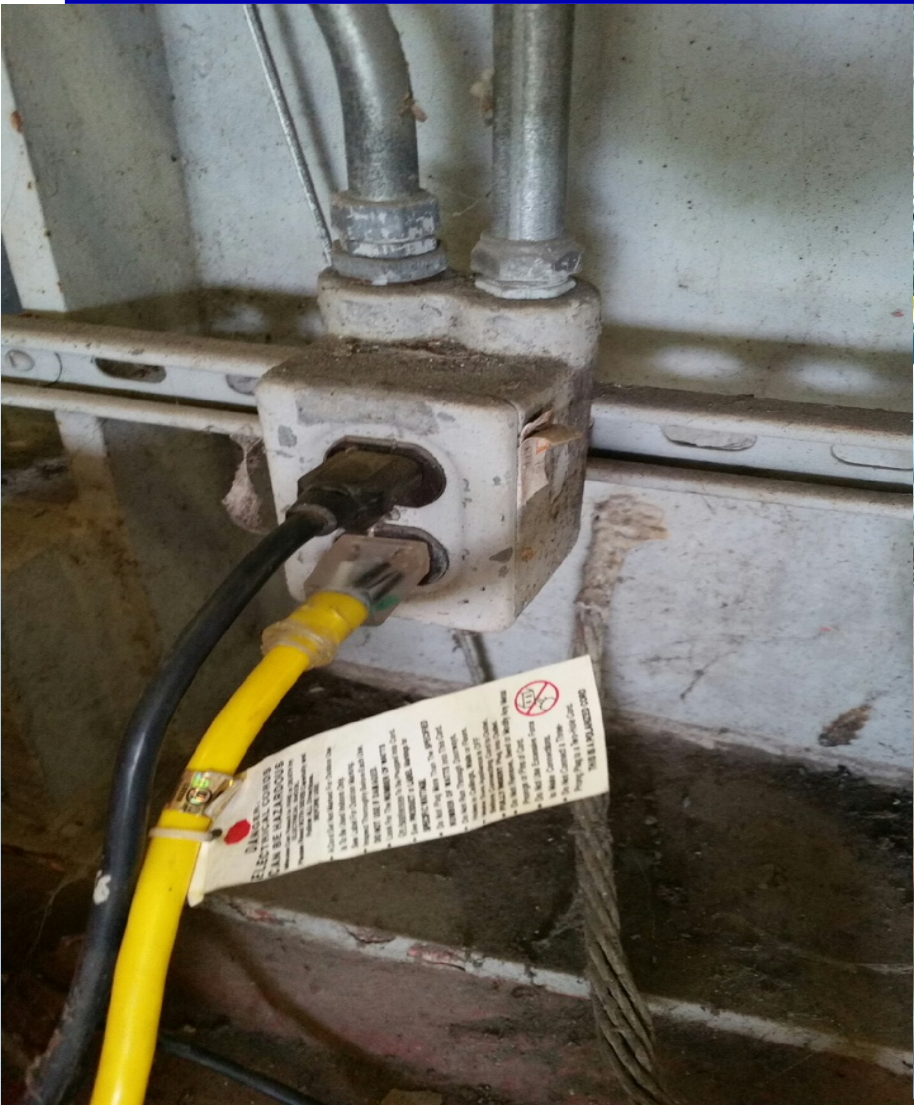
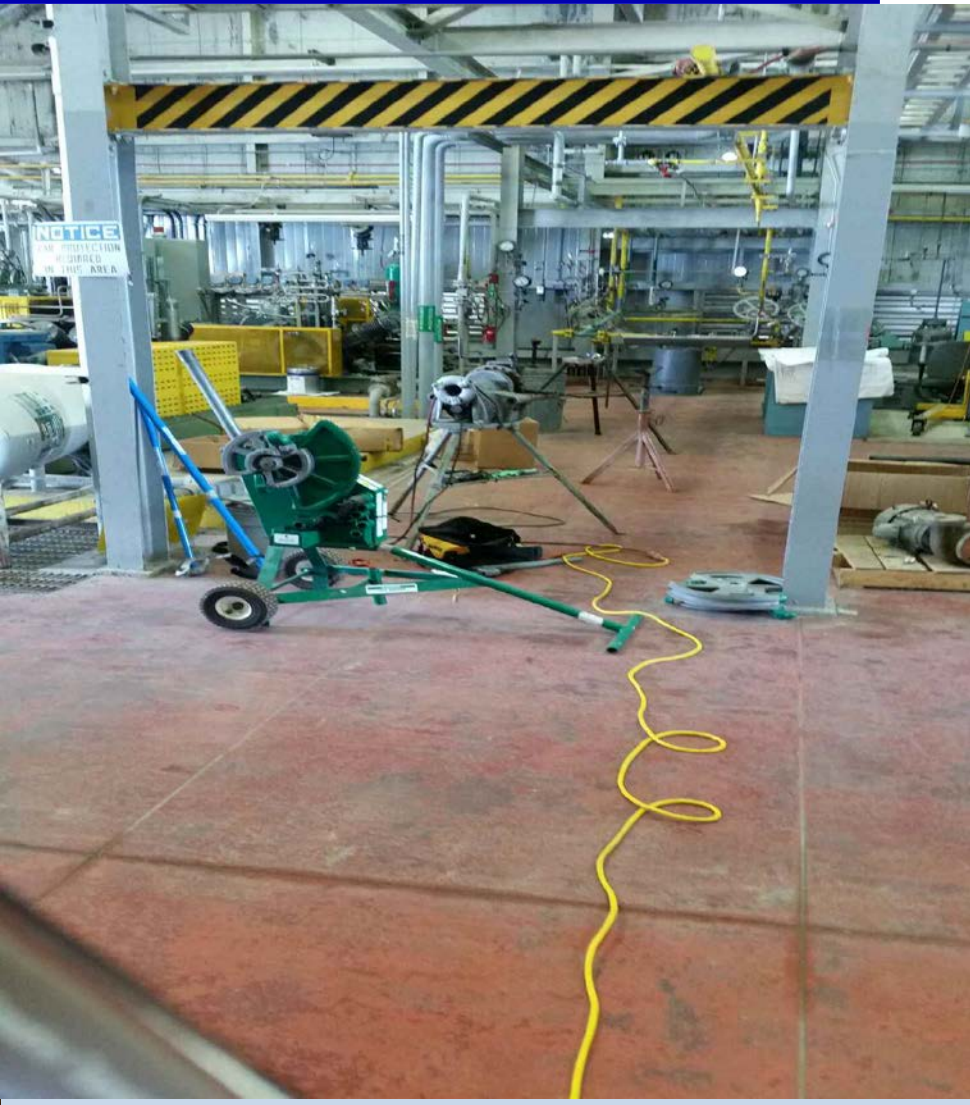
Site–Wide Fire Hazard Detection Replacement: On August 08, the contractor failed to use the required ground fault circuit interrupter on a wall outlet power source. The extension cord was plugged into a mechanical pipe threader. Ref: 29CFR1926.404 (b) (1) (ii). SHEtrak closed. ID# 88491

Site–Wide Fire Hazard Detection Replacement: On August 08, three contractor employees failed to wear the required bright color shirt or high visibility apparel while in a construction zone. Ref: SCWI-8715-0008 9.3. SHEtrak Closed. ID# 88490

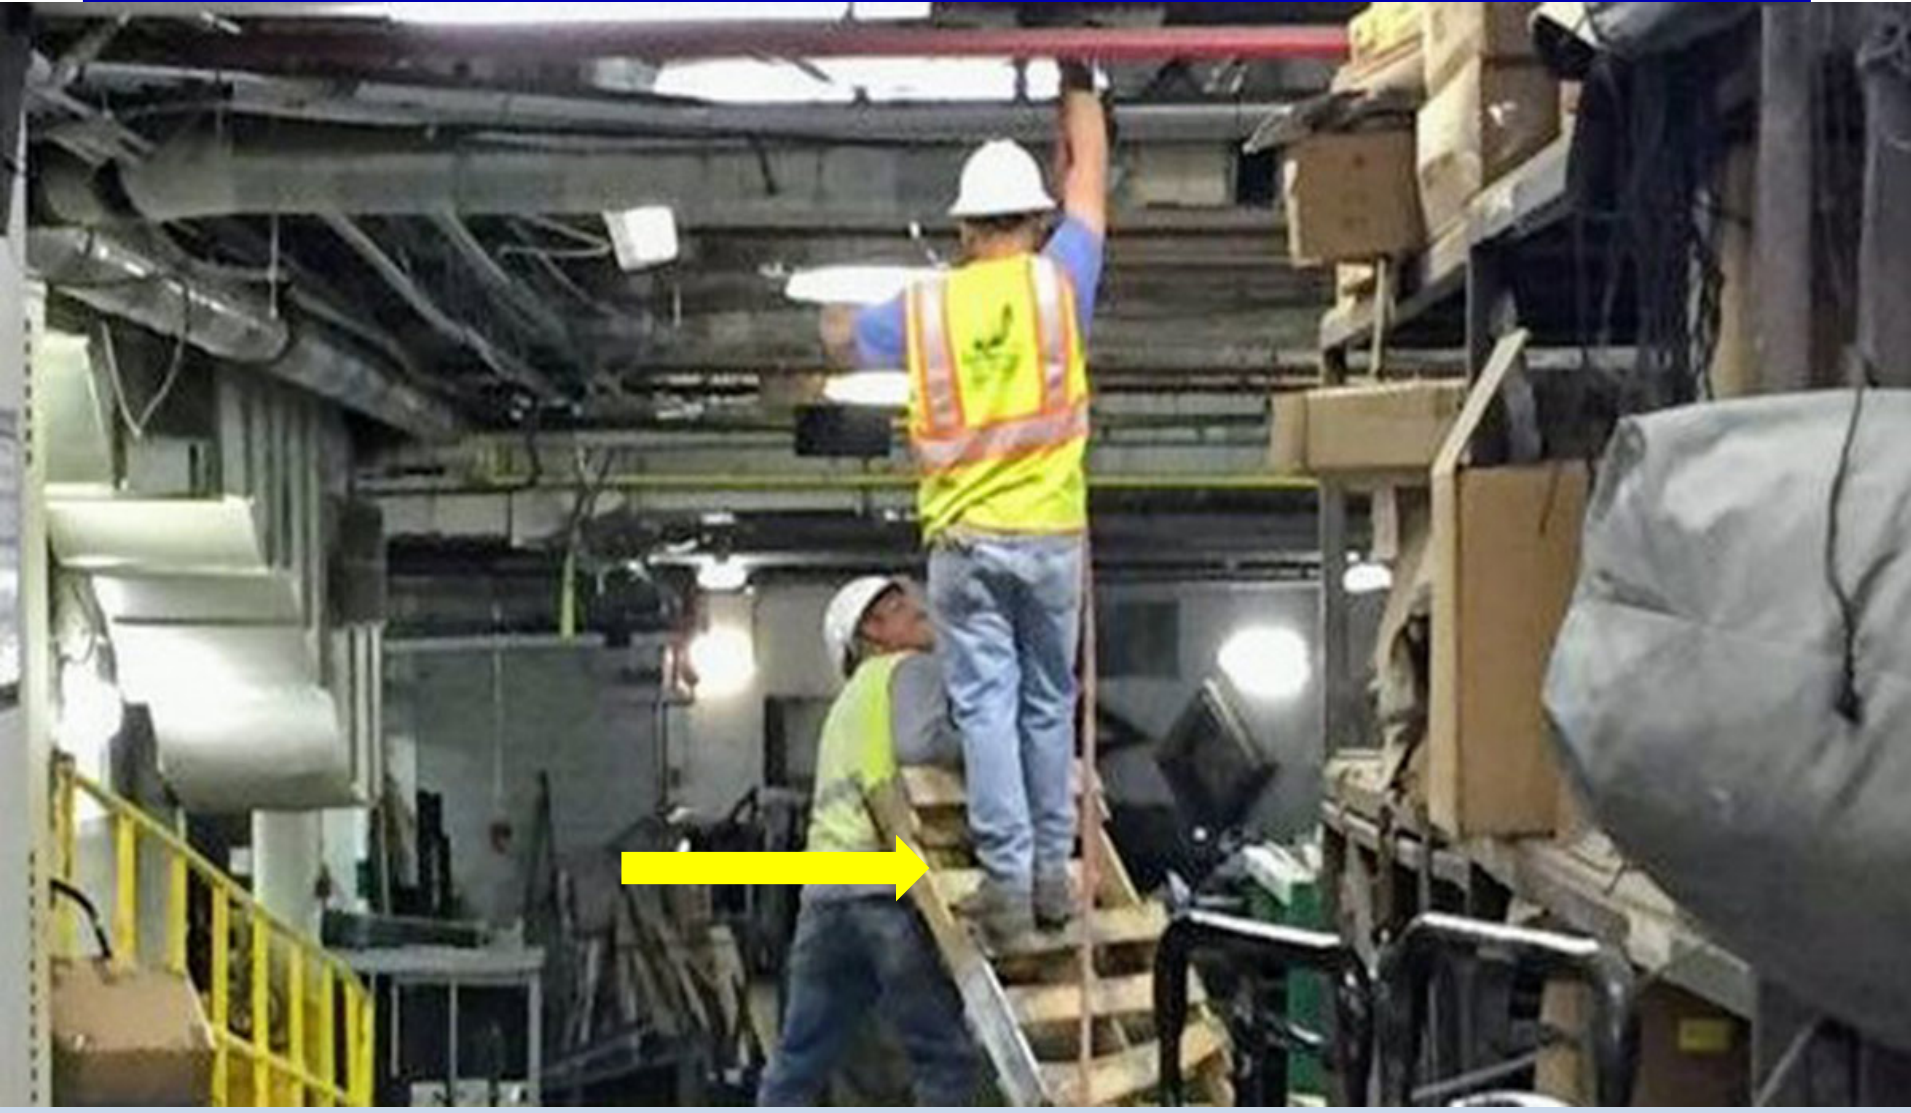
This ladder is missing a rung:
