# SSC Construction Inspection Safety Findings/Stats

# September 2010

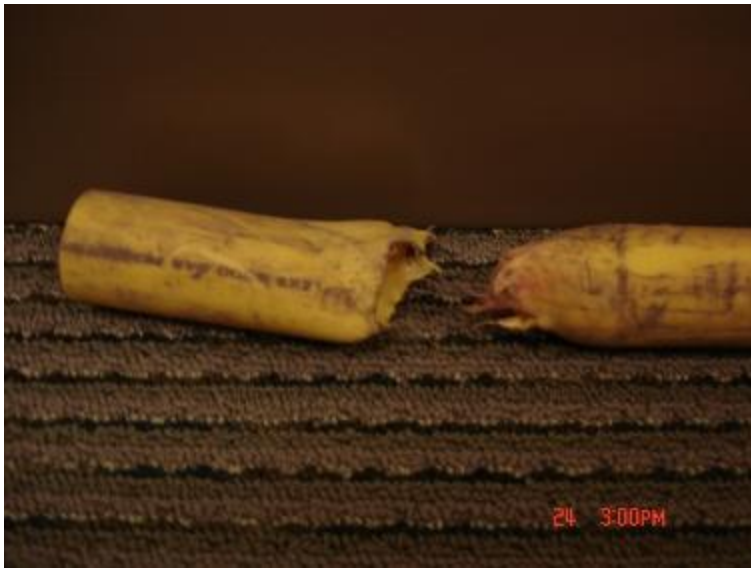
On August 25, 2010 at approximately 0930 hours, an employee struck a 1 inch MDPE (Medium Density Polyethylene Plastic) buried gas line located on the west side of building 1104. The line was a low pressure (under 50 psi) line located approximately 24 inches below grade (ground). The line was marked and identified. The worker struck the gas line using a mini excavator. The fire department was immediately notified and the area was restricted until the gas was turned off and necessary repairs were made. There were no injuries and the damage less than one thousand dollars, making this a Close Call.

View of Damaged Section of Plastic Low Pressure Gas Line

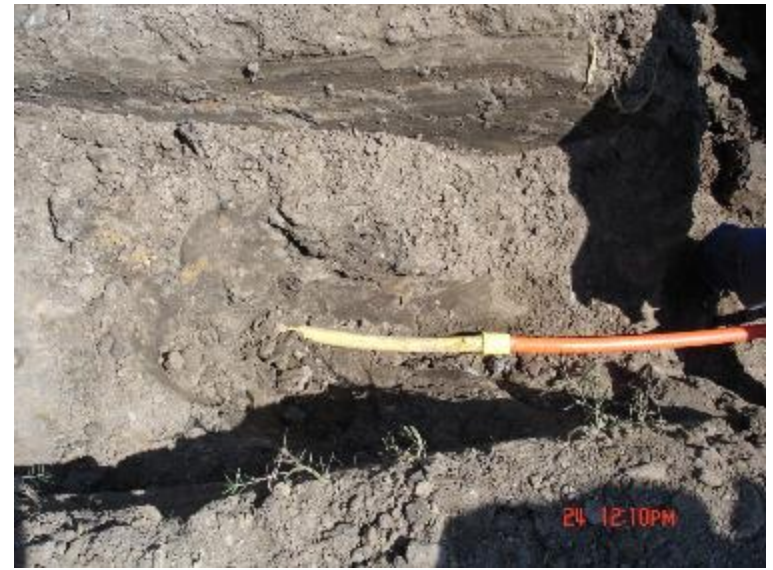
View of Repaired Section of Plastic Low Pressure Gas Line

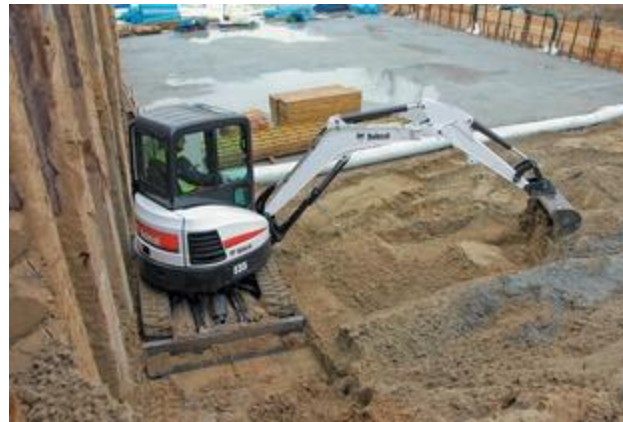
Picture of Type Mini Excavator
