SSC Construction Contractor Safety Meeting

October 07, 2021

SSC Construction Inspection Safety Findings/Stats

September 2021

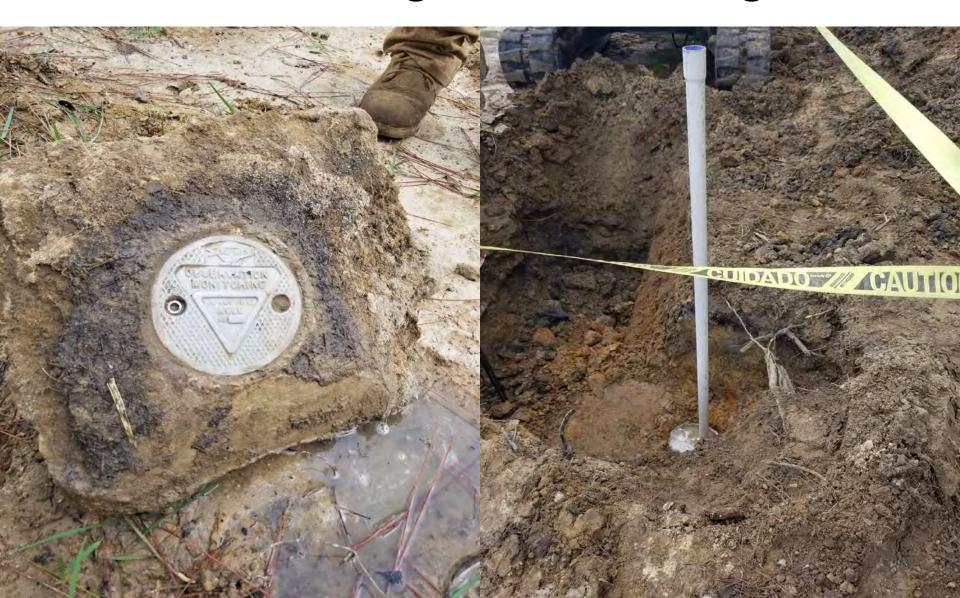
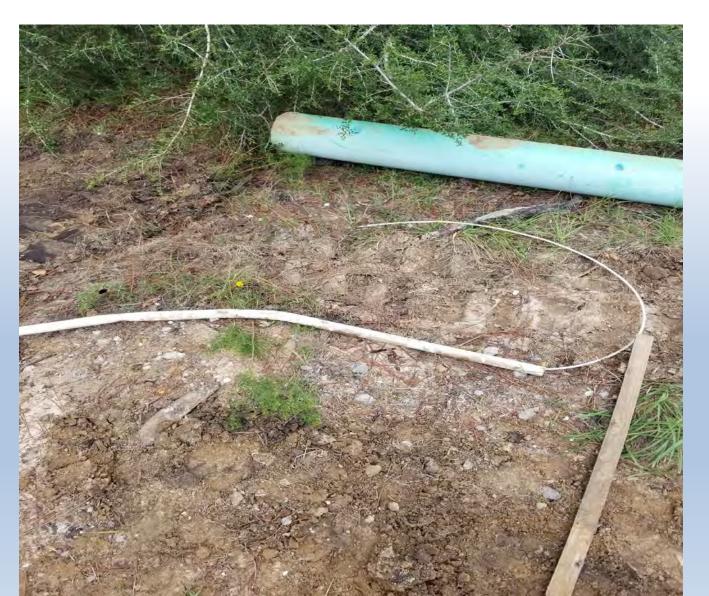
Monitoring Well Damage

On September 8, 2021, contractor personnel pulled up an environmental monitoring well during excavation activities.... NMIS # 21-100875

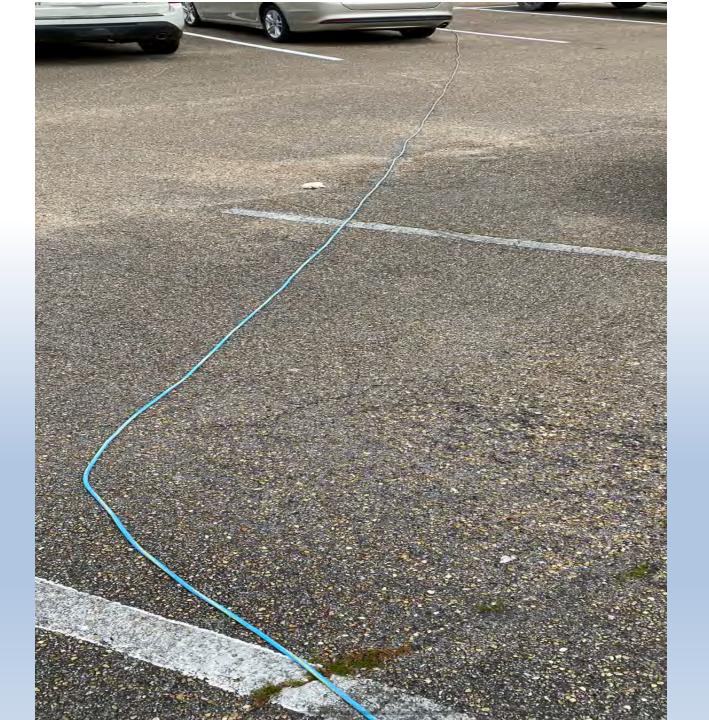
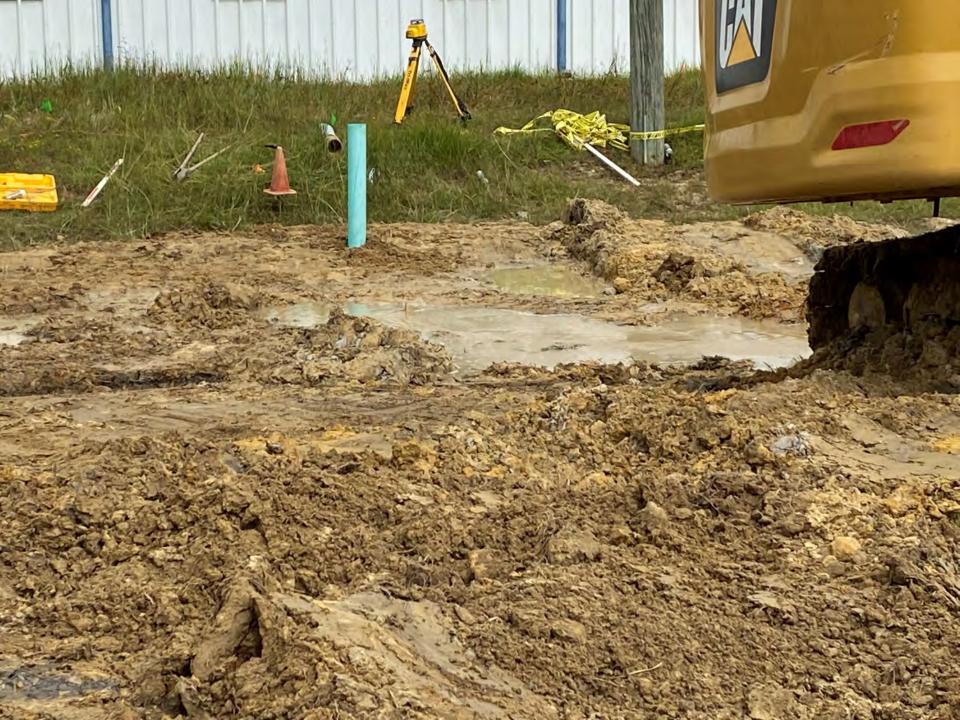
On Sept 28th, While backfilling over a newly installed sewer pipe at the Data Buoy Center, an old existing Transite water line was broken 4' below. Vibration or down pressure from the heavy equipment may have created the disturbance. The incident is currently still under investigation.
