Construction Safety

SSC Construction Inspection
Safety Findings/Stats

September 2019

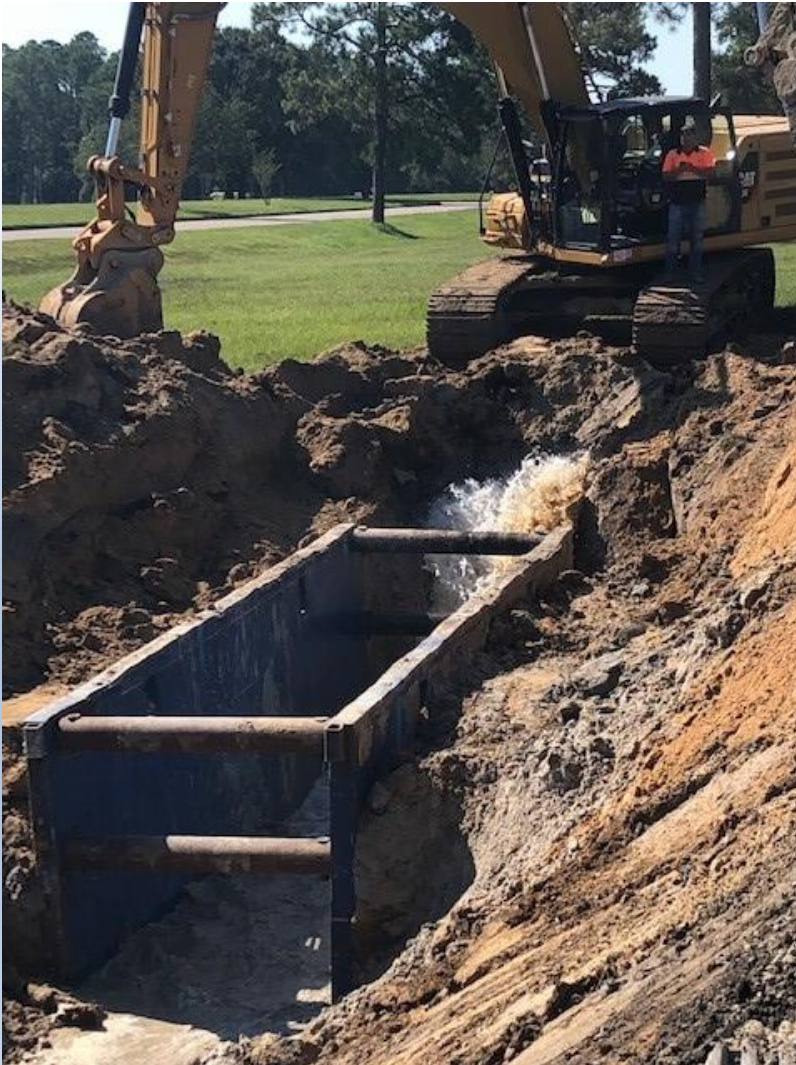
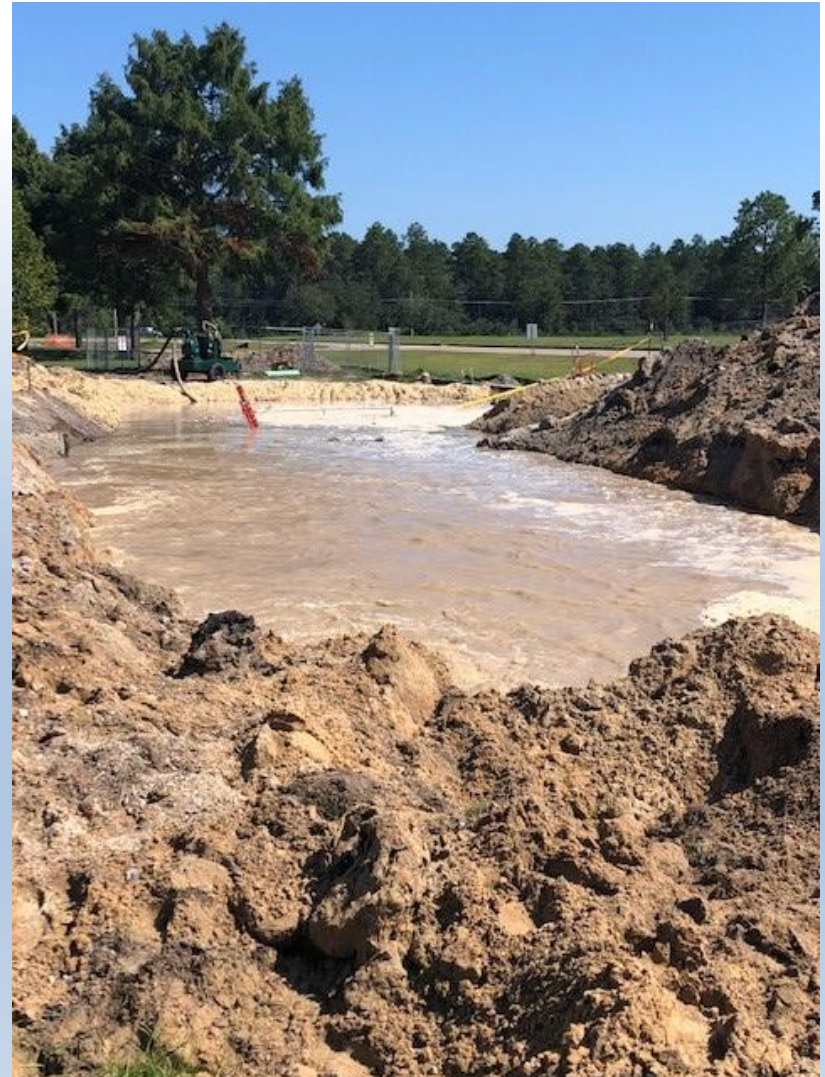
Sanitary Sewer Recapitalization: On September 6, during excavating activities east of building 1200, a transite potable water line burst filling the dig site. As a result of the breach and subsequent valve closures, service was interrupted to building 1200. NMIS 19-101257.

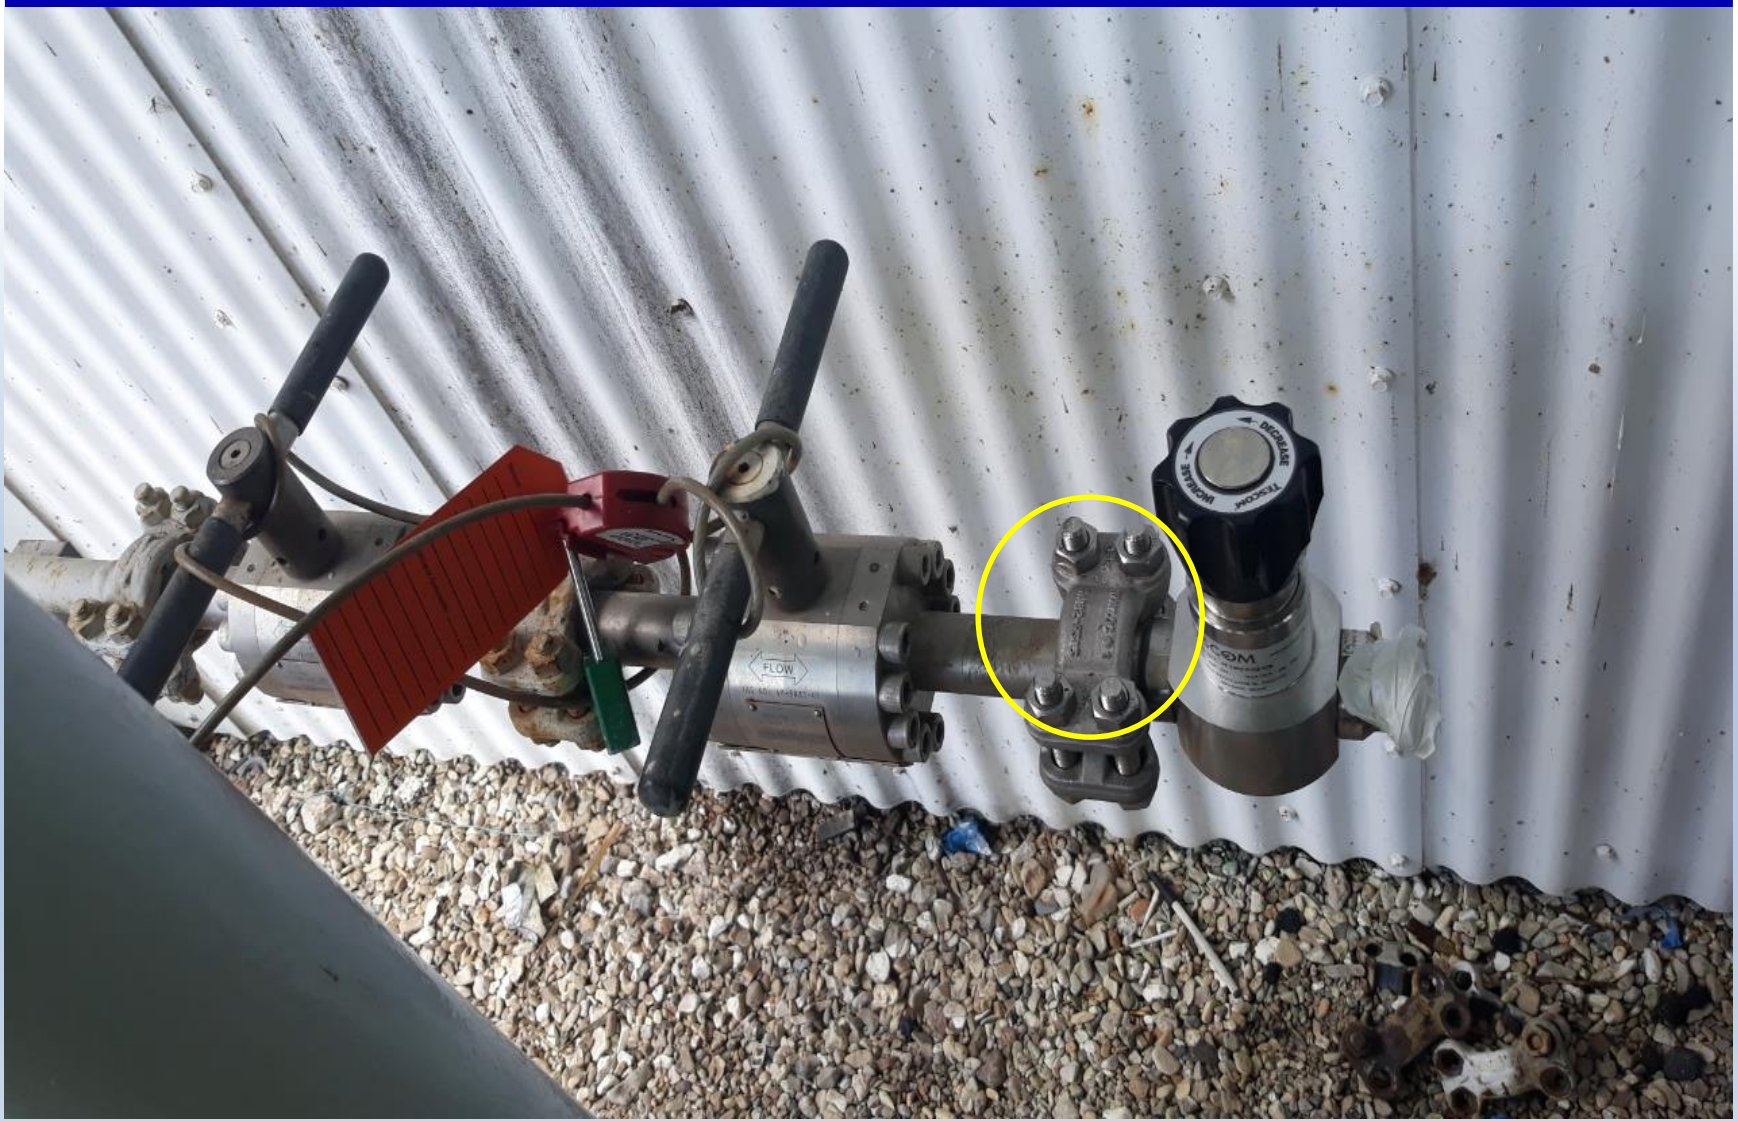
High Pressure Air Dryer Compressor Replacement: At approximately 10:45 AM on September 12, while attempting to remove the nuts & bolts from a grayloc valve clamp outside of 3305, an employee was struck on the lip by a clamp nut. System air pressure hadn't been reduced to zero before clamp removal. The employee refused medical attention. NMIS Case 19-101285.

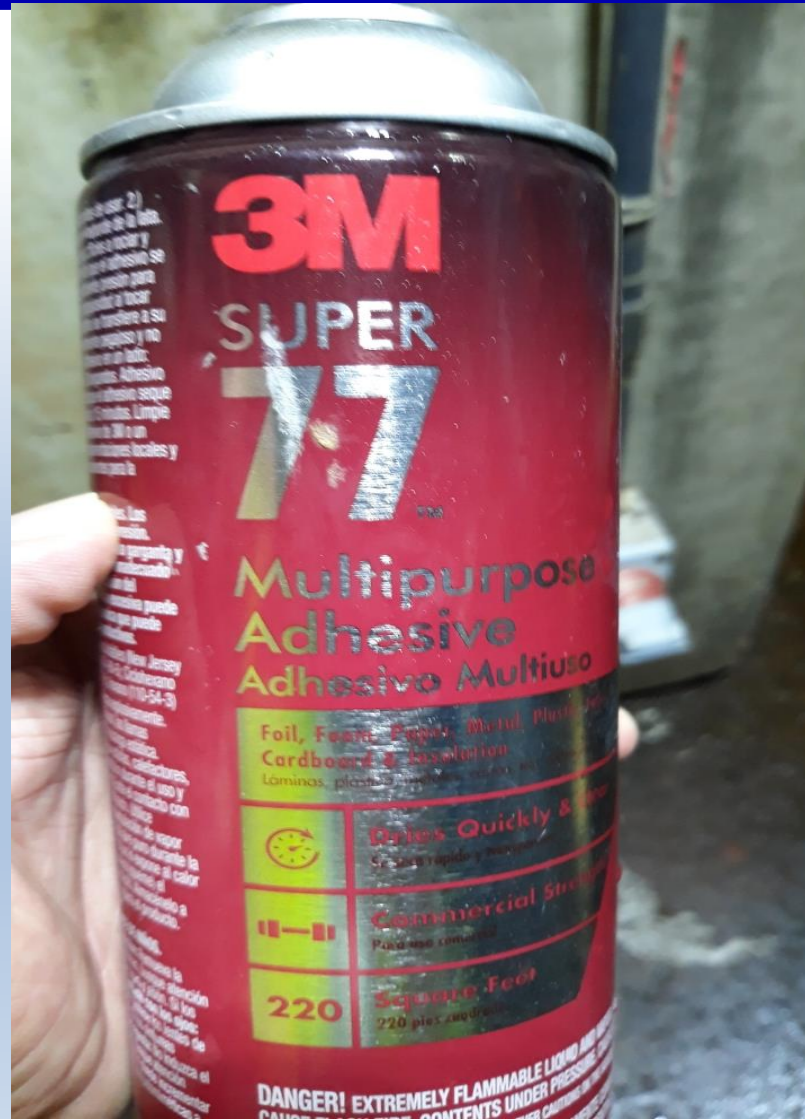
HPG II / Cryogel Insulation: The contractor was found to have previously used a canned spray adhesive which was present in an articulating boom basket that had not been preapproved by SSC before use. Ref: SCWI-8715-0008 9.12 (1&2). SHEtrak ID # 105846.

HPG II / Cryogel Insulation: on September 25, during suspended scaffold erection under level 16 of the B-2 T/S, a worker lost their footing on a scaffold cross member. The worker, who was protected with a personal fall arrest system (harness, shock absorbing lanyard, anchorage), held on with their hands to an upper cross member and relaxed within the harness deploying the lanyard shock pack about ½". Several colleagues assisted the employee back to the platform. NMIS 19-101356
