Construction Safety

SSC Construction Inspection
Safety Findings/Stats

September 2018

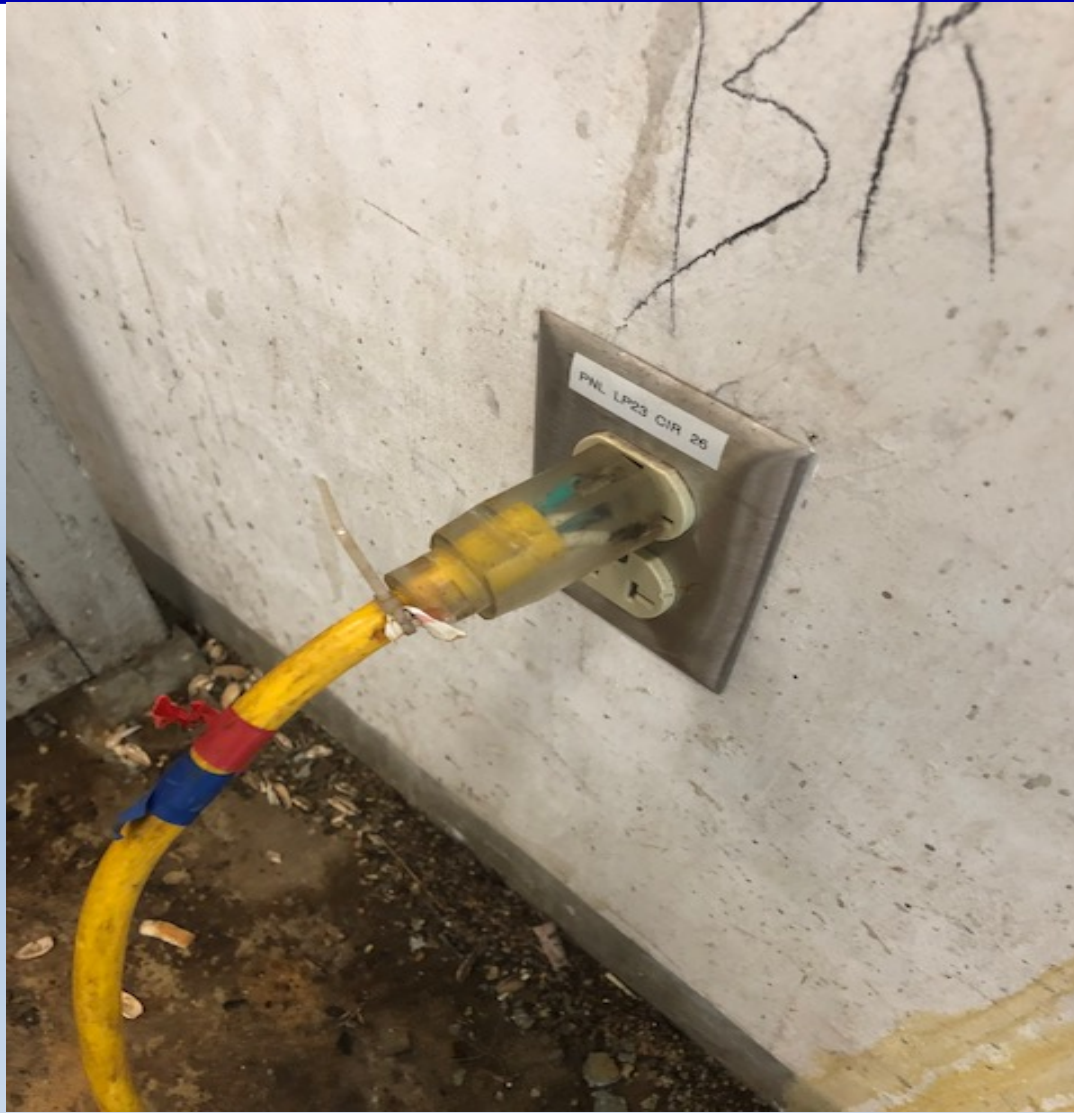
B-2 Fire-X/HPIW Piping Replacement: On September 20, a contractor failed to use the required ground fault circuit interrupter on a wall outlet power source. The extension cord was used for a power tool. Ref: 29CFR1926.404 (b) (1) (ii). SHEtrak closed. ID#. 89256

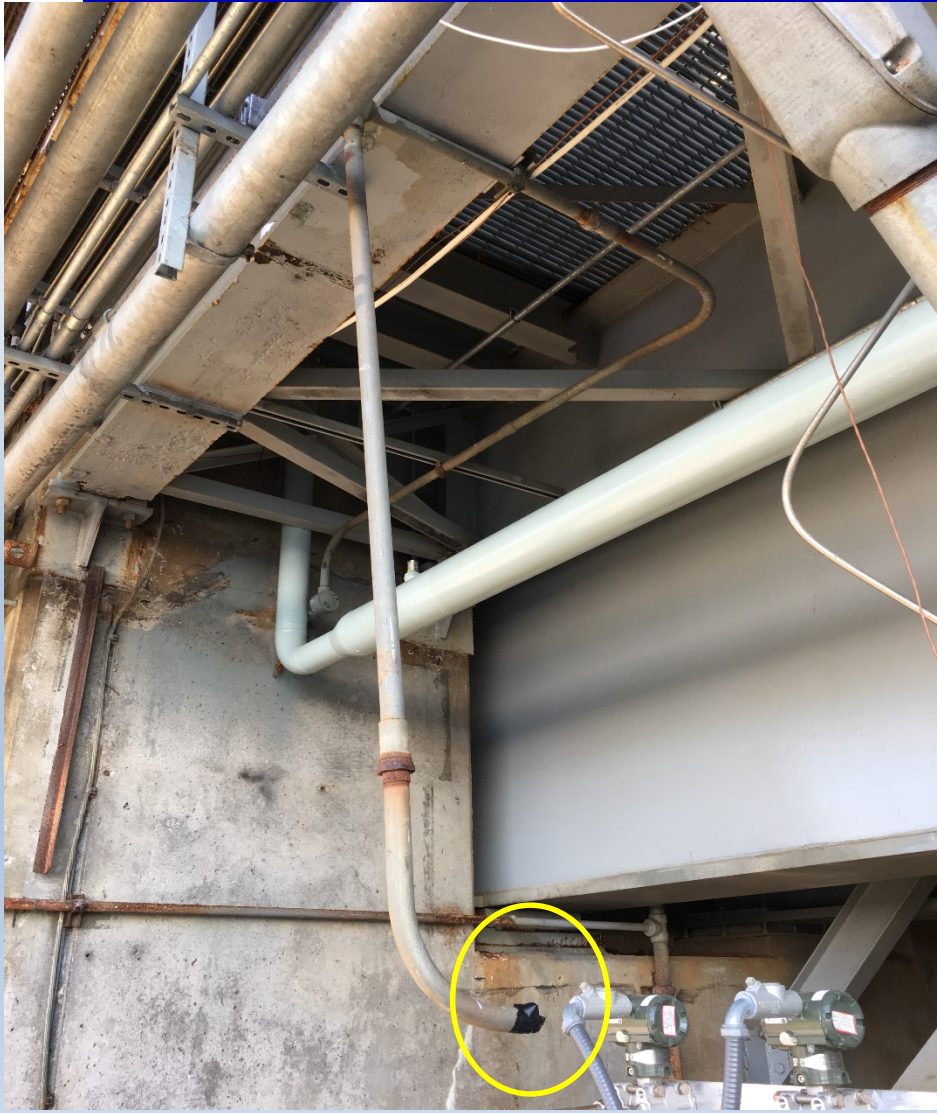
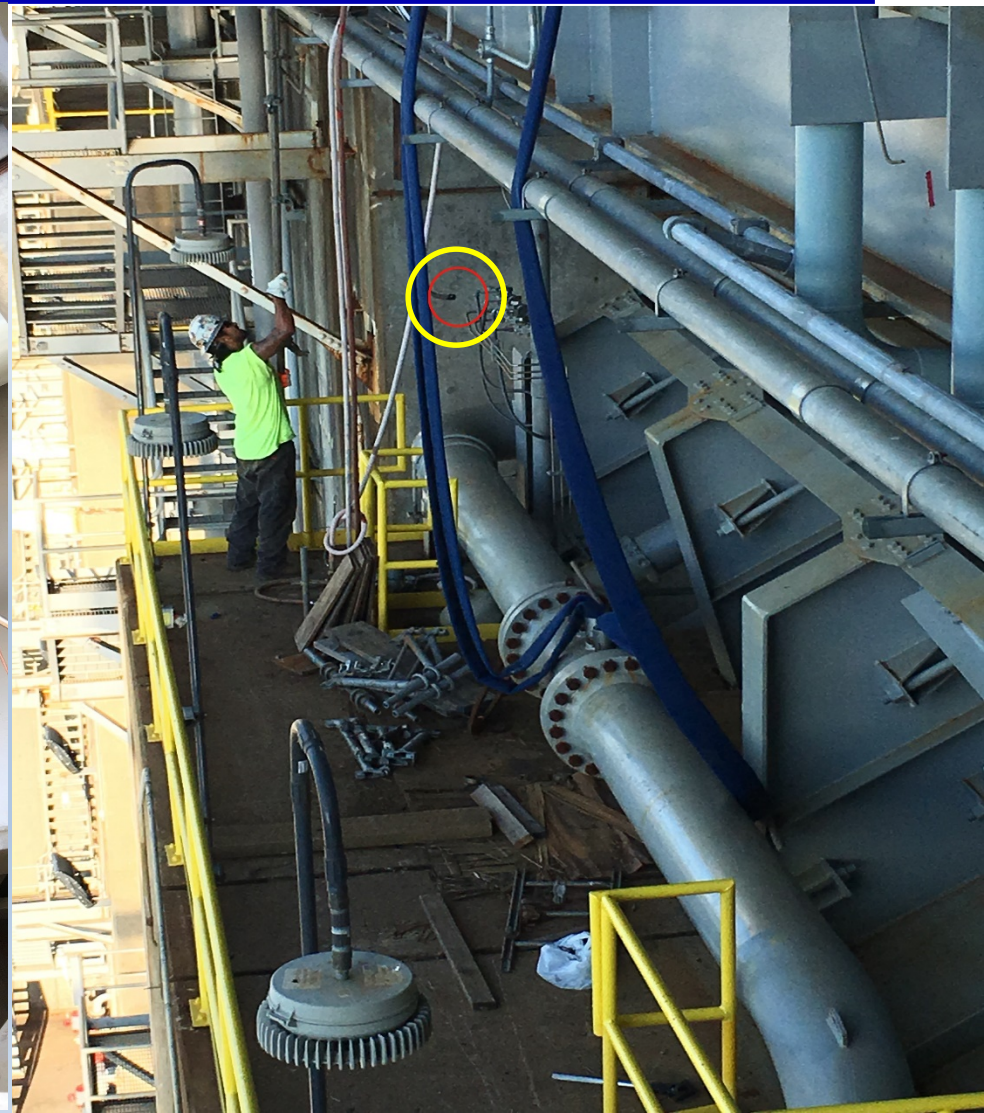
While disassembling a section of scaffolding on level 6.5, a B-2 scaffold builder received a mild shock when they inadvertently touched a bare energized wire that was protruding from an abandoned section of electrical conduit hanging from level 7. No medical attention was sought. The incident was entered into NMIS. Case # 18-101547

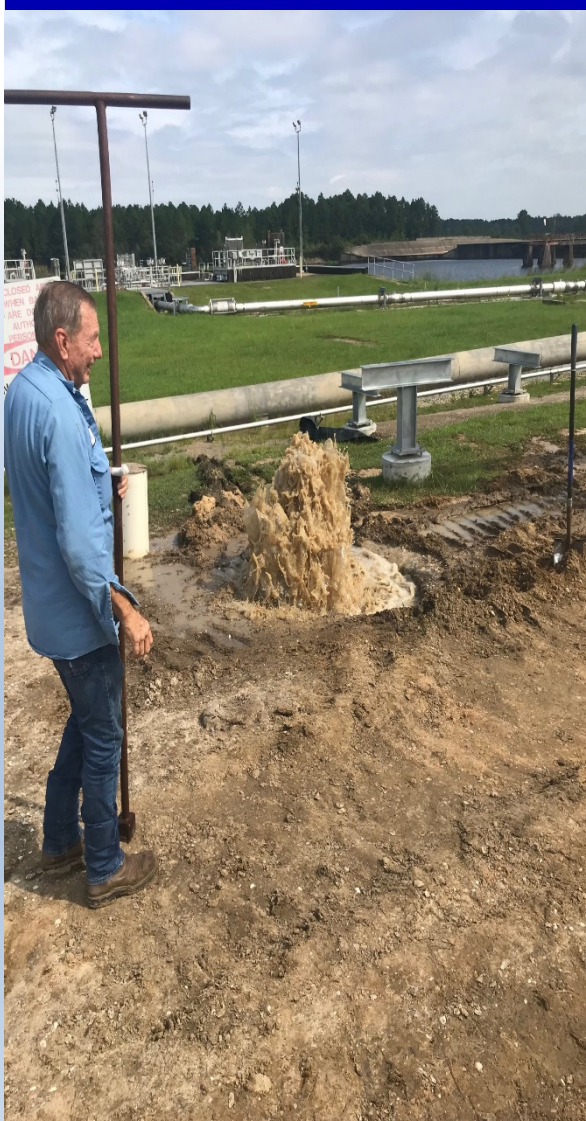
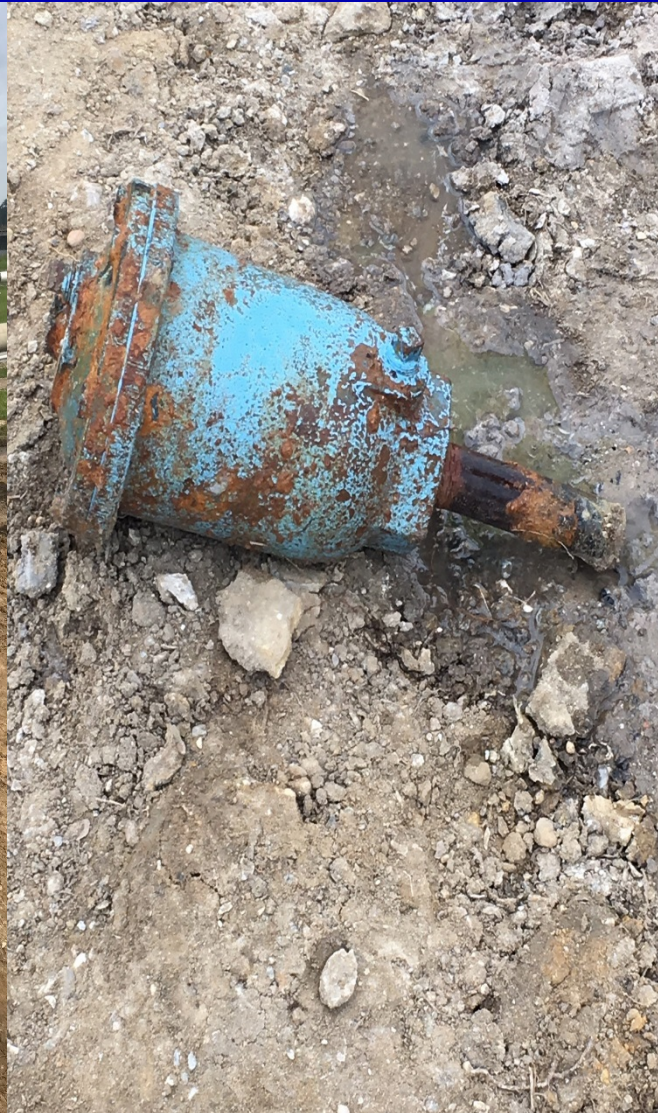
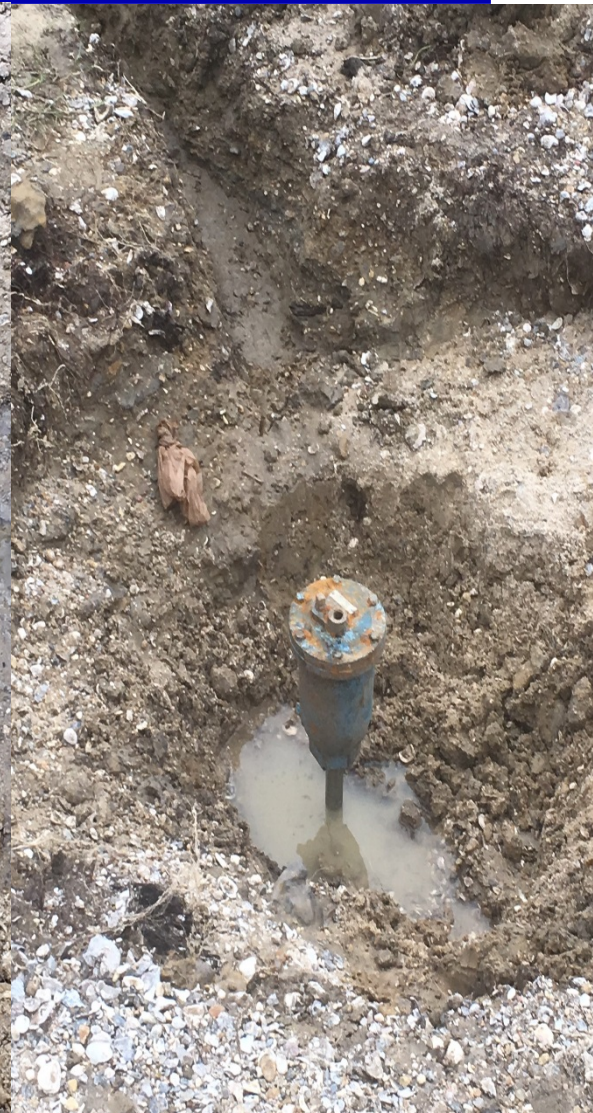
HPG Phase II : While working on the installation of the new road crossing near A-2, South of hydrogen dock. The contractor was tracking the excavator into position to dig up the roadway. The weight of the excavator rolled over a PVC cap that was covered by grass and dirt. Under the PVC cap was an Air Relief Valve attached to a 10 inch underground waterline. The pipe broke at the threaded nipple. S-3 shops responded and made repairs.
