Construction Safety

SSC Construction Inspection Safety Findings/Stats

September 2017

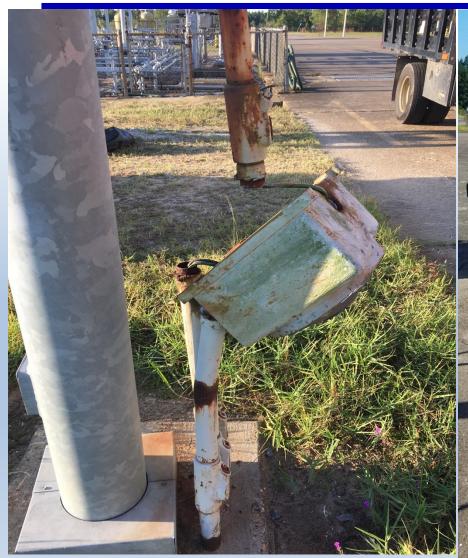
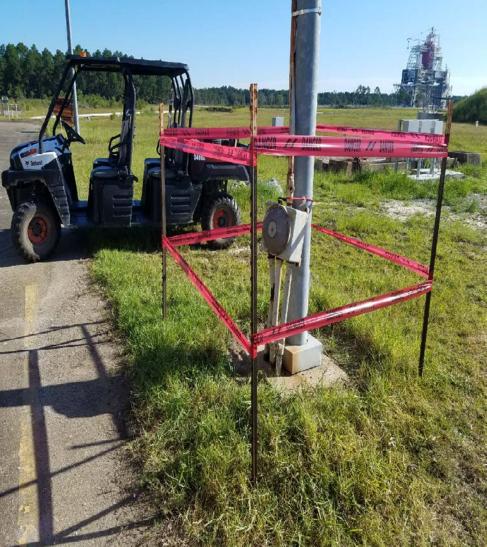
HPG: Subcontractor backed vehicle into power box for street light assembly outside PRN of the A2 test stand. No electrical damage, no electrical hazard. Repairs to be determined. SSC 1627 generated. SMA and COR notified. General contractor had their electrical team review the area for electrical safety and secured electrical box. A SSC 1627 form completed.

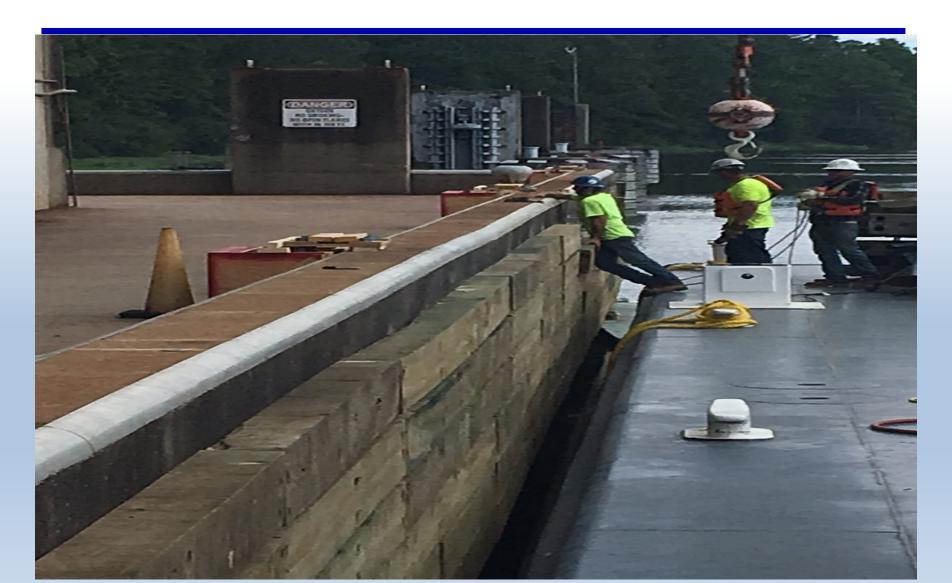
B2 STE Phase II: Contractor was not wearing the required PPE (PFD) while working over water. Ref: SCWI-8715-0002. Section 7.9 (C). ID # 82252 SHEtrak closed. (NNS17AA10T)

Natural Gas System Modification Project: Contractors excavation area did not have ground area marked as an approved dig area or no available or attached drawing for the dig permit. Ref: SSTD-8070-0119-MISC Rev B-1 Section 5.2.3 (e). ID # 82199 SHEtrak closed. (NNS17AA36T)

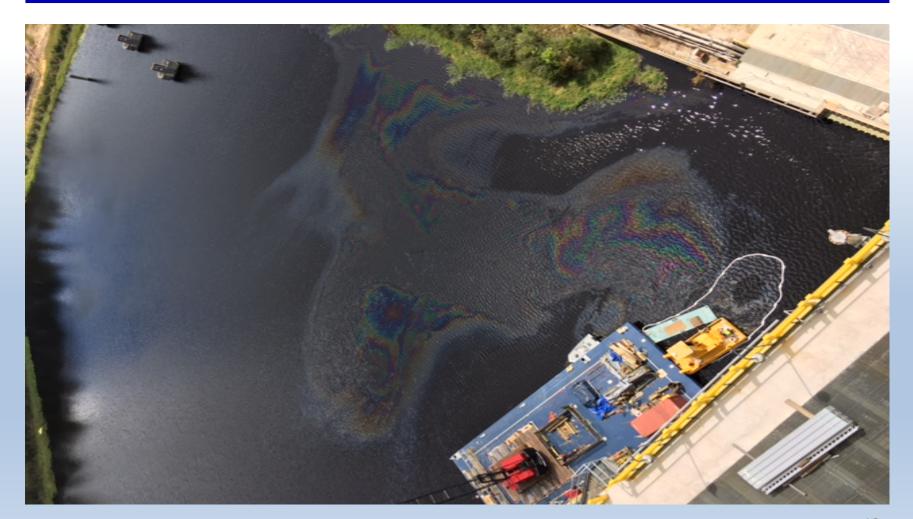
- <u>STE Phase II:</u> On 9-25-17 a contractor spilled approximately 1-3 gallons of hydraulic fluid from a ruptured hydraulic line on the barge tug in the B-stand area water canal. Emergency response agencies assessed the spill area and directed the contractor to place absorbent floating booms to contain and absorb the spill. A SSC 1627 form and Environmental Spill Report was completed and properly submitted.
- <u>Cathodic Protection</u>: On 9-28-17 at Bldg. 2101 a contractor using a mini-excavator to excavate a trench, struck an underground energized 110 volt electrical line. The electrical line was not identified by underground imaging. The electrical line circuit breaker was de-energized by SACOM. Proper incident reporting was initiated and SSC 1627 form was submitted by the General Contractor. This incident was reported in NIMIS. Ref Event ID: 17-101737
