Construction Safety

SSC Construction Inspection
Safety Findings/Stats

September 2015

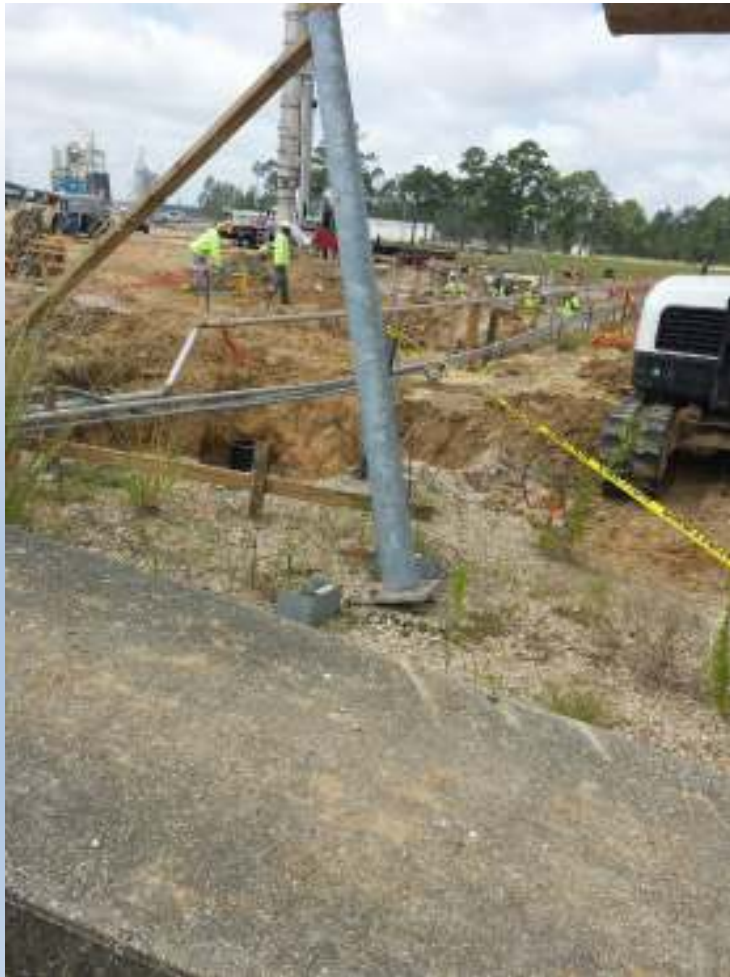
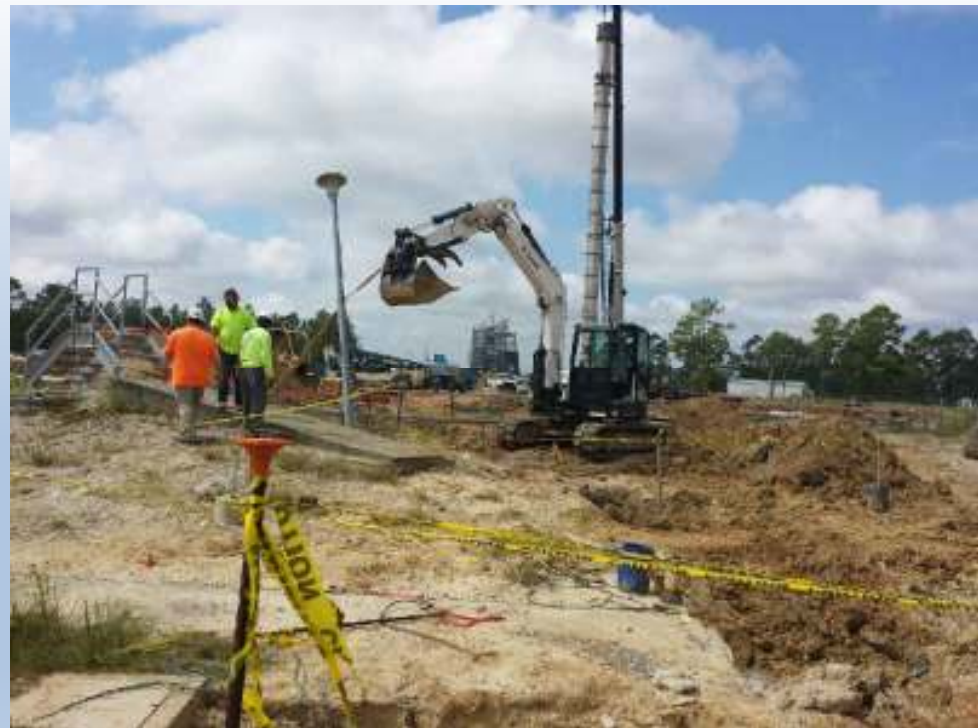
Construction Safety Findings: 14-18 September 2015

1. A sub-contracted employee was operating a mini-excavator just south of the B Test Stand when the bucket of the excavator struck an existing light pole, nearly knocking it over. Work was stopped and the light was secured to prevent further damage. Contractor is investigating.

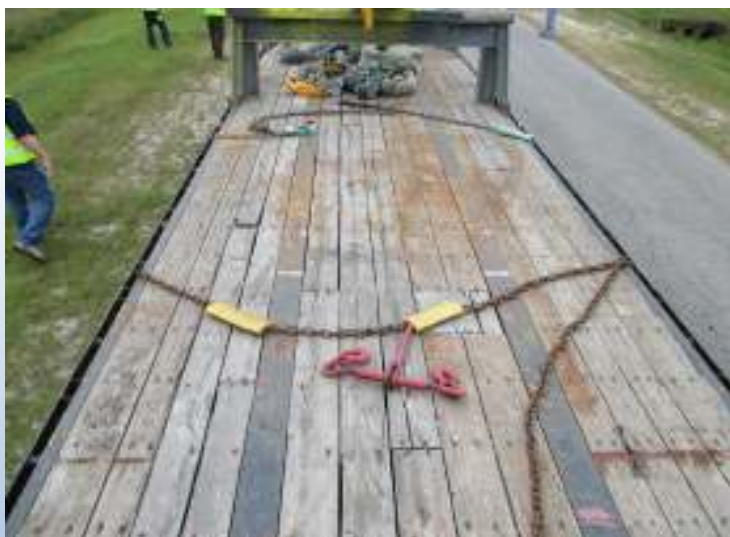
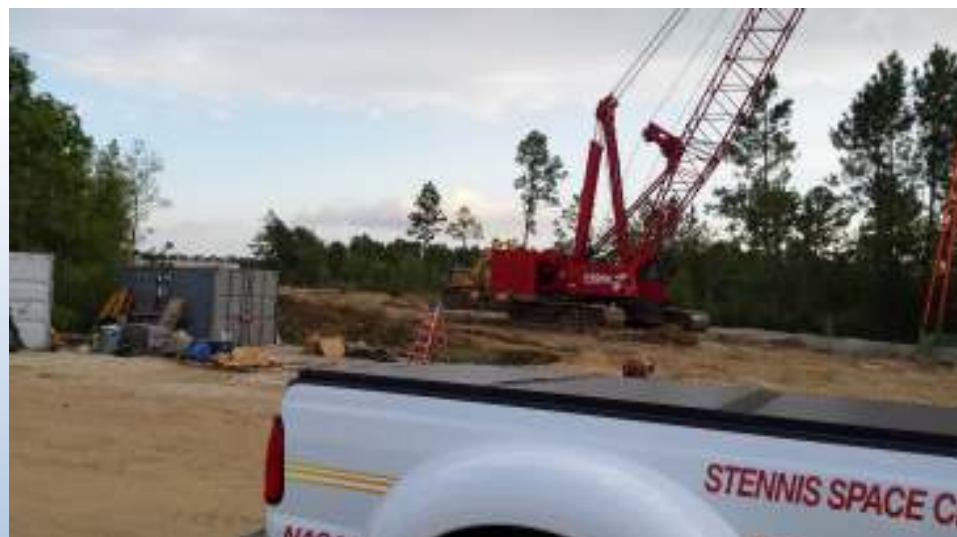
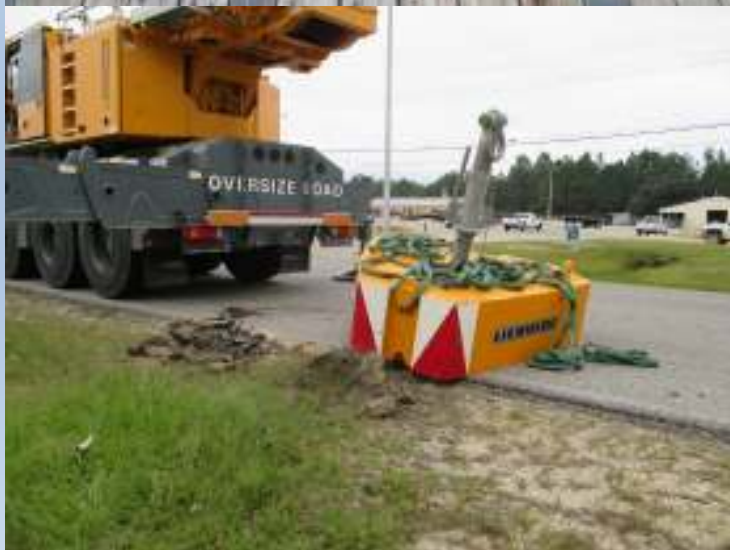
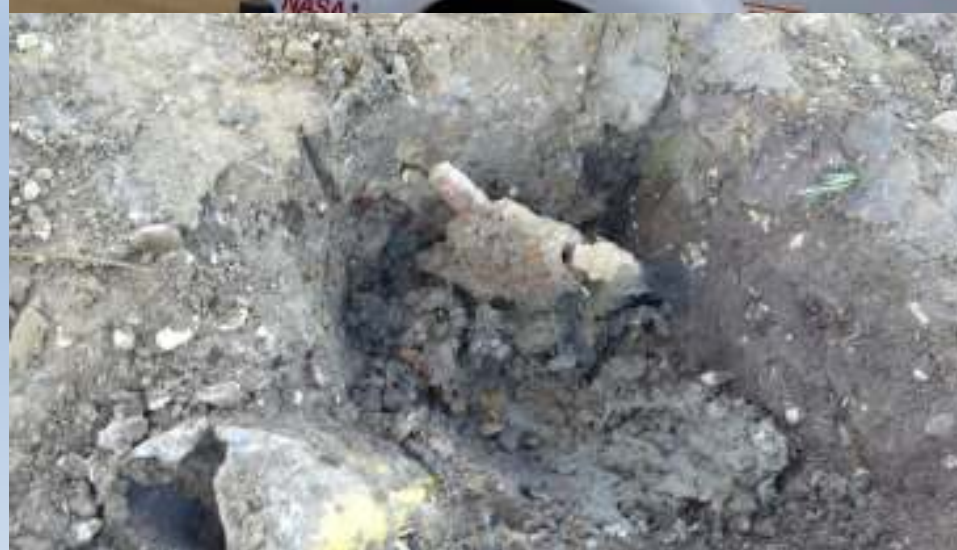
Construction Safety Findings: 21-25 September 2015

1. While in route to a construction site, a mobile crane's counterweight being hauled on a separate tractor trailer fell from the trailer onto Saturn Drive, near Building 8304. There was minor damage to the counterweight, as well as to the east-bound lane/shoulder of the road. Contractor is investigating.
2. A natural gas leak occurred within the construction site. The leak appeared to have been caused from an excavator driving over a buried "drip line" valve, causing it to break. Service was disrupted to the A-Complex flare stacks but, no other damage. Contractor is investigating.
