# Construction Safety

SSC Construction Inspection  
Safety Findings/Stats

October 2018

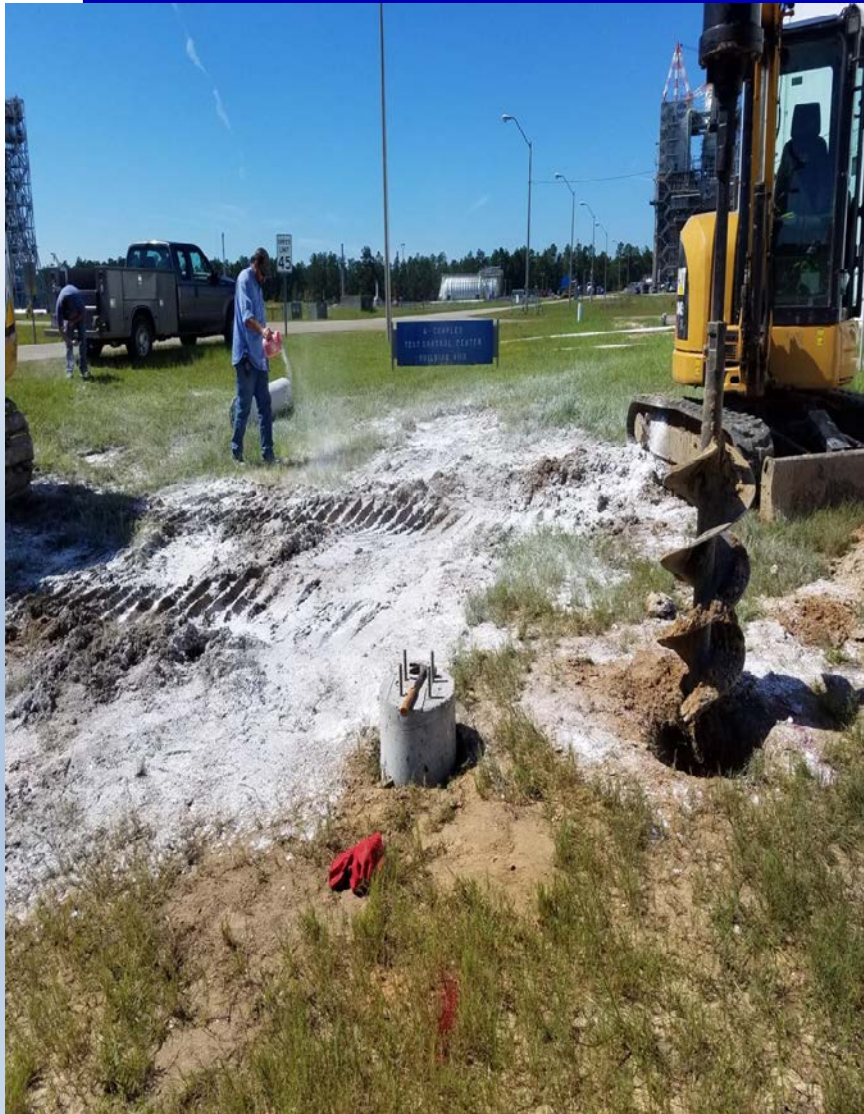
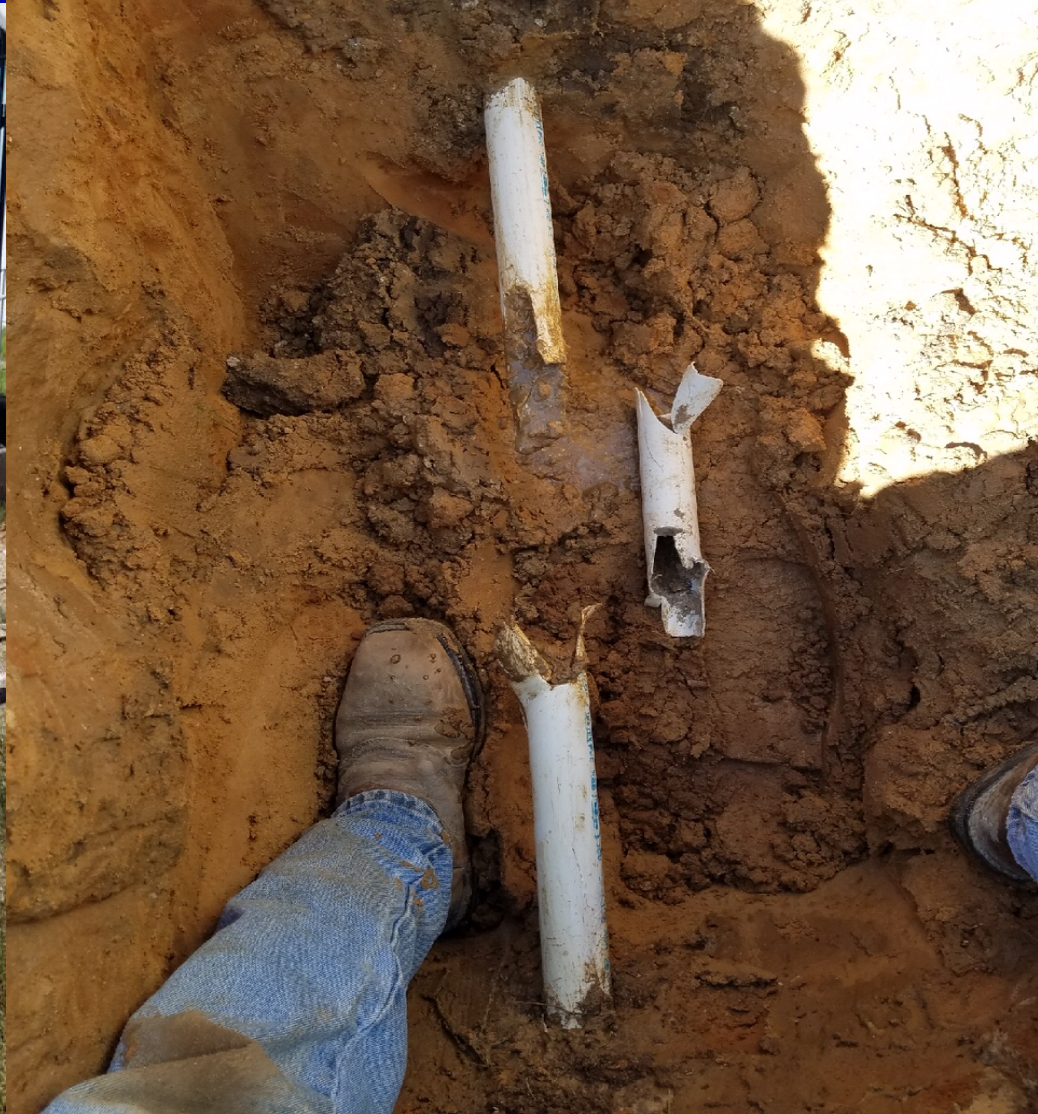
**HPG Phase II:** On October 18, near A-1 T/S, the HPG Phase II contractor was auguring holes for concrete pedestals and struck an underground 1 ½" PVC force main line which had not been imaged during the subsurface utility location process. S-3 shops responded and made necessary repairs. A safety stand-down was conducted to discuss the incident and determine future preventative corrective actions.

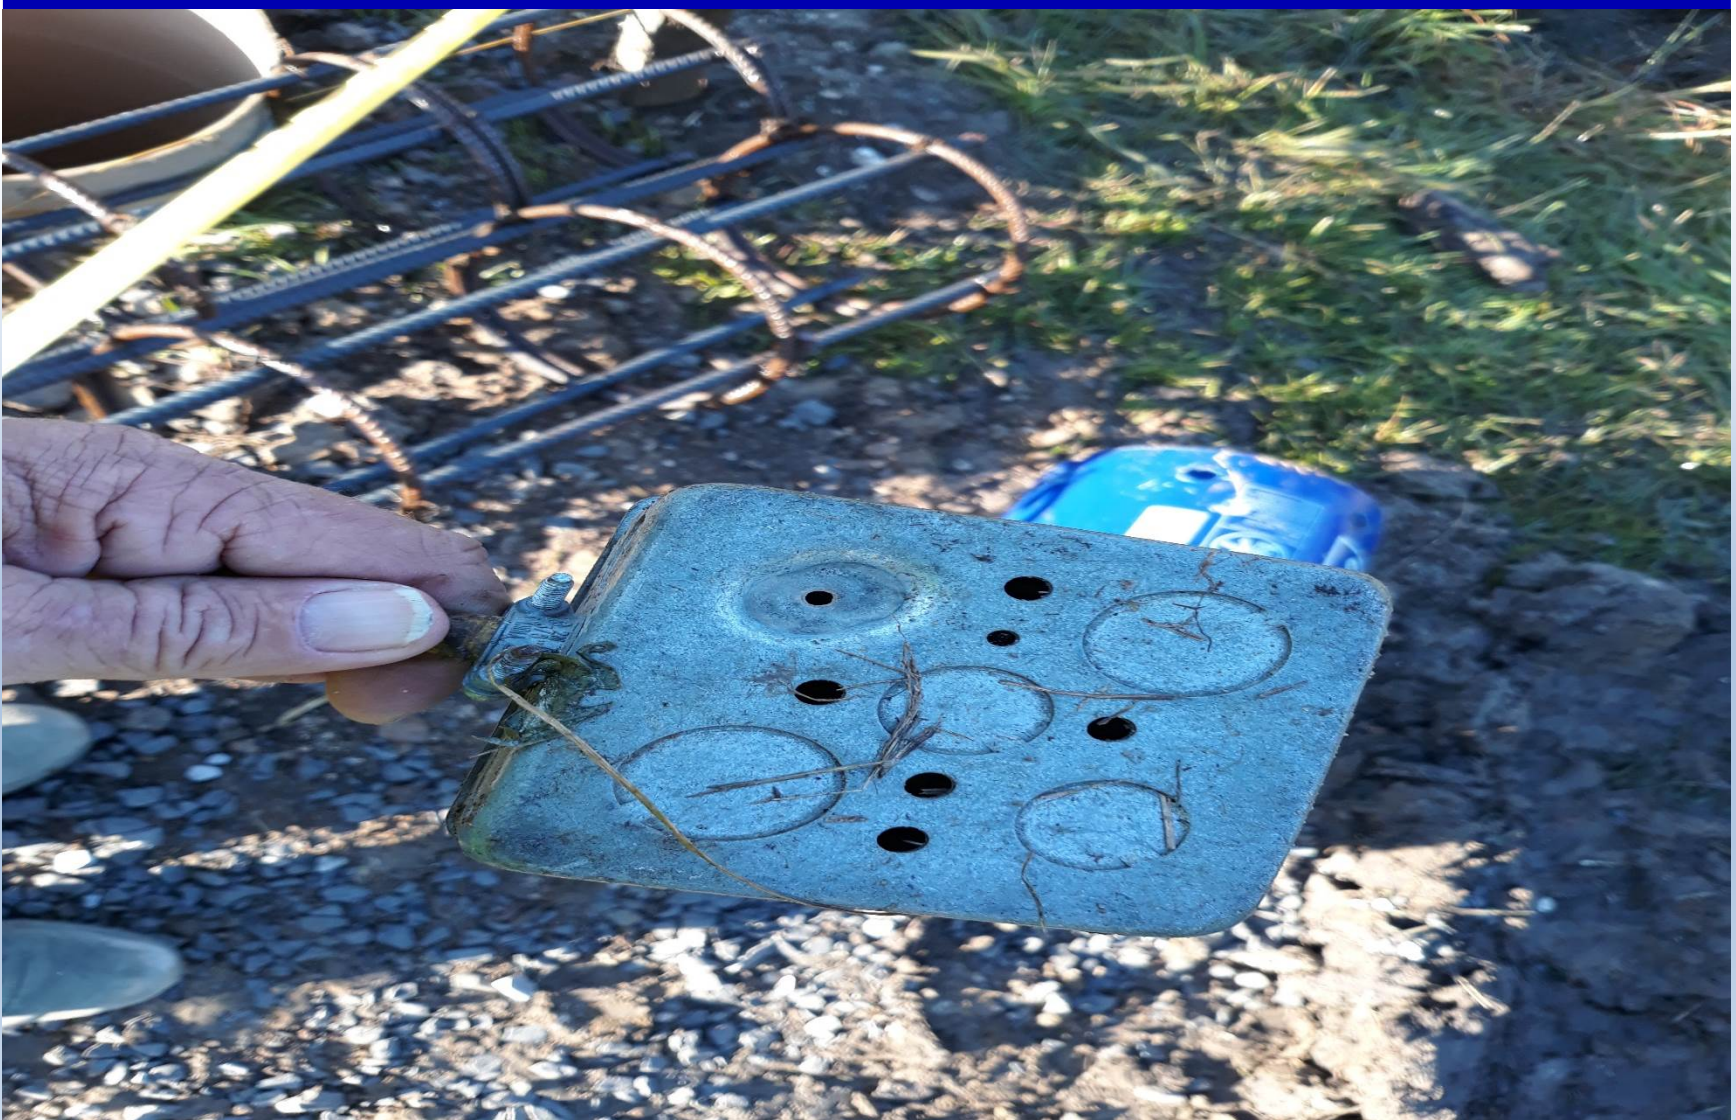
**LMRS Building B-1204:** The contractor was using a job made electrical extension cord with a junction box designed for wall mount. The junction box has several open holes on the bottom and sides. The junction box was laying in the grass plugged into a wall outlet with GFCI protection. Ref: 29CFR 1926.405 (j)(2)(ii) SHEtrak # 114288 Closed.
