SSC Construction Inspection
Safety Findings/Stats

September 2011

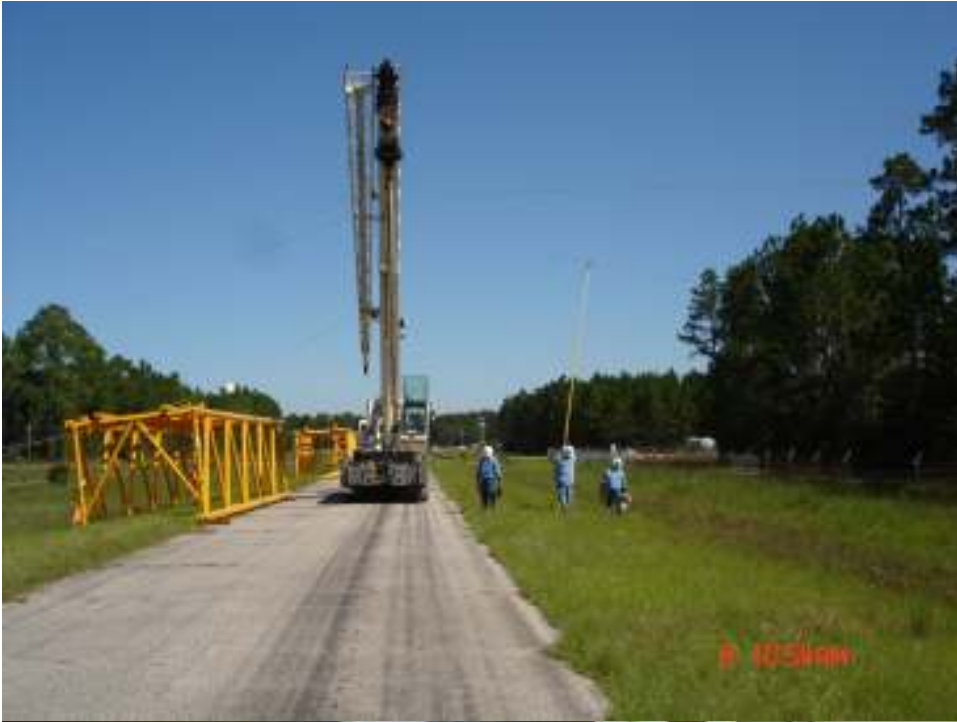
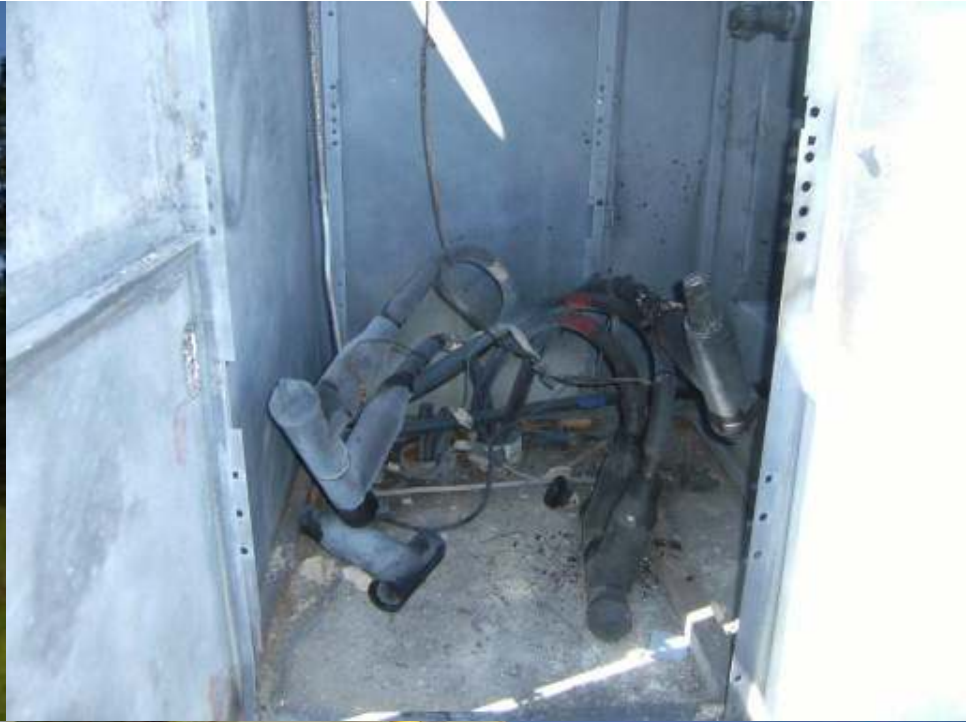
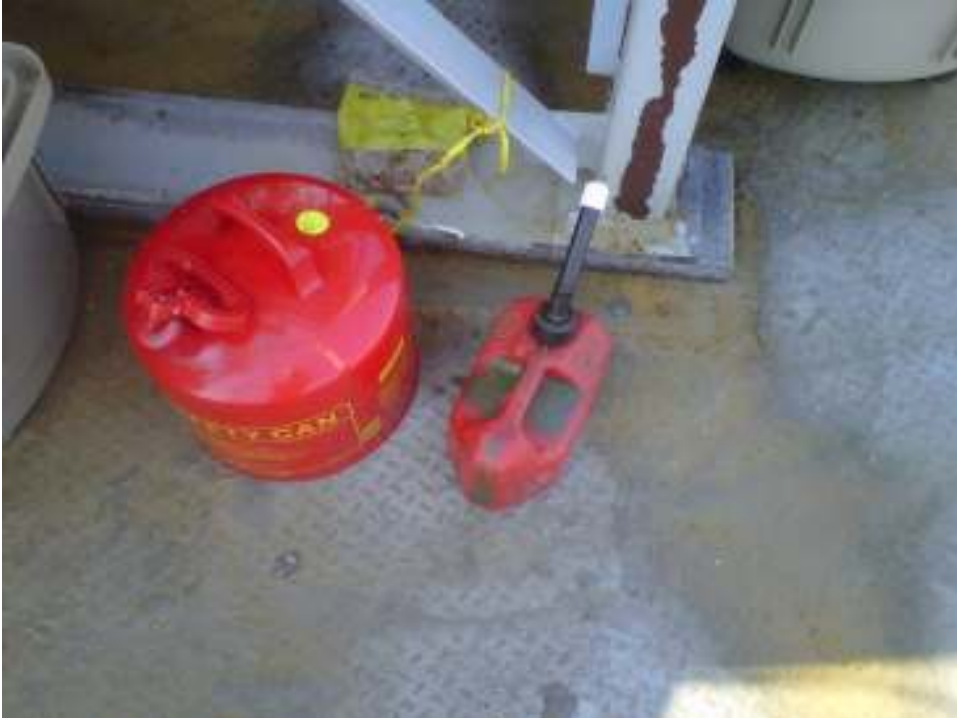
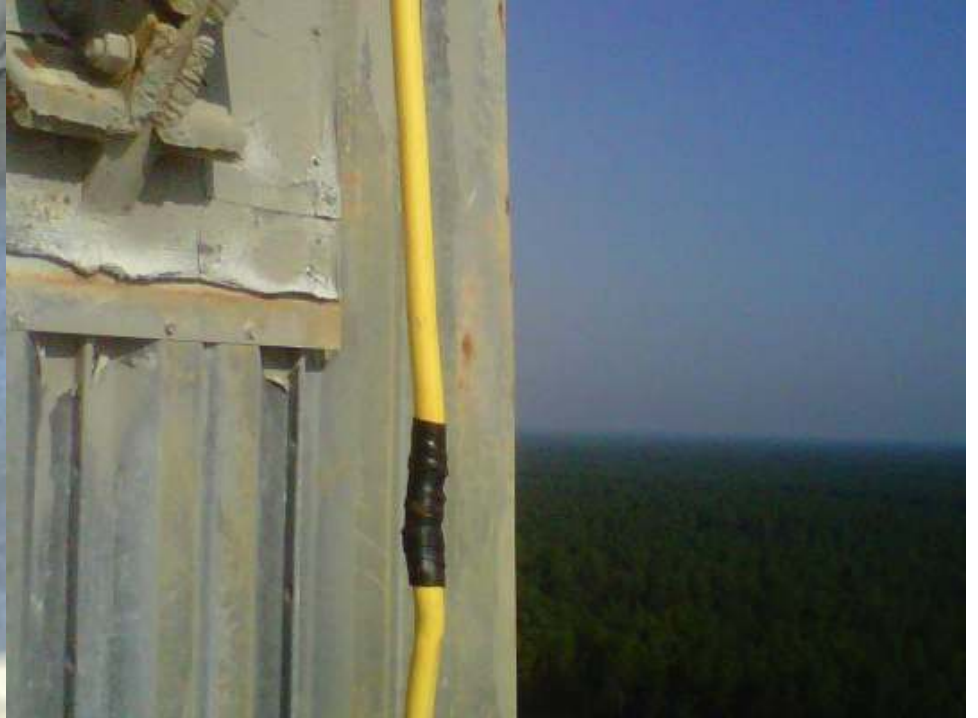
1. While moving a mobile crane north on Road 5, the slightly raised boom contacted overhead power lines. No one was injured but, the lines, several poles and a transformer station were damaged. This case is currently under investigation.
