## **Construction Safety**

## SSC Construction Inspection Safety Findings/Stats

## October 2016

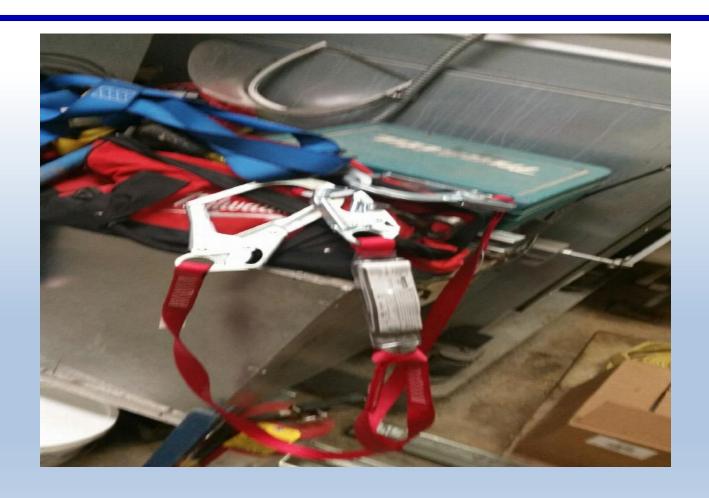
# Construction Safety Findings: 03 – 08 October 2016

ATTCC HVAC: On October 3, two employees were working in building 4110 installing HVAC duct in an area approximately 12' above the floor of the basement. Though both of the employees were equipped with a personal fall arrest system/harness and single legged lanyard, only one of the employees was observed as being attached to a fall protection anchorage, rendering the other employee vulnerable to a fall to a lower level. This is a violation of SCWI 8715.0003, "Fall Protection", Section 5.2, which states, "In the construction industry fall protection is required at six (6) feet. The six (6) foot rule applies to any situation where an employee could fall or contact dangerous equipment."

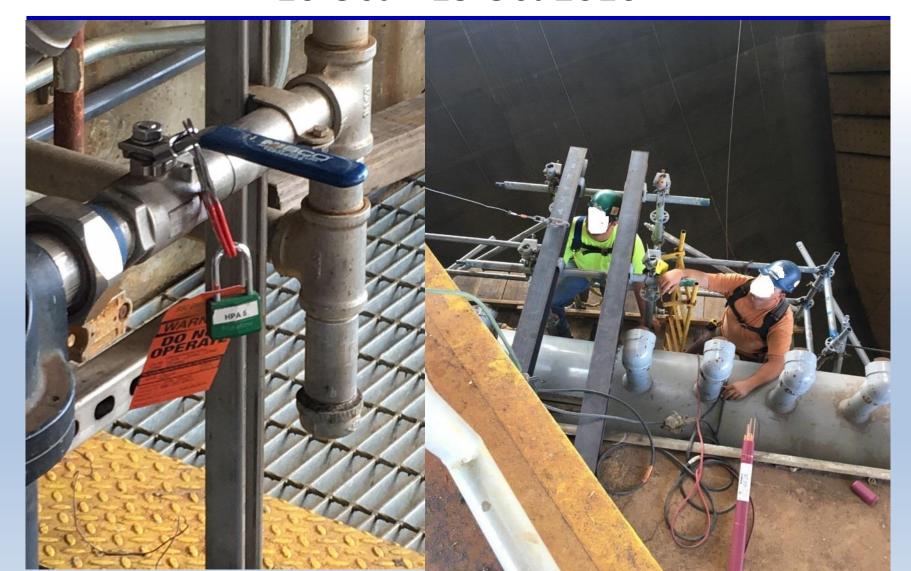
## Construction Safety Findings: 10 Oct – 15 Oct 2016

B2 WP3: Inspector observed 2 individuals working on the B2, level 7 aspirator, who although authorized to perform LOTO, didn't add their locks and tags on the rolling deck air valve.
 Ref: 1910.147(f)(3)(ii)[D]

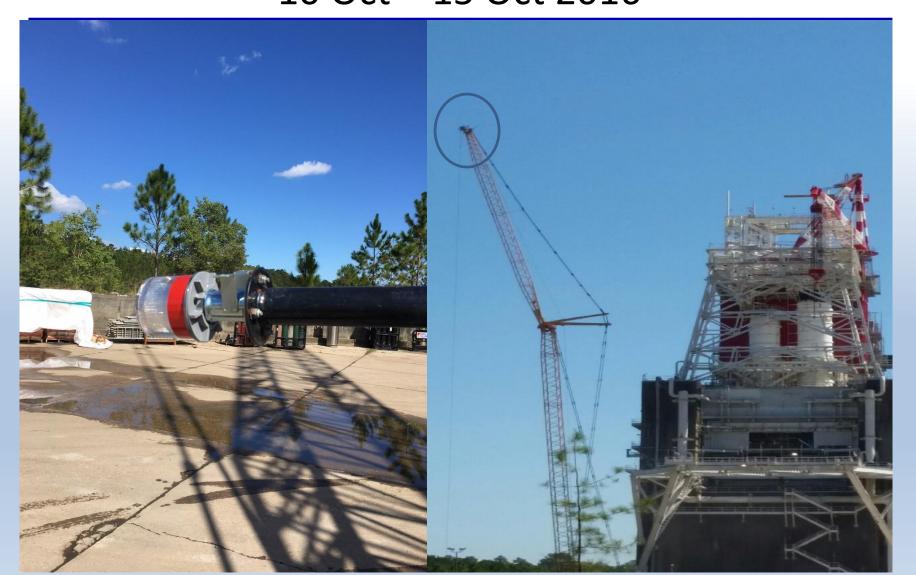
## Construction Safety Findings: 10 Oct – 15 Oct 2016

- B2 WP3: Inspector observed the crane elevated during the hours of darkness above the B Stand mounted FAA Beacon. The crane's FAA Beacon was required to be illuminated but was not because the crane operator didn't switch it on as required. Ref: SCWI 8715 0008 (5)
- B2 WP3: The contractors required fire watch was not within the required vicinity of the hot work. SCWI-8715-0008 9.5 (13)
- B2 WP3: Inspectors observed 3 scaffolding ladders that were not within the OSHA guidelines for access or egress. 29 CFR 1926.1053 (b) (1)

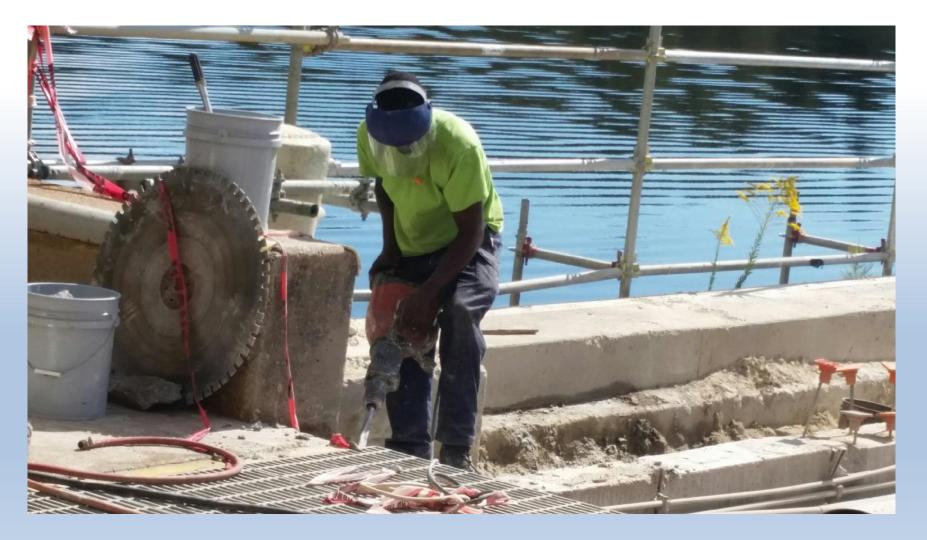
- Serious: 0
- Other than Serious: 2
  - B2 Tarmac Project: Employee failed to use proper PPE while performing a construction activity, specifically during jackhammering operations. Employee failed to have on: Hard Hat, Gloves and Hearing protection. SCWI-8715.0008 Section 9.3 Item 11
  - <u>B2 Tarmac Project</u>: During the same jackhammering activity, the employee failed to use a wet method to control the concrete dust as required. SCWI-8715.0008 Section 9.23.2 Item 2

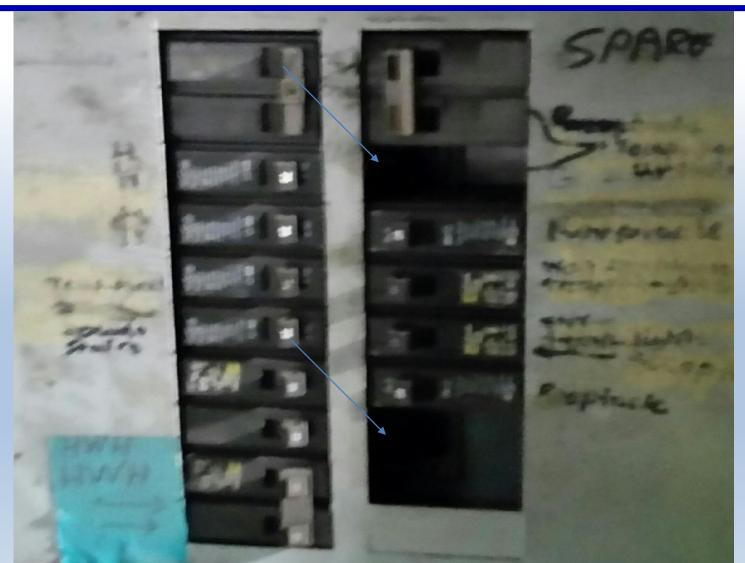
- Serious: 0
- Other than Serious: 4
  - <u>B2 WP3</u>: The temporary power panel in the B-2 lead containment area was found to be missing several breakers, thus leaving open holes in the dead front cover. 29CFR1926.405 (b)(1)

# Missing Blanks or Breakers and Poorly Written Breaker Schedule

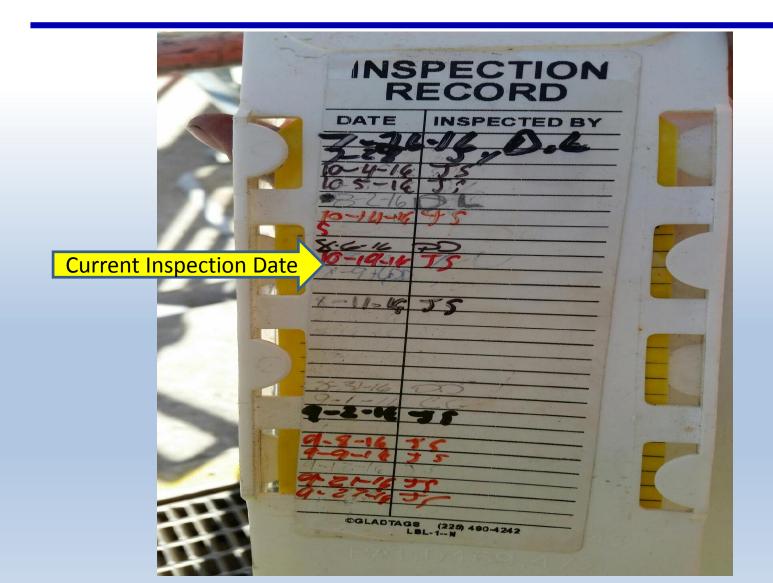
### Inspection Location Will Confuse User
