# SSC Construction Inspection Safety Findings/Stats

# October 2010

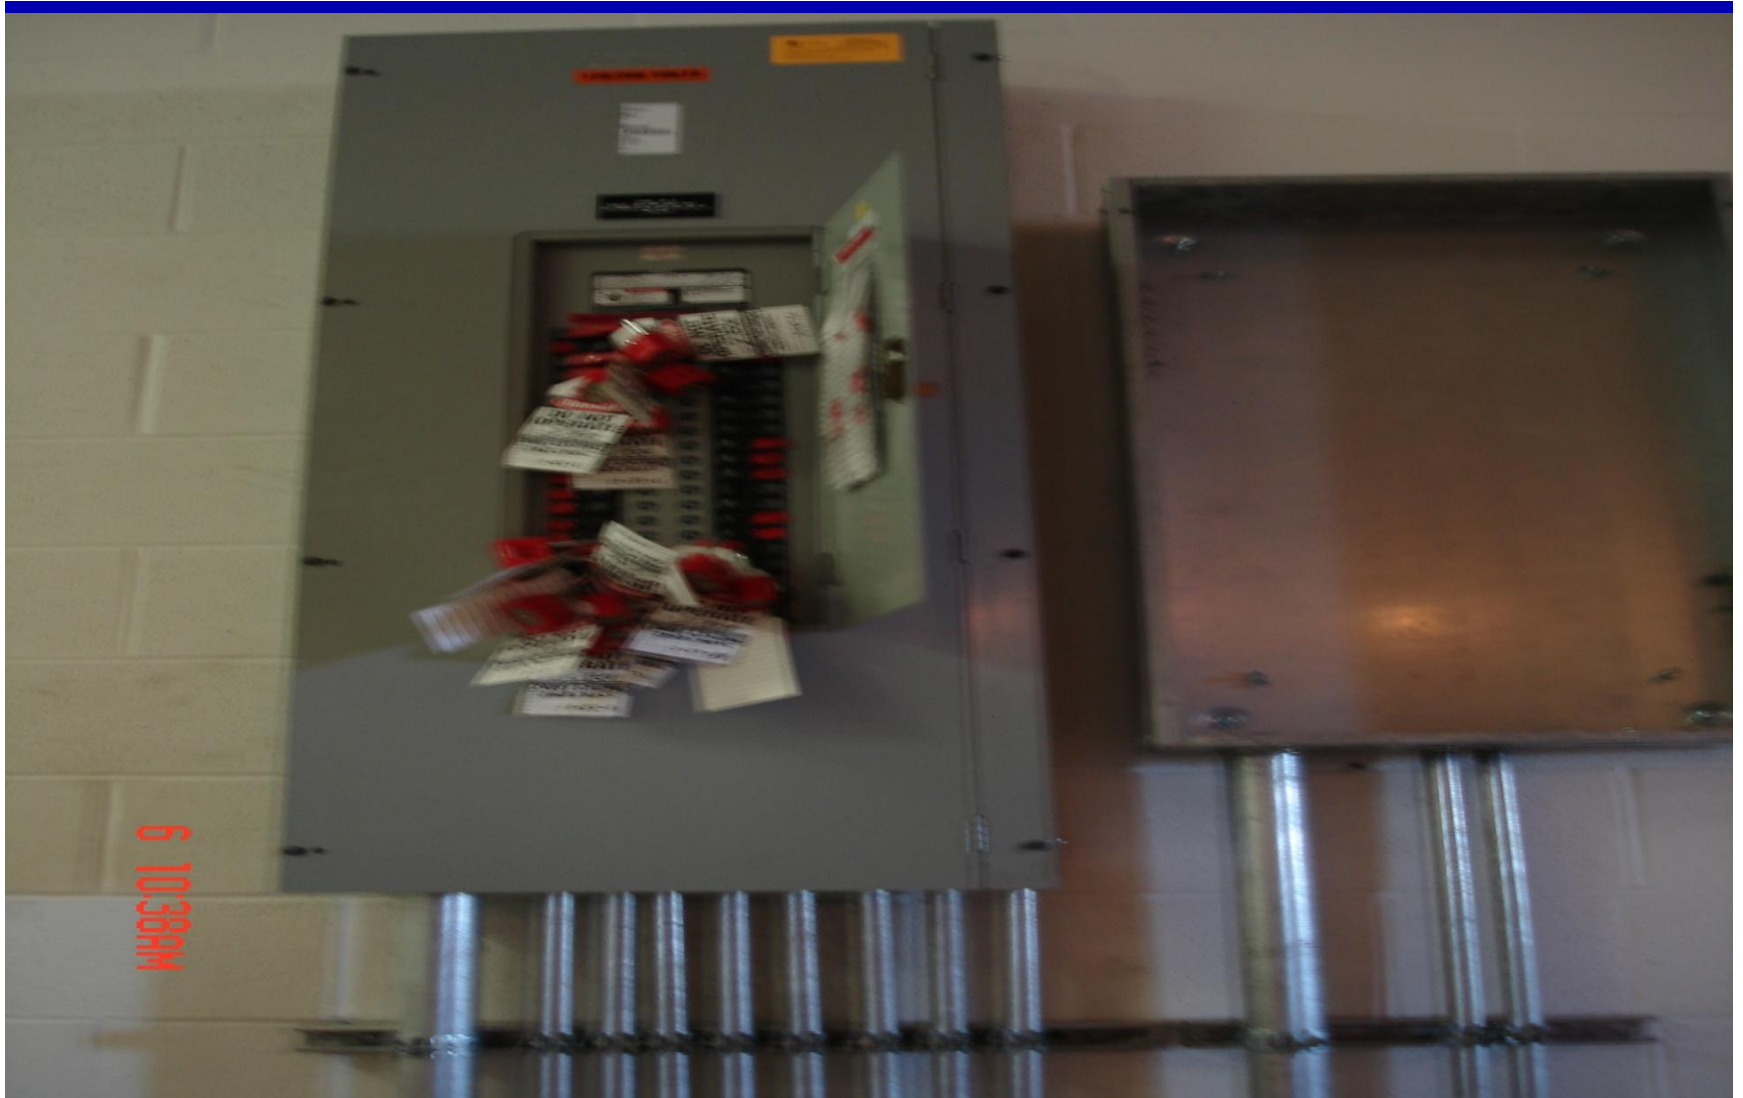
Example of correct LOTO Procedures at building 4995

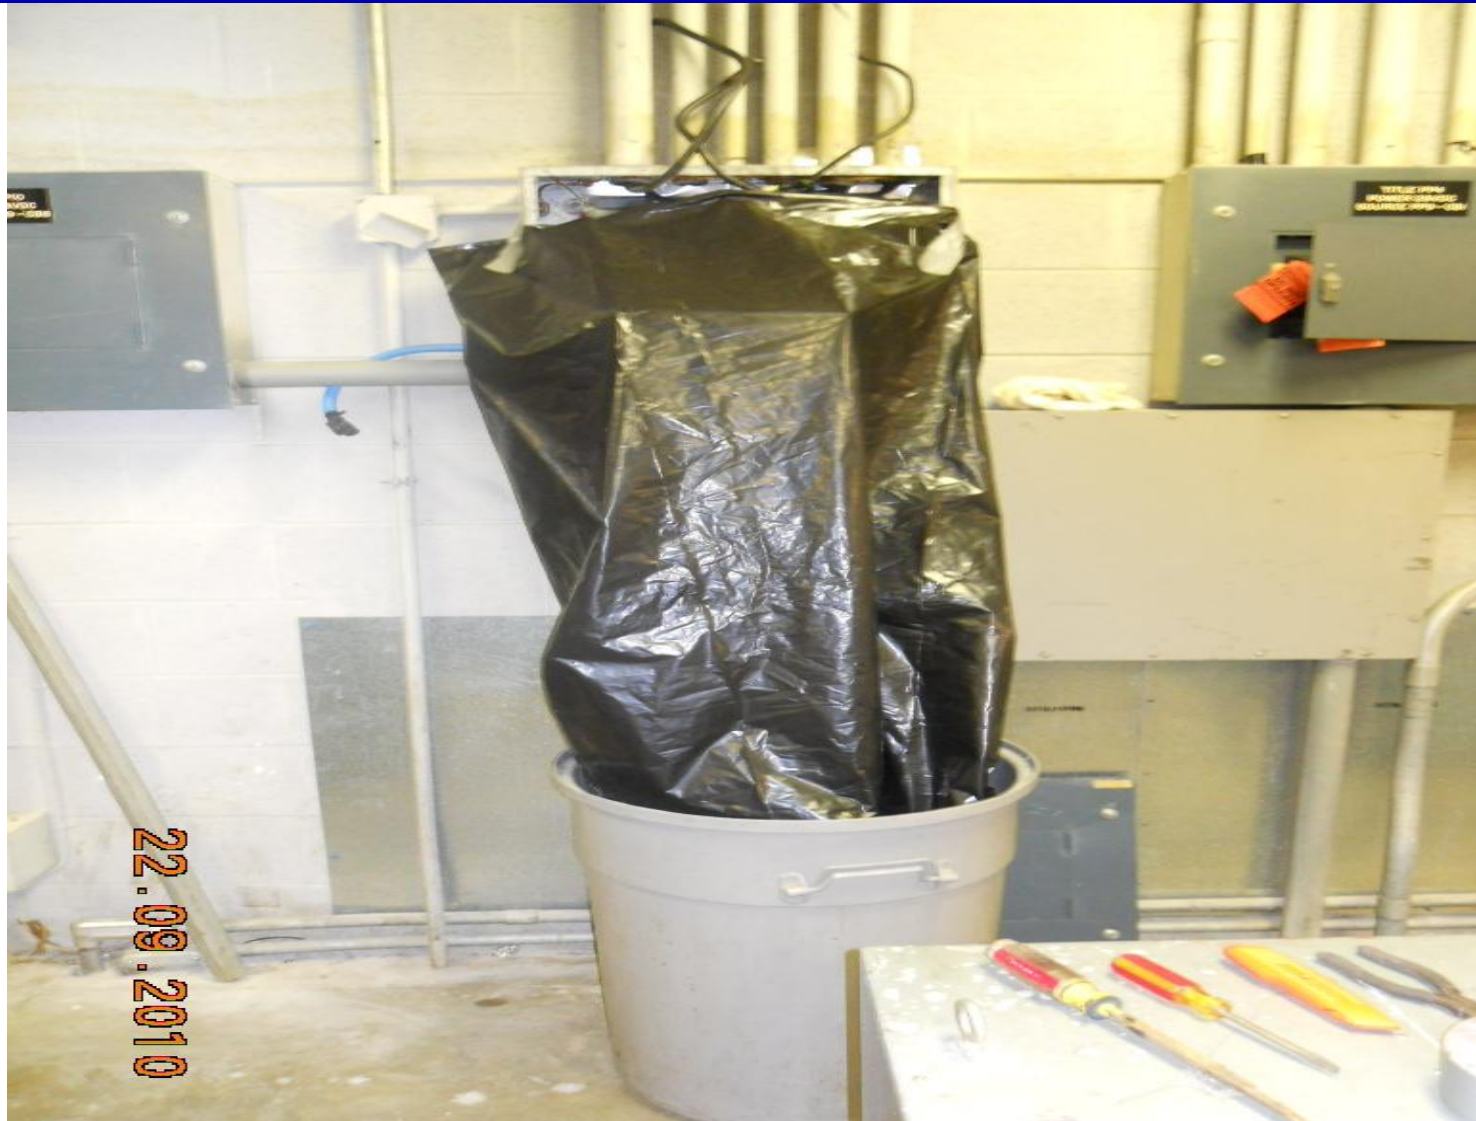
Sheet metal behind the garbage bag used to collect water runoff from core drilling which was in response to a close call due to water intrusion into a de-energized electrical panel located at building 4995 mechanical room.

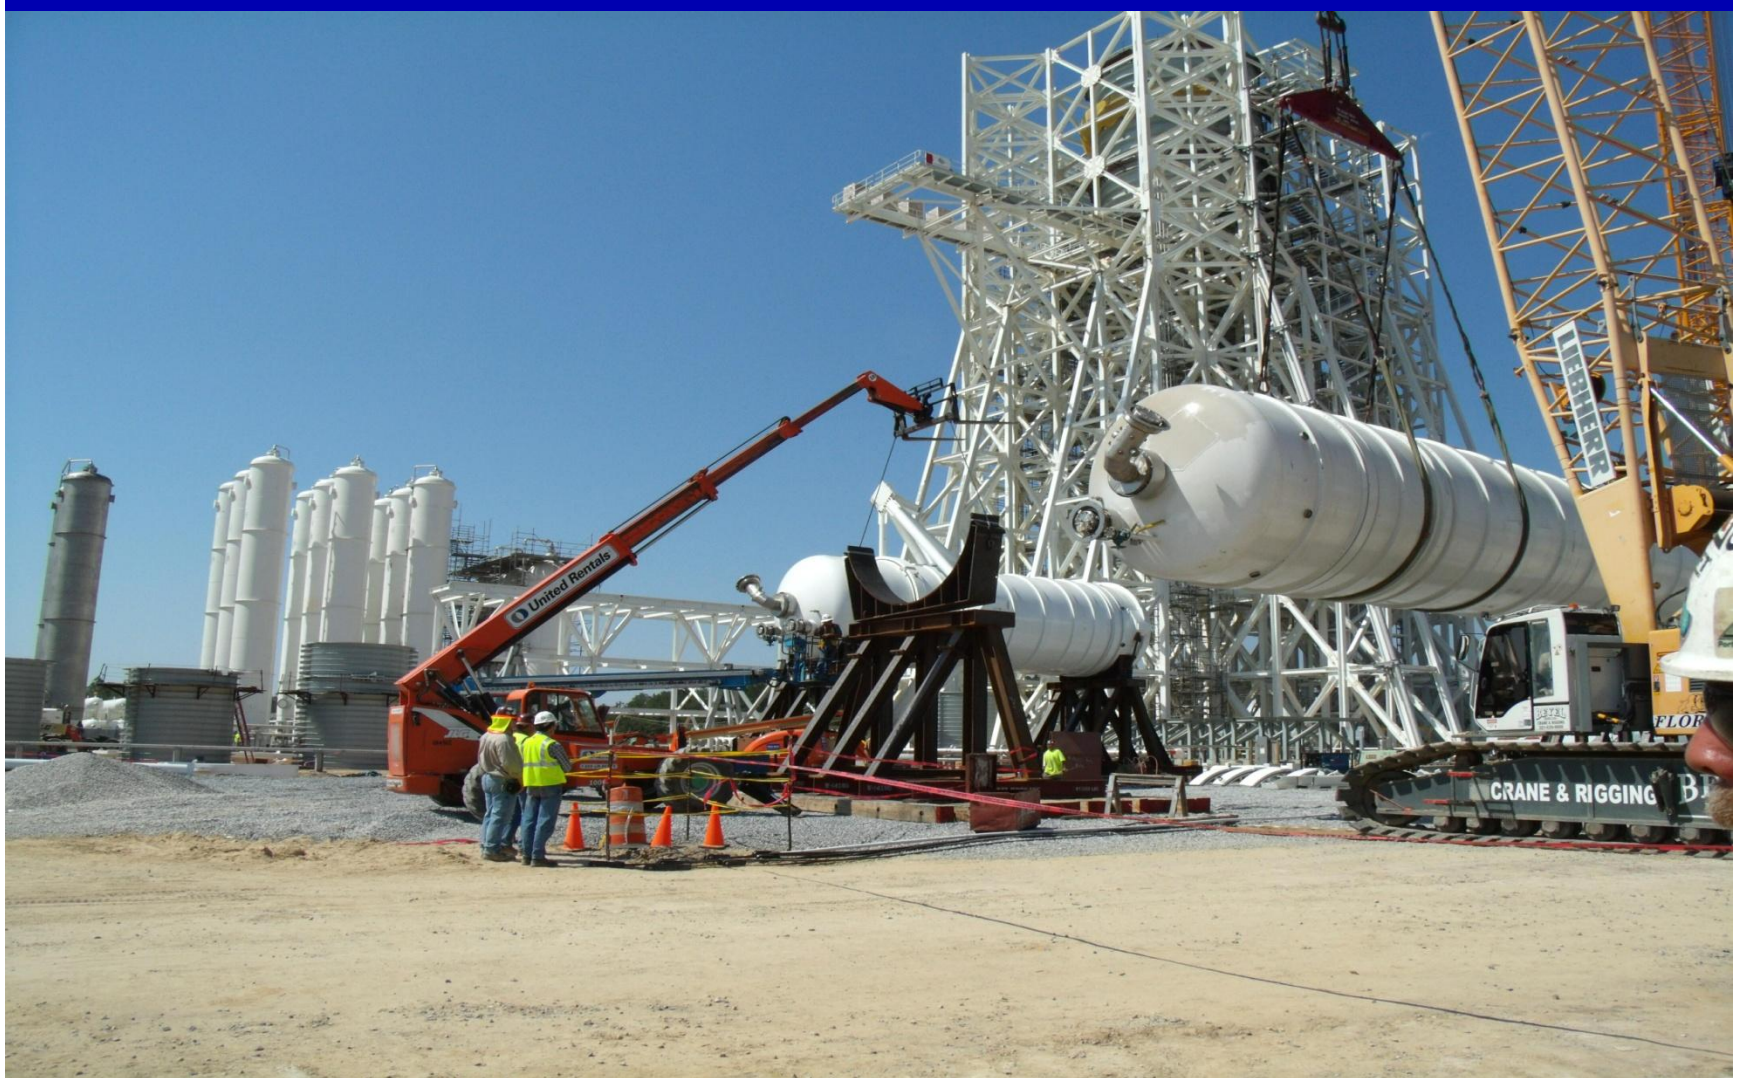
Lift of LH Tank, the brackets are being put into place while the tank is suspended
