Construction Safety

SSC Construction Inspection
Safety Findings/Stats

November 2018

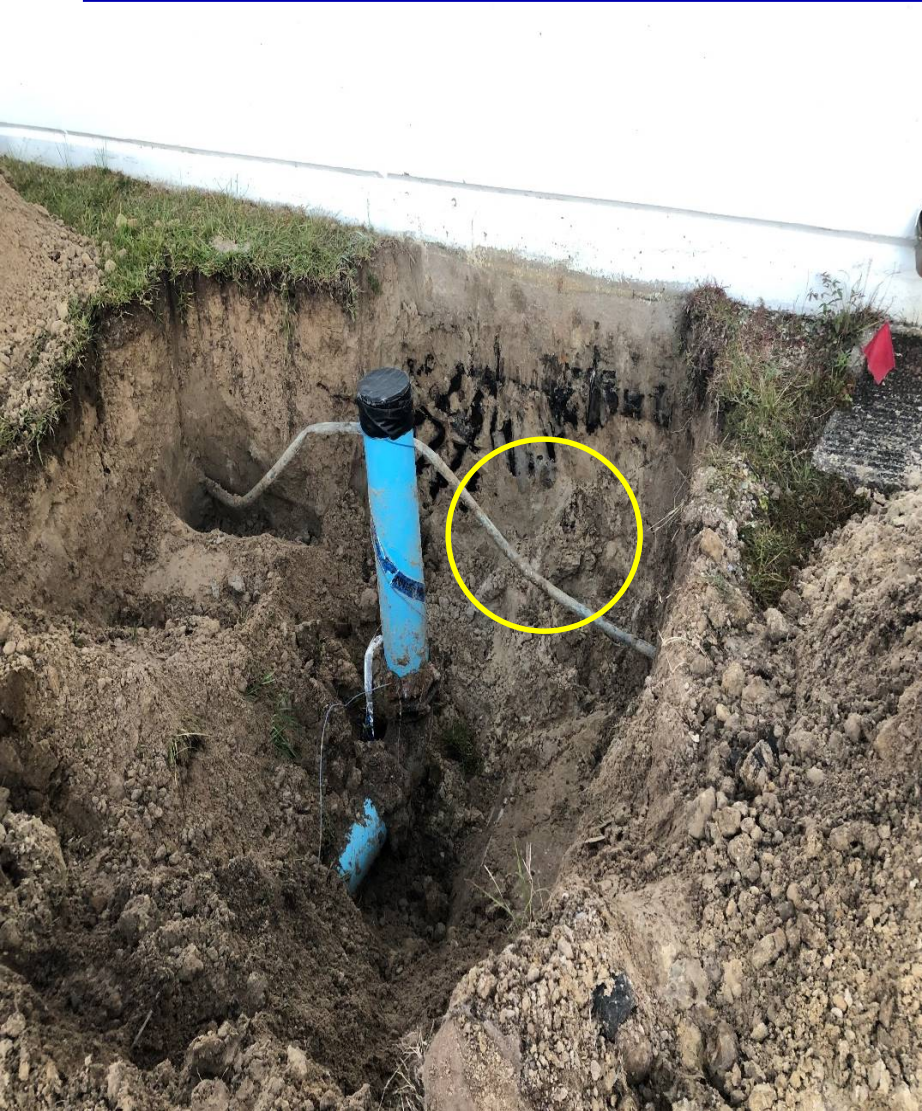
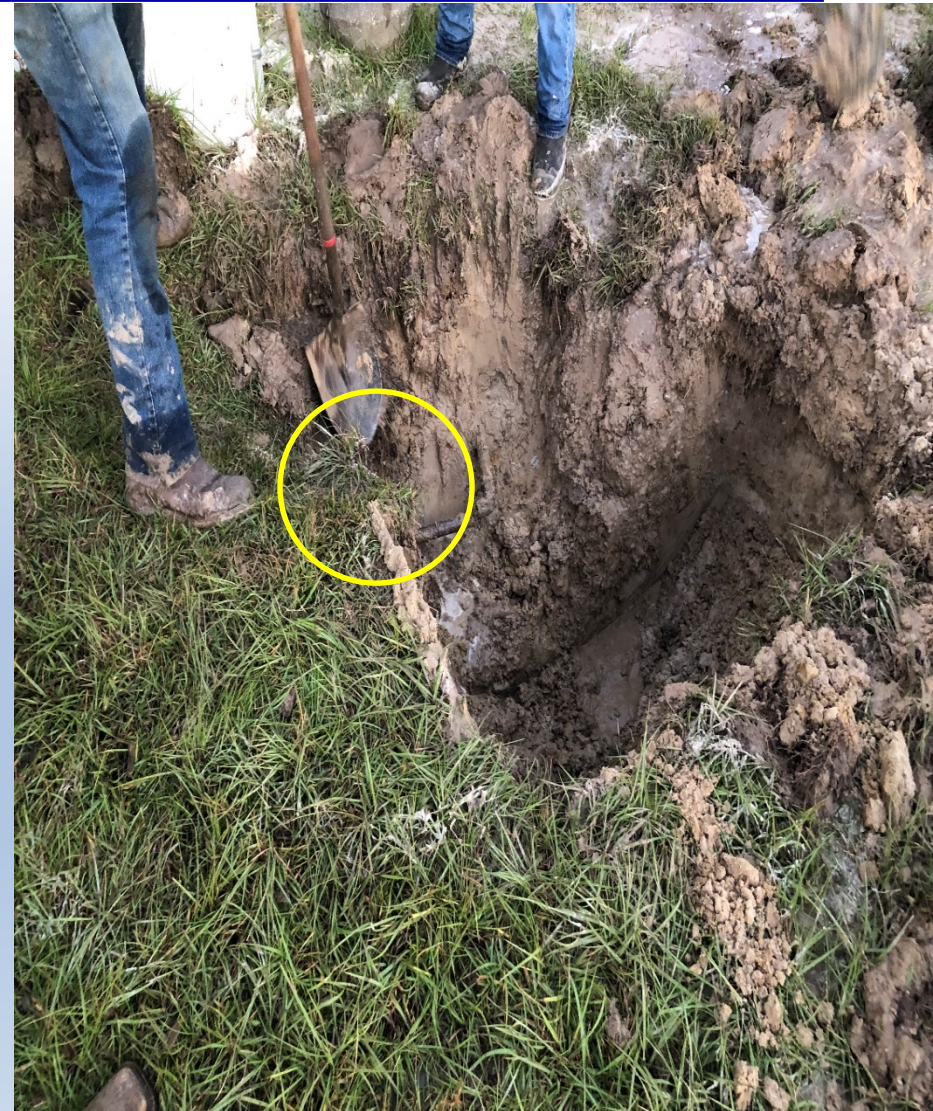
Construction Safety Findings:

Building 4210: On 11-20-18, At approximately 1530, an unmarked 1-1/4" copper water line was struck at B4210. This 1-1/4" copper waterline serves the exterior building spigots and has been temporarily isolated while S-3 made the repair. No other building systems were affected. The excavator pulled the line from the elbow approximately 15' south of the excavation where the strike occurred. A SSC form 1627 was generated.
