Construction Safety

SSC Construction Inspection
Safety Findings/Stats

October 2015

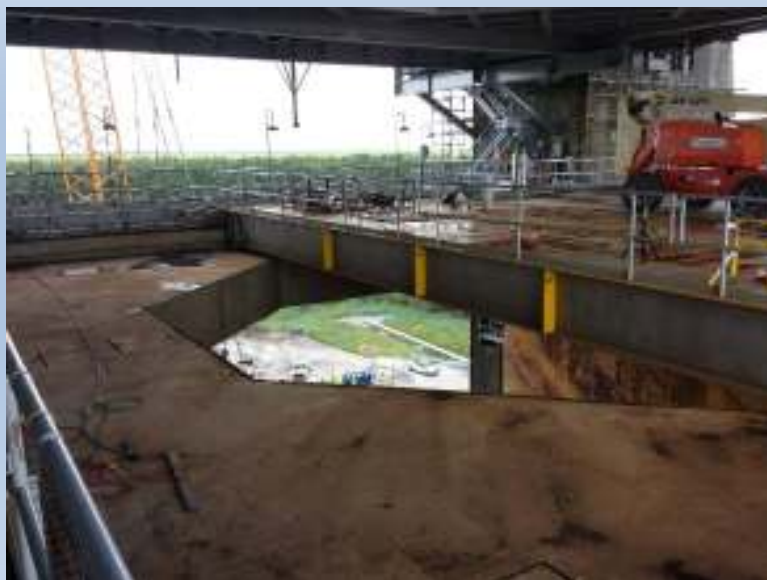
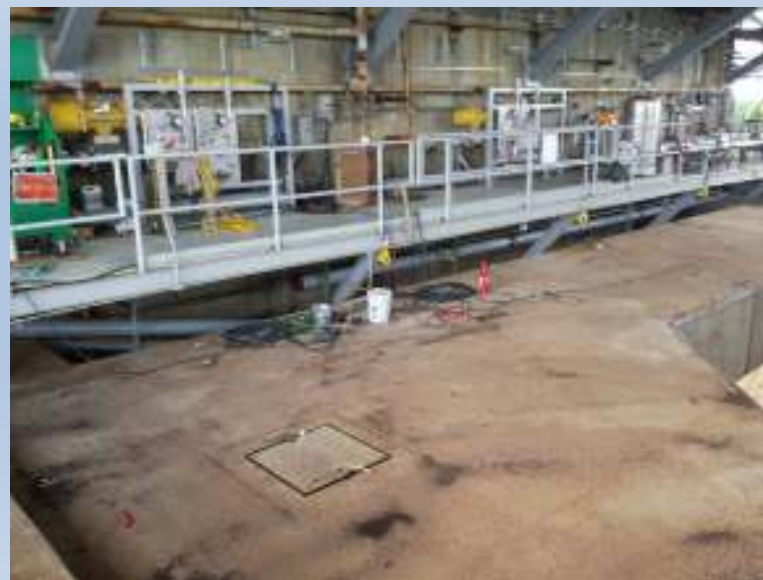
1. Three (3) subcontractor employees working below the B-2 rolling deck failed to apply their locks and tags to an already locked out rolling deck air actuator handle. SCWI-8715-0013
