Construction Safety

SSC Construction Inspection
Safety Findings/Stats

October 2014

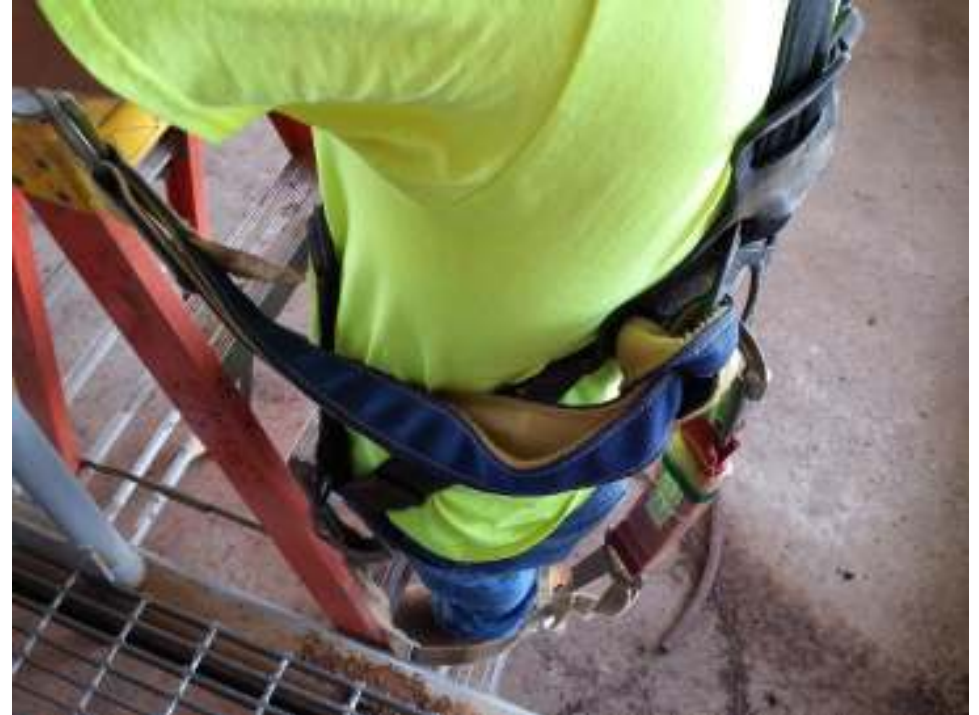
1. Employee found using a beam strap as a lanyard. SSP-8715-0001 section 3.3(f)
2. Employees working without first completing their daily Activity Hazard Analysis (JHA) or equivalent. SCWI-8715-0008 section 6.5.1

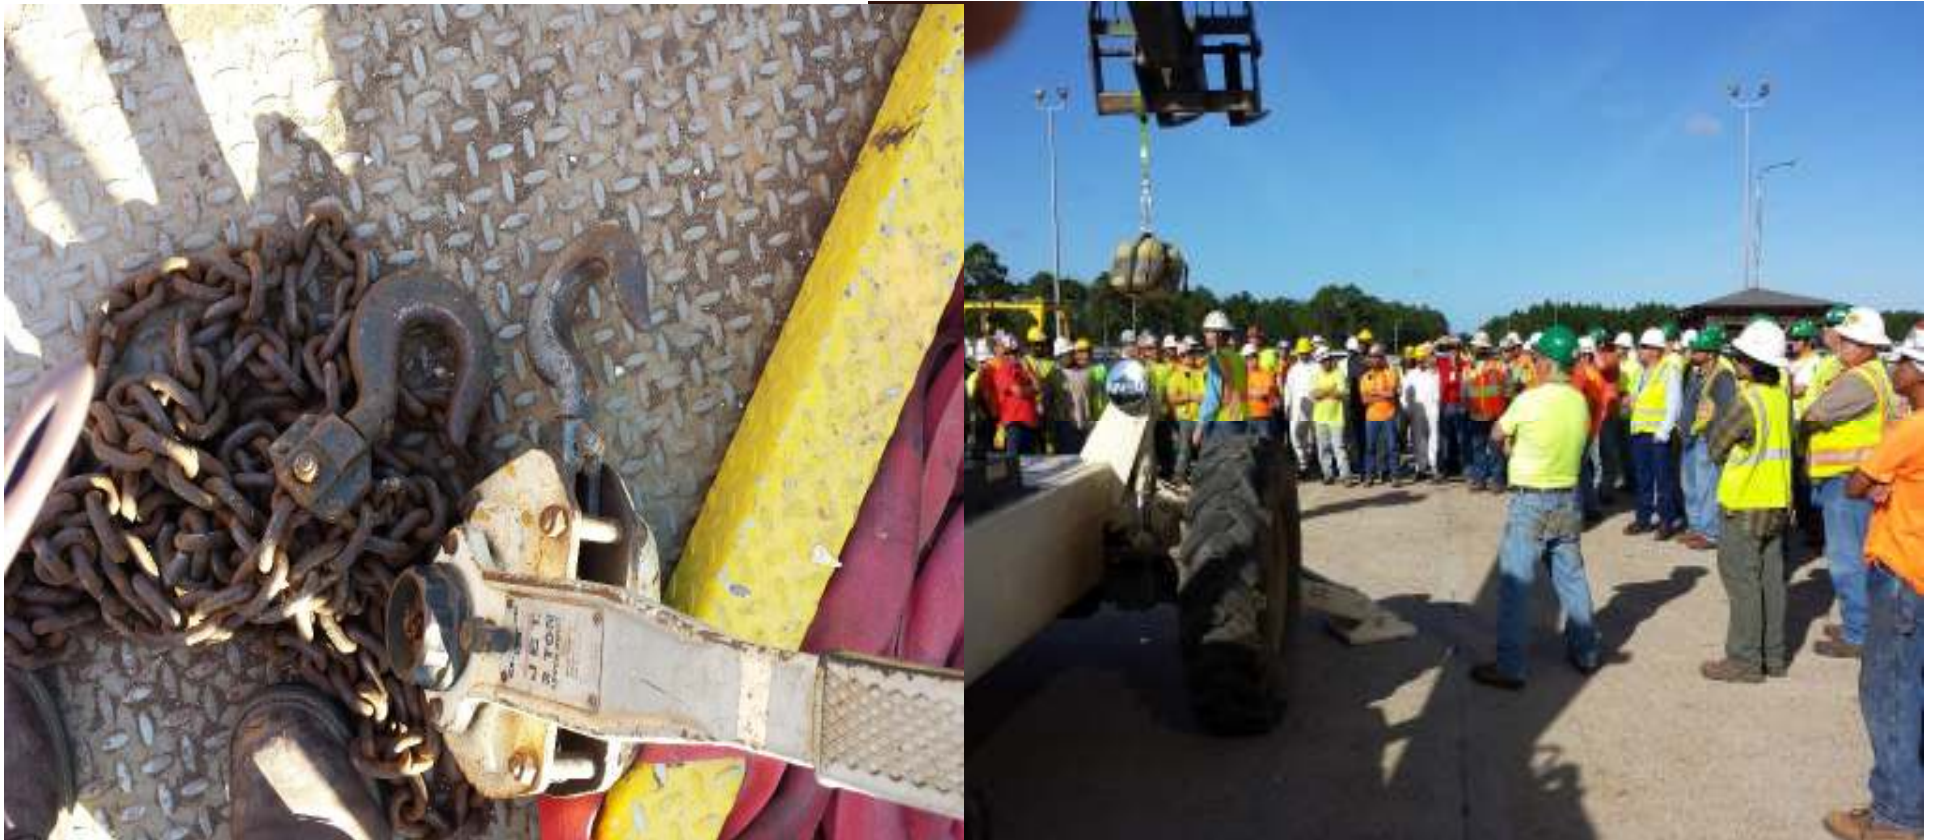
Construction Safety Findings: 06-10 October 2014

1. Observed a chain fall hoist in use that was missing the safety latches on the hooks. 29CFR1926.753(c)(5)
2. Observed a welding lead stinger repaired within six feet of the end. 29CFR1926.351(b)(2)

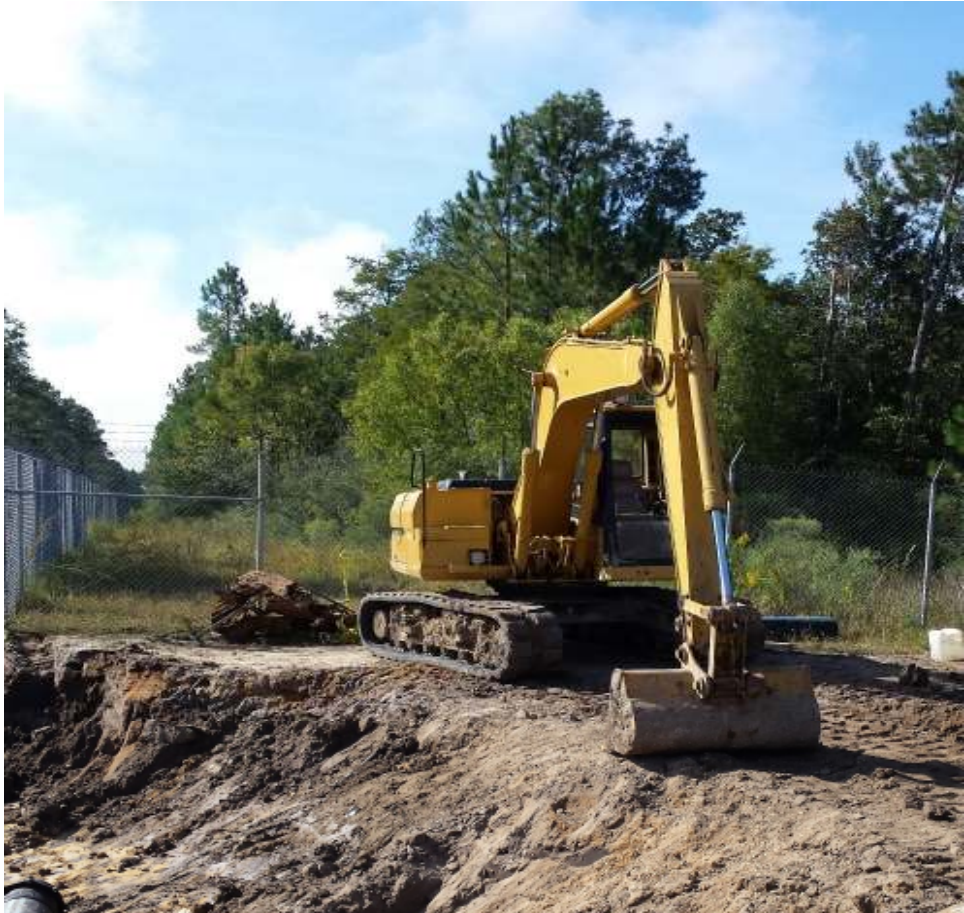
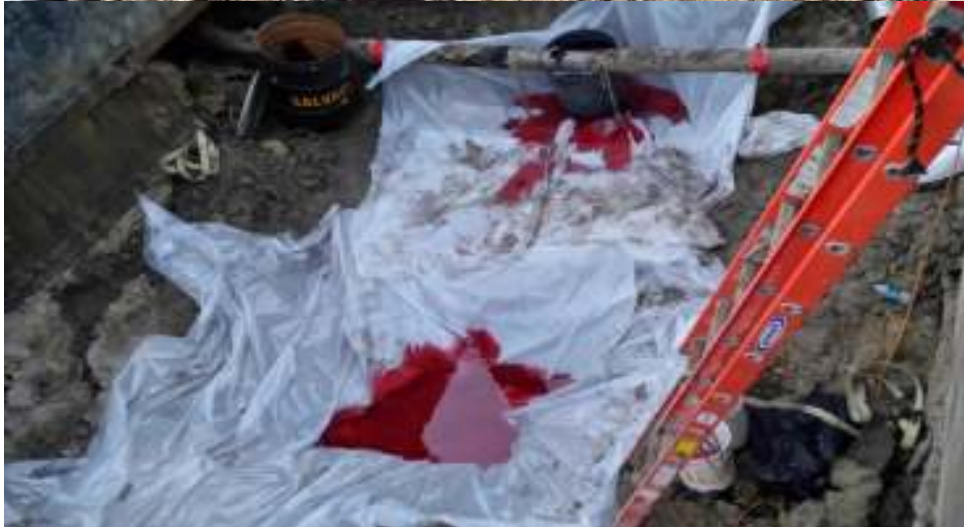
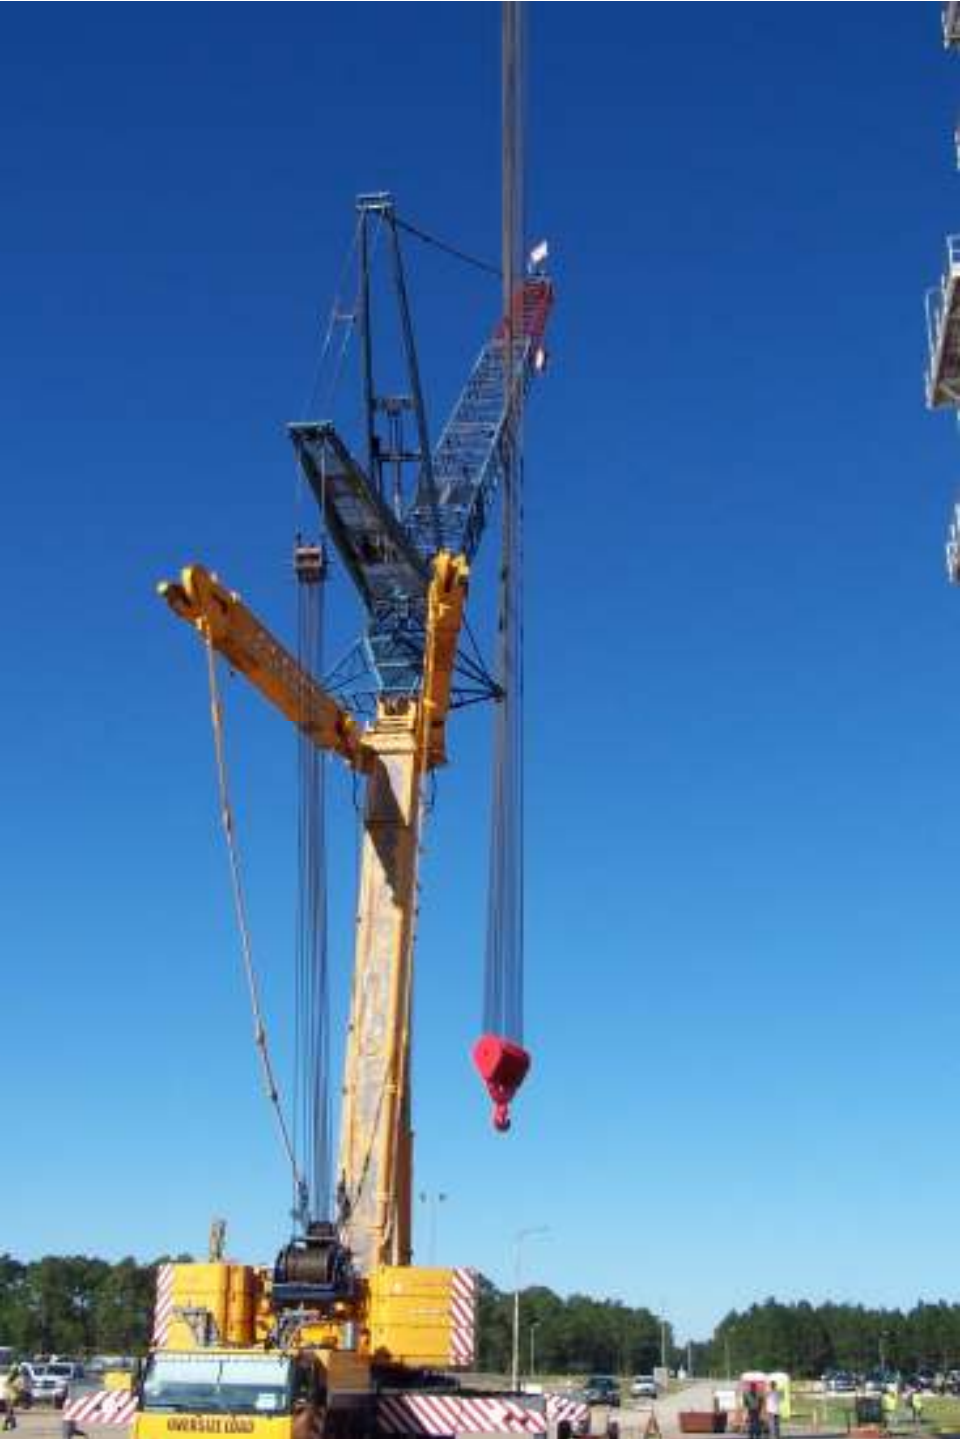
1. A gust of wind caught the derrick crane boom on the B Test Stand and swung it to the left. An employee was able to grab the boom with a chain and secure it before the derrick crane boom made contact with a Glenn crane boom. The derrick's cables did contact the Glenn crane, causing Glenn to lower the boom and perform a thorough inspection. No injuries or property damage noted.
2. A working was standing next to 10' deep excavation when the bucket from an excavator hit the worker's left buttock area, knocking the worker into the excavation. The worker received minor injuries.
3. The contractor was attempting to cut and cap an abandoned line believed to be absent of any liquid, when after making the initial cut, RP-1 flowed from the line.

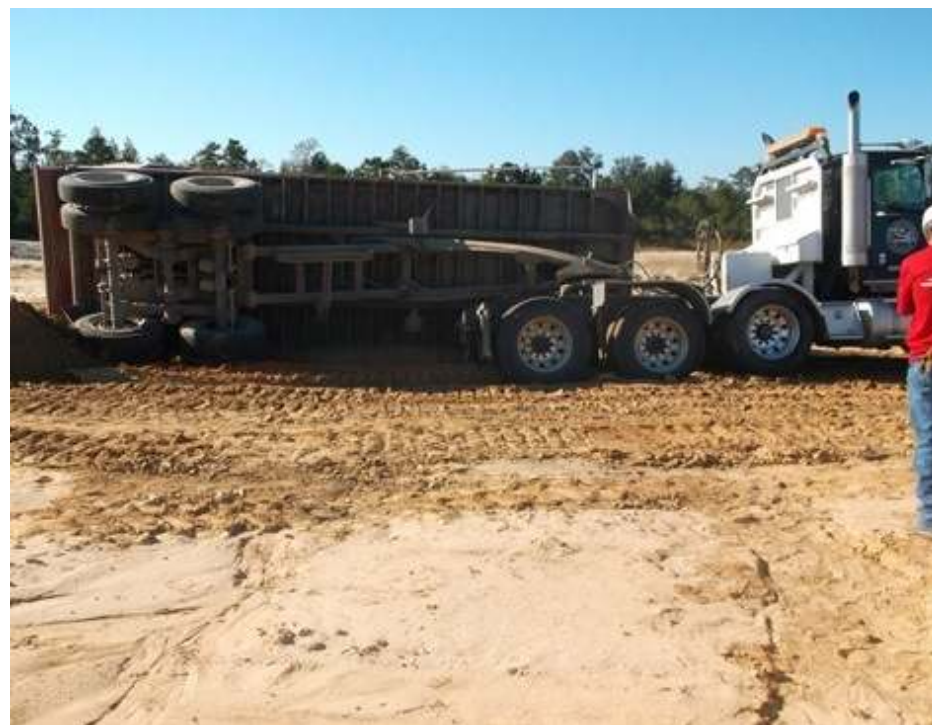
1. A truck driver was attempting to dump a load of dirt at the SSC Landfill when the trailer fell over. The subcontractor brought an excavator to the site the following morning to remove the remaining dirt from the trailer and lift it up-right. No fluids were leaked and only minor damage occurred to the trailer's frame, making this a close call.

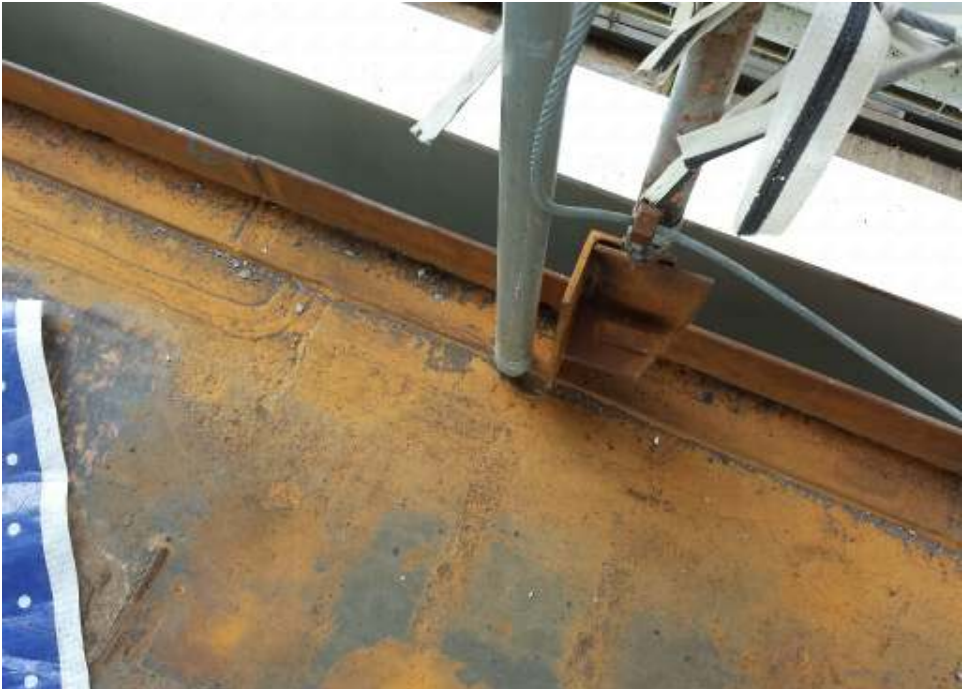
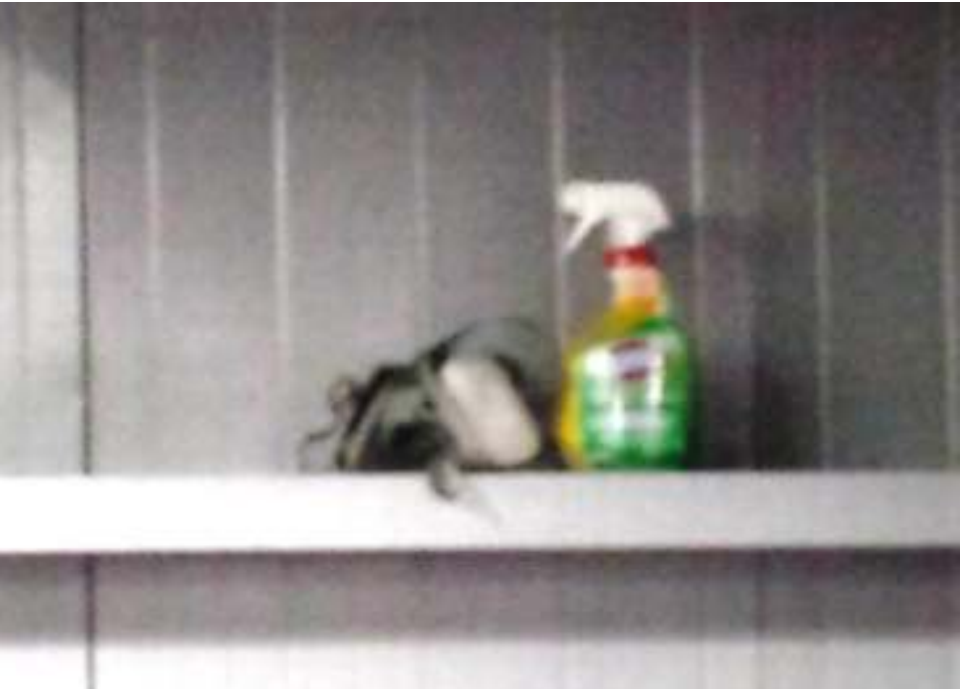
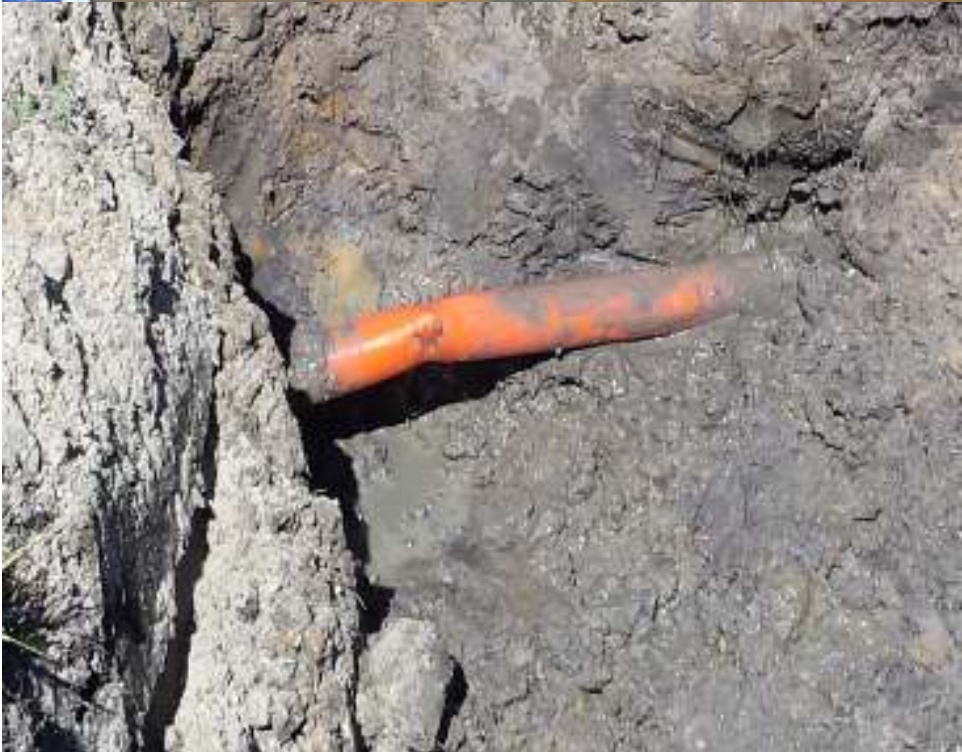
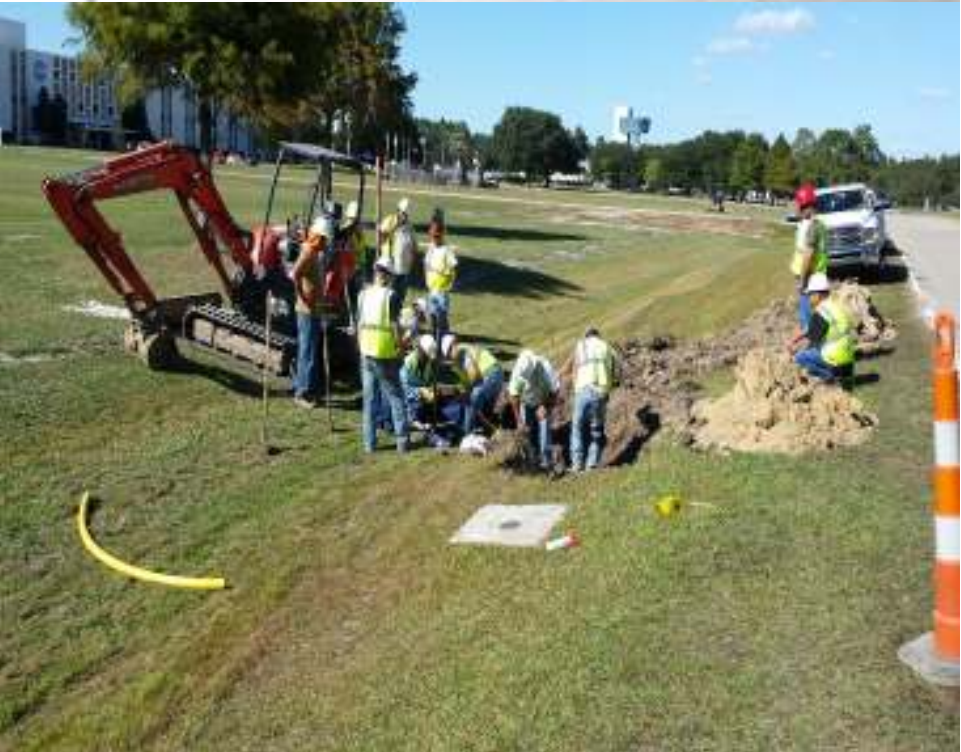
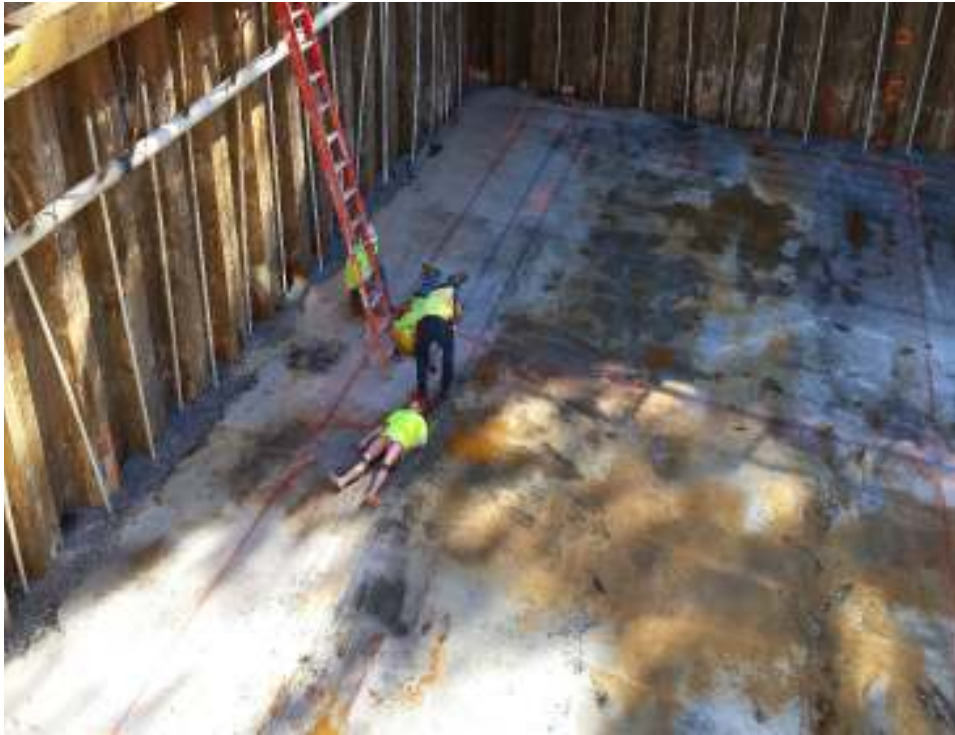
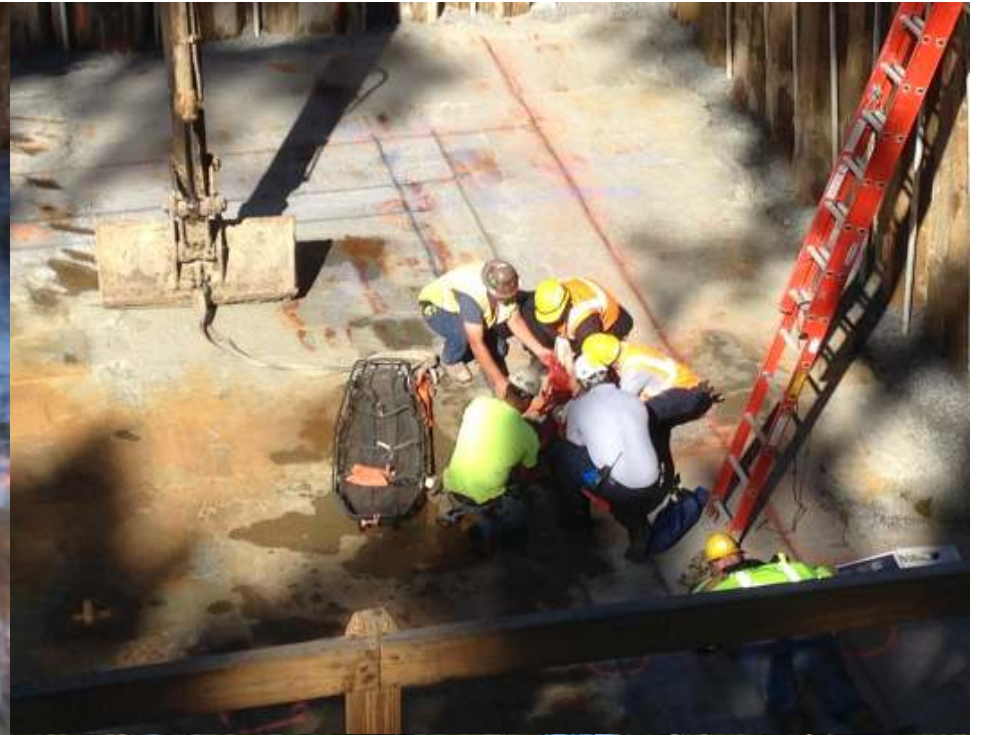
1. Failure to place base plate under supporting upright scaffold leg, 29CFR1926.451(c)(2)
2. Improper storage of half mask respirator, 29 CFR 1910.134(c)(1)(v)

1. A subcontracted employee was operating a mini-excavator near Balch Boulevard, in front of Building 1103 attempting to dig a trench and struck a buried natural gas line. SSC Fire Department was notified and responded. Jacobs FOSC plumbing shop personnel responded and were able to secure the natural gas at the nearest valve. Buildings in the 1000 series (NAVO) were affected by the gas outage to the plant boilers.

On Thursday, October 30, 2014, a construction contractor and the SSC Fire Department participated in a drill to perform a confined space rescue. The contractor had an employee simulate a fall to the bottom of the 96" valve vault construction site, which is currently seventeen feet below grade. The drill resulted in the injured worker being successfully lifted out of the vault without incident and an overall successful test of the contractor's rescue plan.
