Construction Safety

SSC Construction Inspection
Safety Findings/Stats

September - October
2013

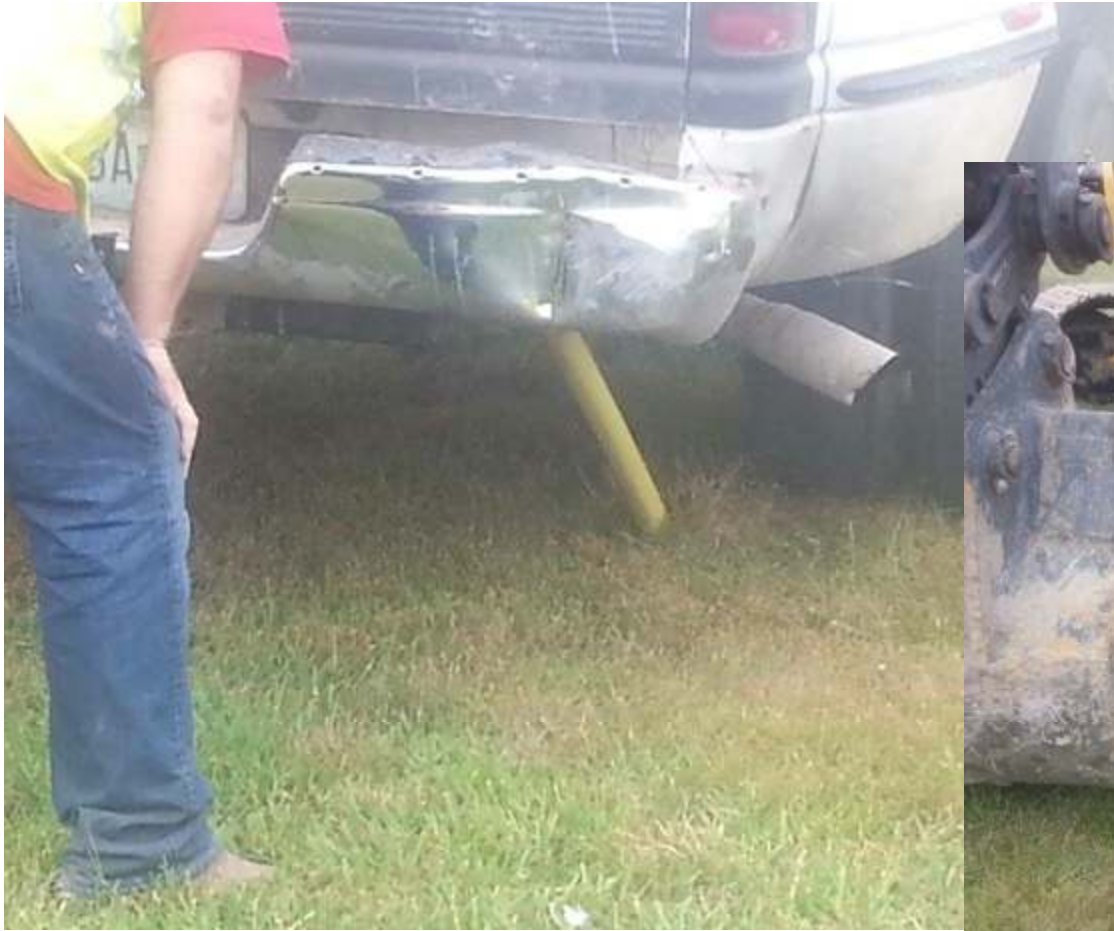
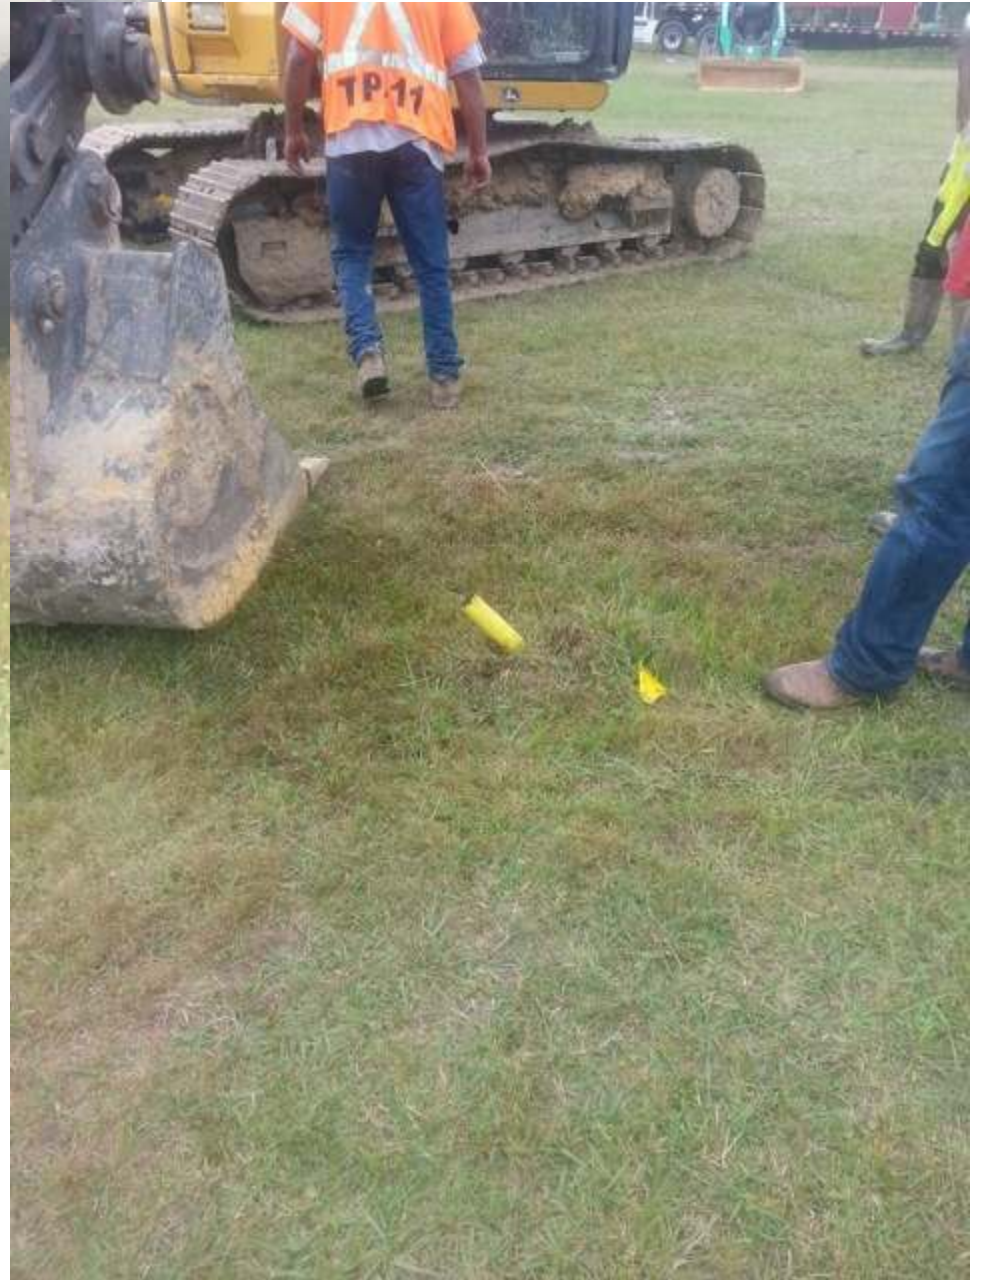
1. Building 3204: An employee backing a pick-up truck in the open field in front of Building 3204 struck a natural gas casing vent stack. There was minor damage to the truck and the vent stack had to be cut, since it became entangled in the truck's frame. Contractor is working on a suitable corrective action and will repair the vent stack.

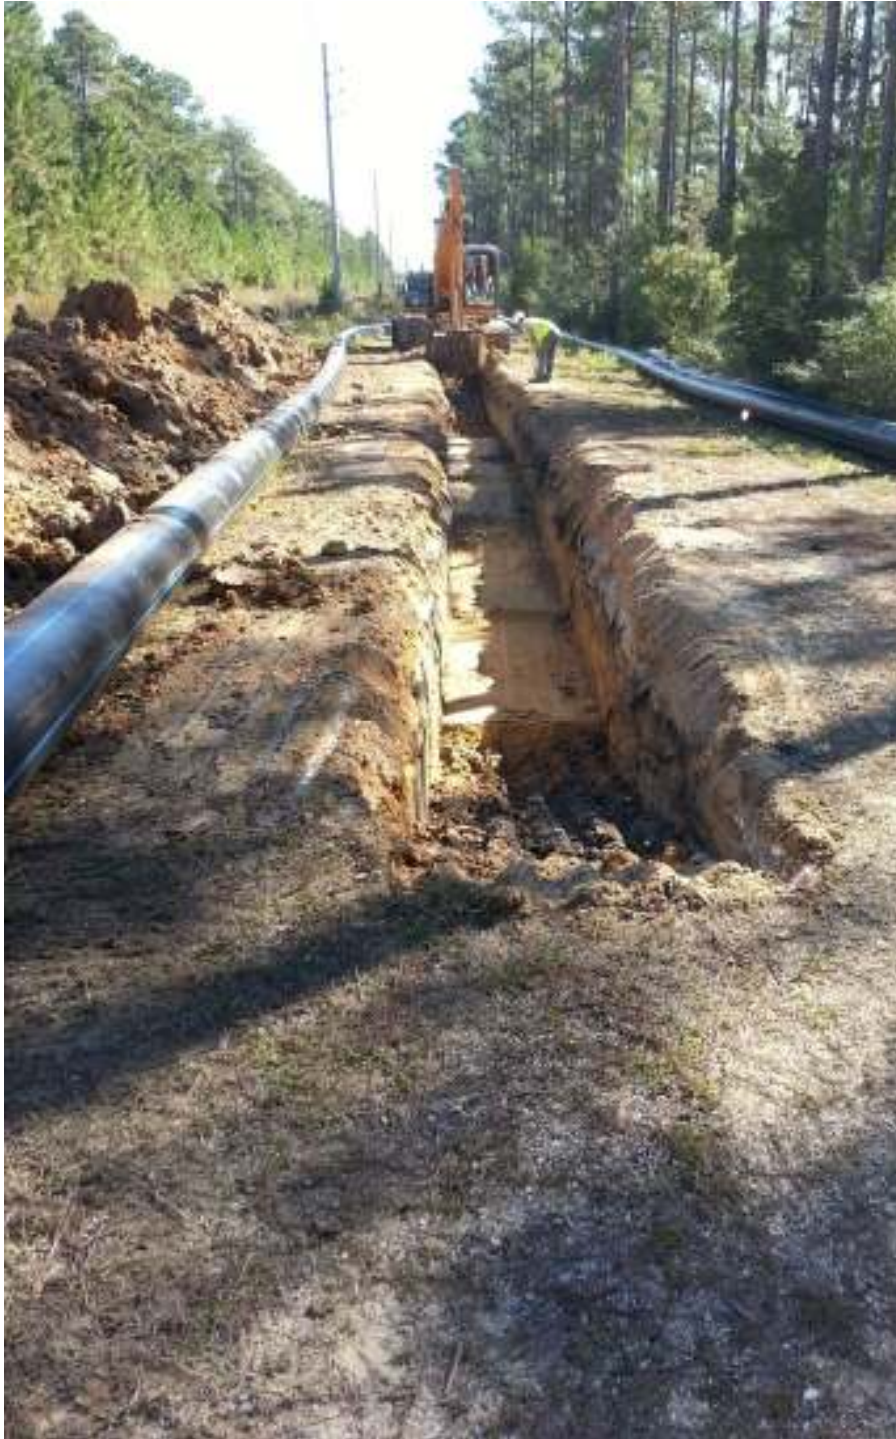
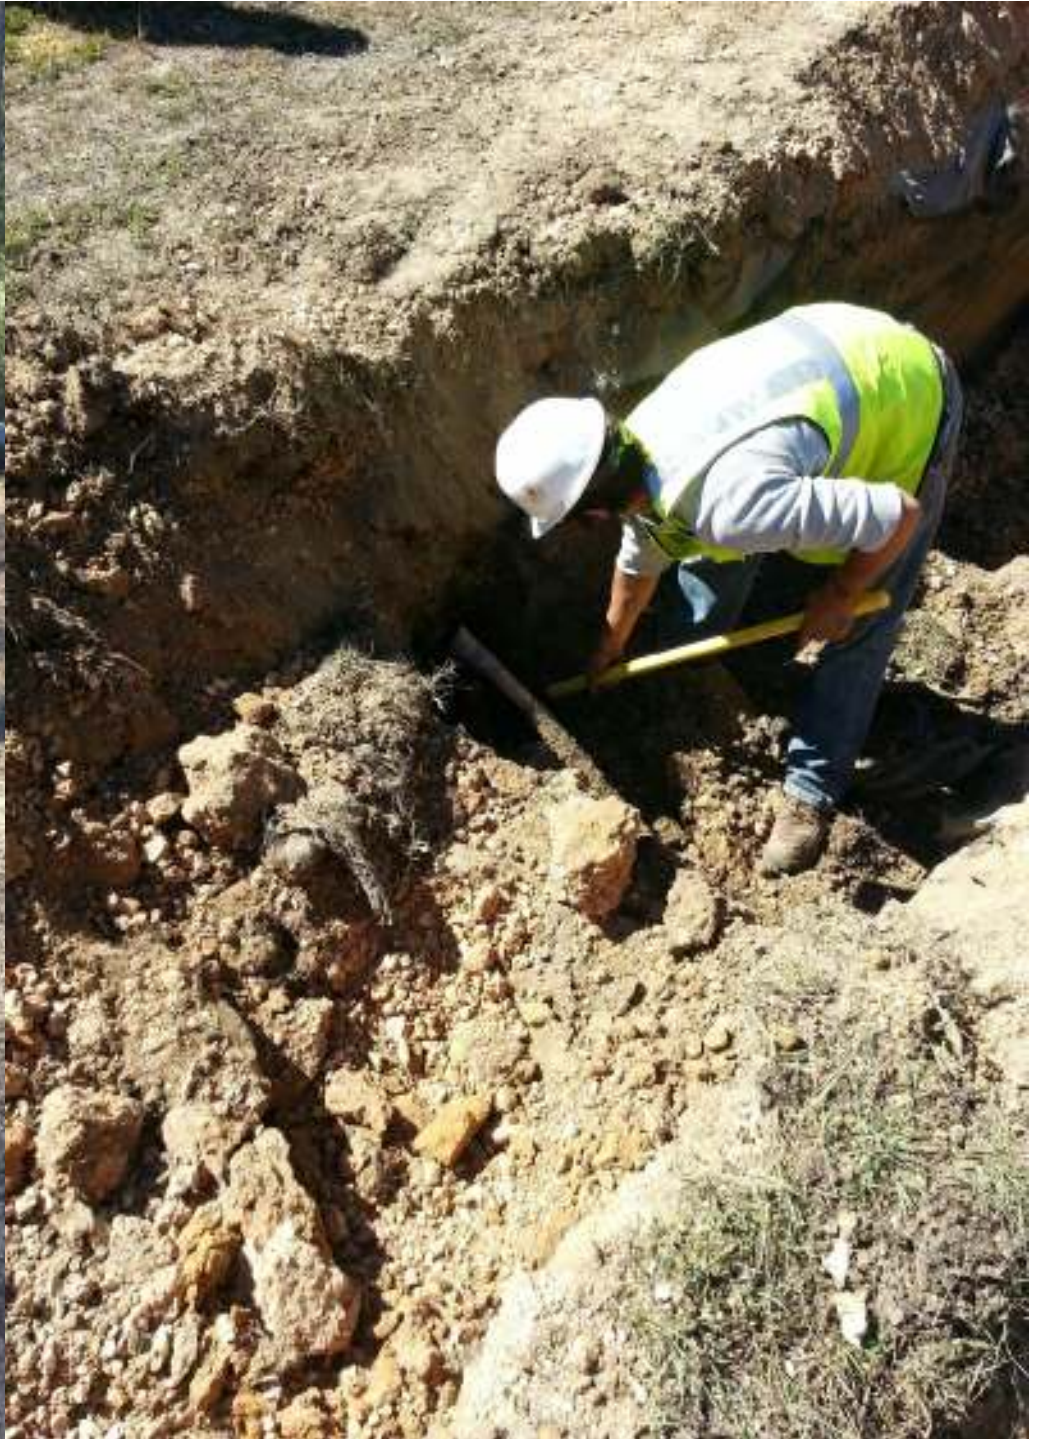
1. Building 1009: An equipment operator was digging a trench to install a sixteen inch diameter water line when the excavator bucket damaged a two inch compressed air line that was buried approximately three feet. This occurred in the power line right of way to the south-east of Building 1009. The air line crossed perpendicular to the excavation and was not found on any drawings or marked on site. TOC Technicians were able to secure the line from a valve pit found approximately 250 feet south of the strike in a densely wooded area. There were no injuries and no known disturbances to utilities at the surrounding buildings.
