SSC Construction Inspection Safety Findings/Stats

November 2013

Construction Safety Findings: 4-8 November 2013

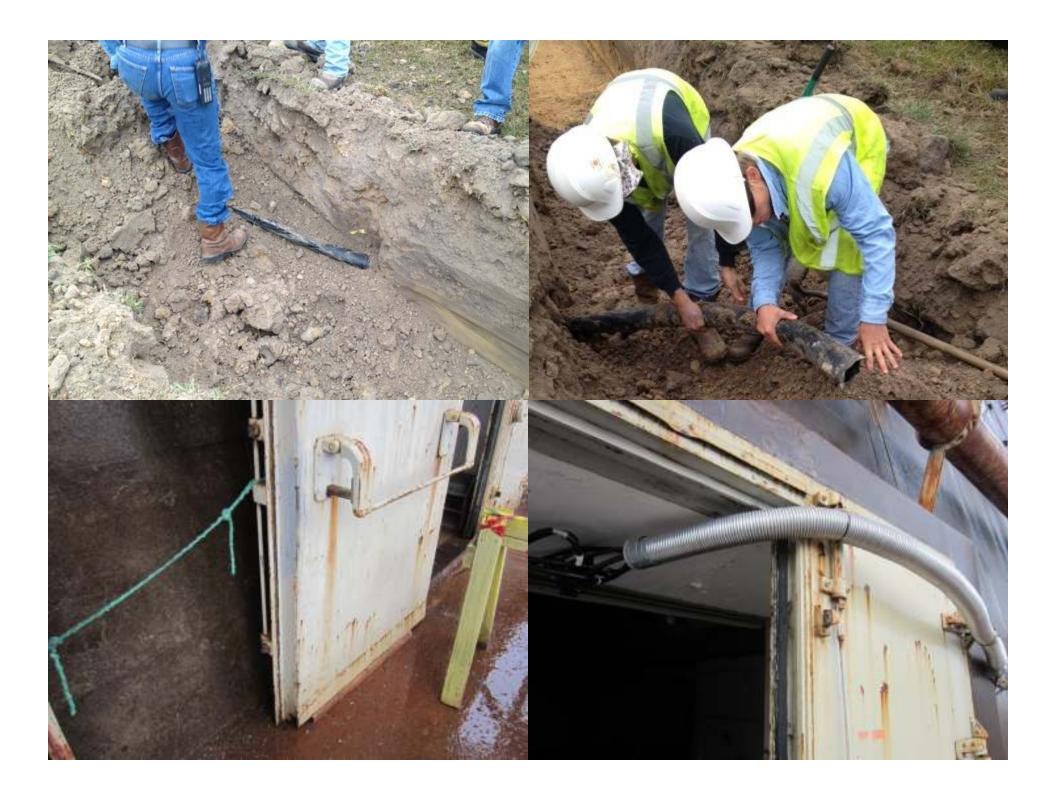
1. A gust of wind blew the blast door at the east pier B-2 Test Stand into a 480 volt temporary power line, cutting the insulation, and tripping the circuit breaker which fed it. The breaker panel/circuit breaker (which was in the T/S basement) was identified and tagged out. The power was then verified to be off and the line was repaired.

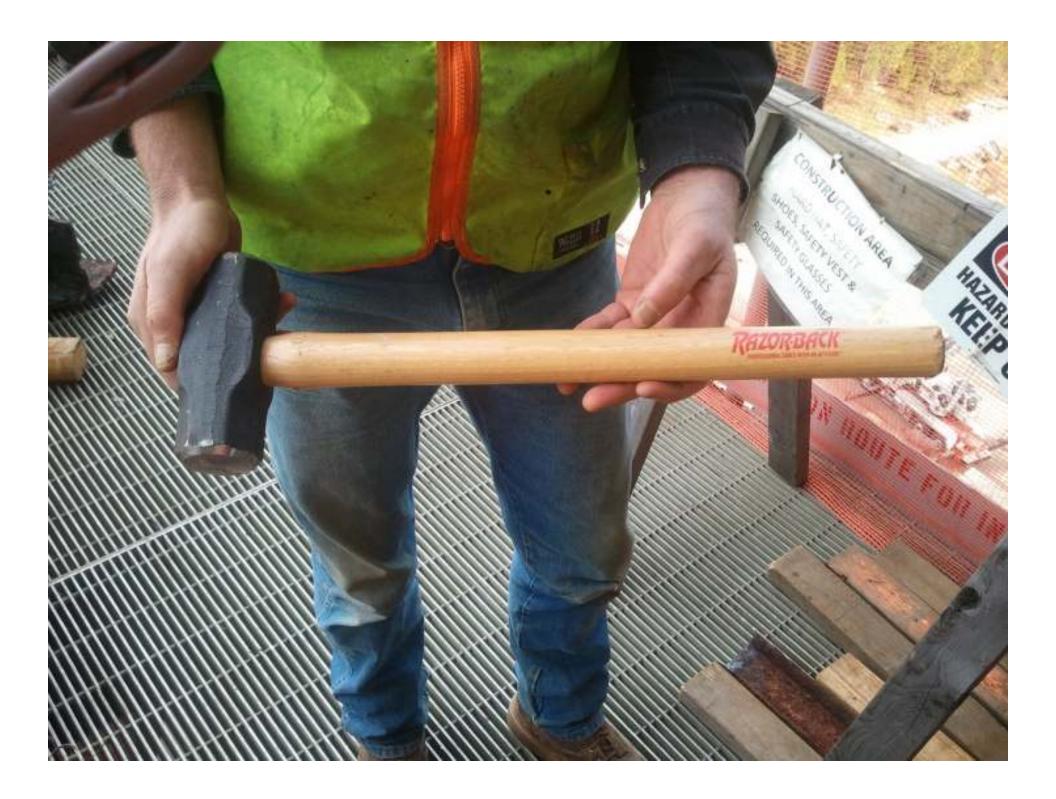
1. Contractor employees were working on B-2, level 8 when a maul hammer dropped to level 7 due to vibration from jackhammer activities. The hammer was laying unsecured and unattended and not in use when the vibration caused it to fall. The hammer fell from level 8 to level 7, then continued down the flame bucket to the ground. There were no injuries and no property damage.
