# Construction Safety

SSC Construction Inspection  
Safety Findings/Stats

March 2018

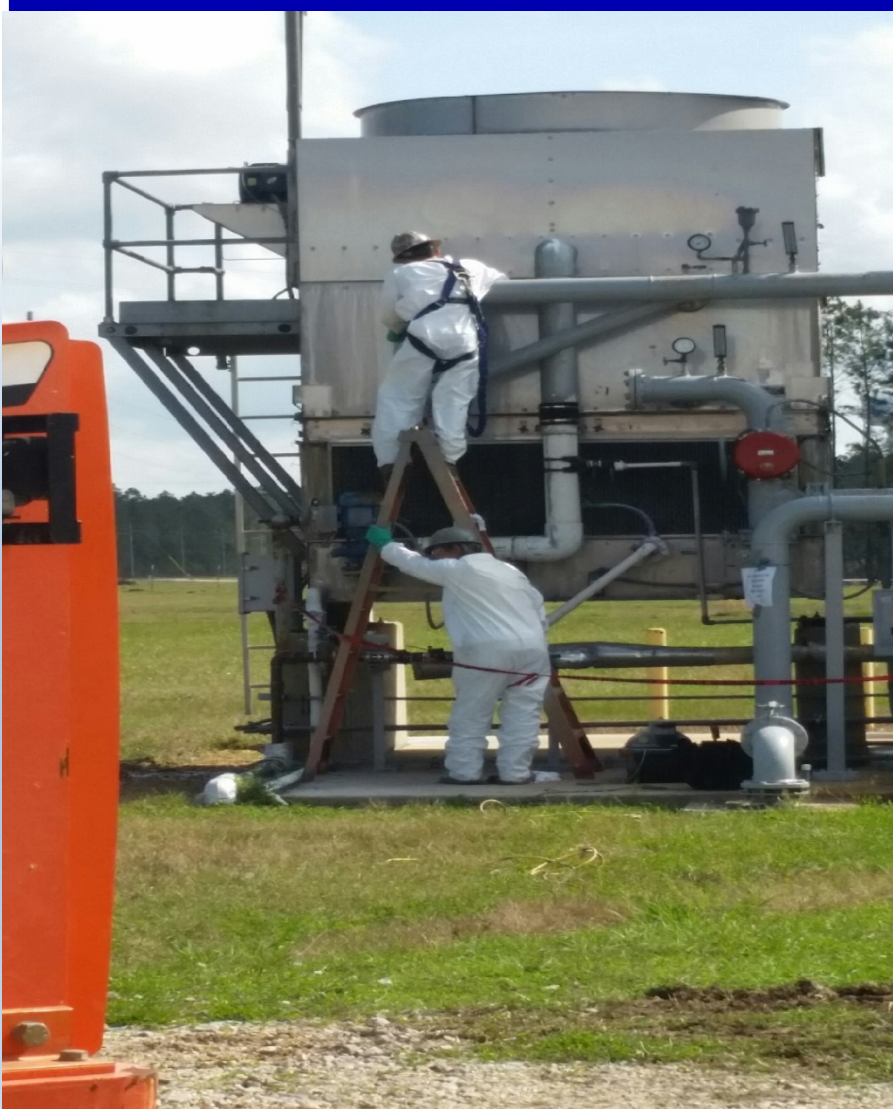
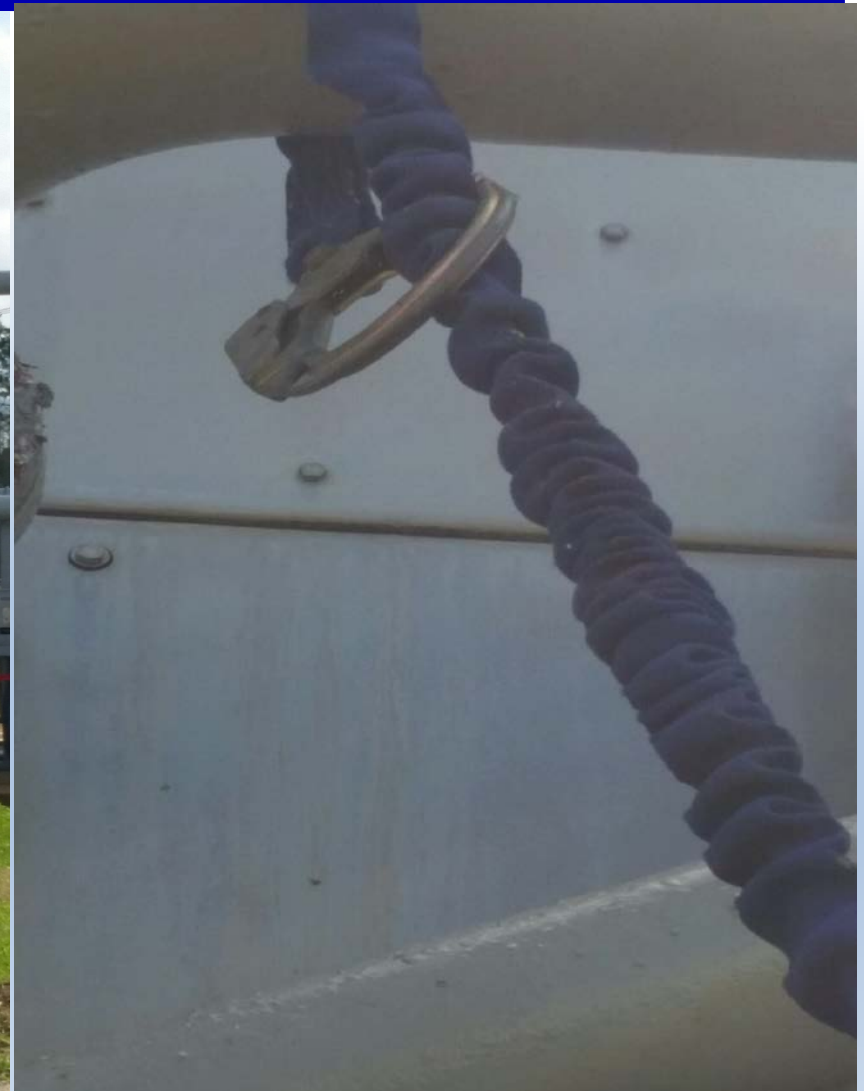
# Construction Safety Findings:

- **Compressor and Air Dryer replacement:** Contractor was standing improperly on an “A” frame ladder. Ref: 29CFR1926.1053 (b)(13) SHEtrak closed ID#: 85073
- **Compressor and Air Dryer replacement:** Contractor improperly tied his harness lanyard back to his harness lanyard. His lanyard did not have the required lanyard connecting ring. Ref: 29CFR1926.95 (b) SHEtrak closed ID#: 85075

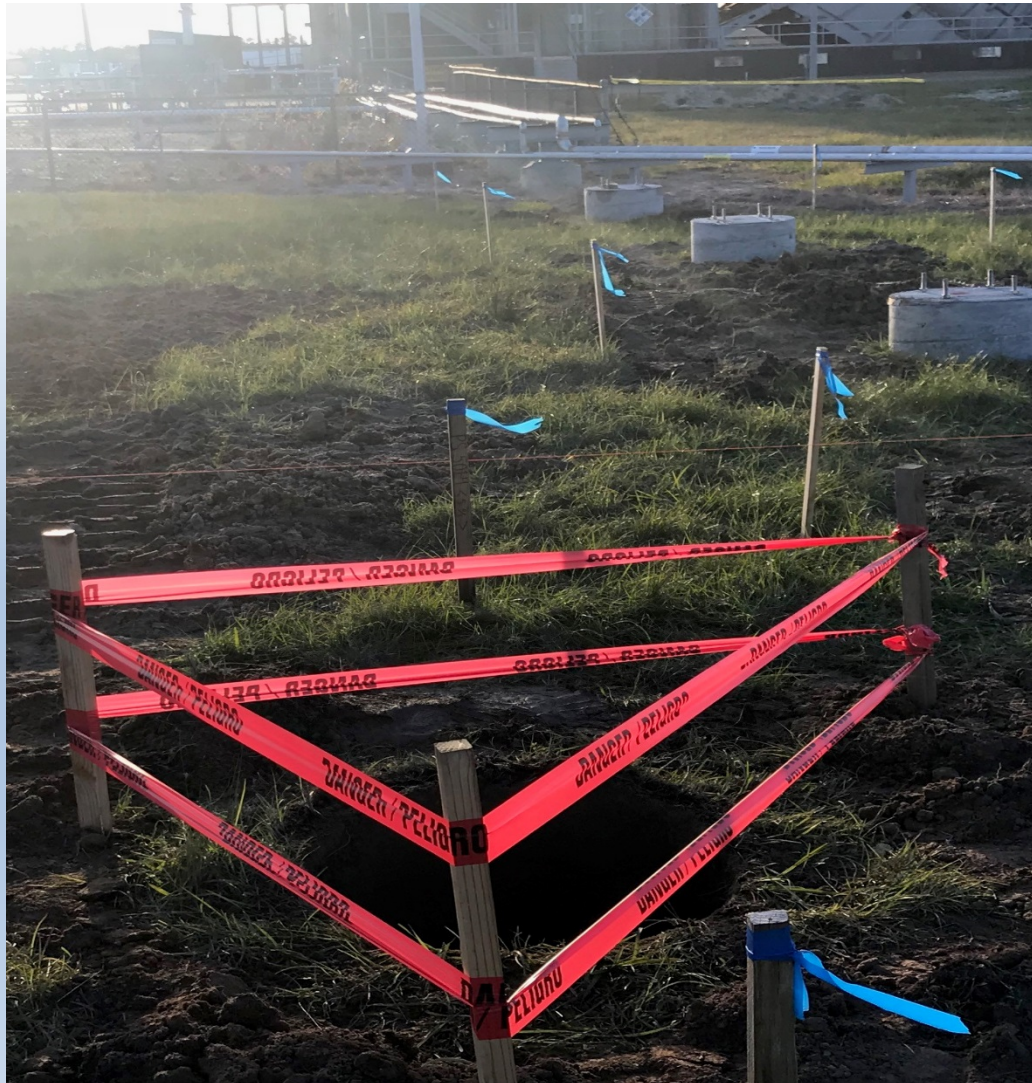
# Construction Safety Findings:

- **HPG Phase II** While performing earth auguring near A-2 on March 16<sup>th</sup>, the augur struck an underground buried line approximately 18-24 inches deep. (The auger drills holes for sonotubes which are used as base supports for the new above ground gas lines.) The underground line was not identified by utility locators, and not marked on the locate map. The line was later determined to be buried, not energized, and abandoned. A 1627 was prepared and submitted.

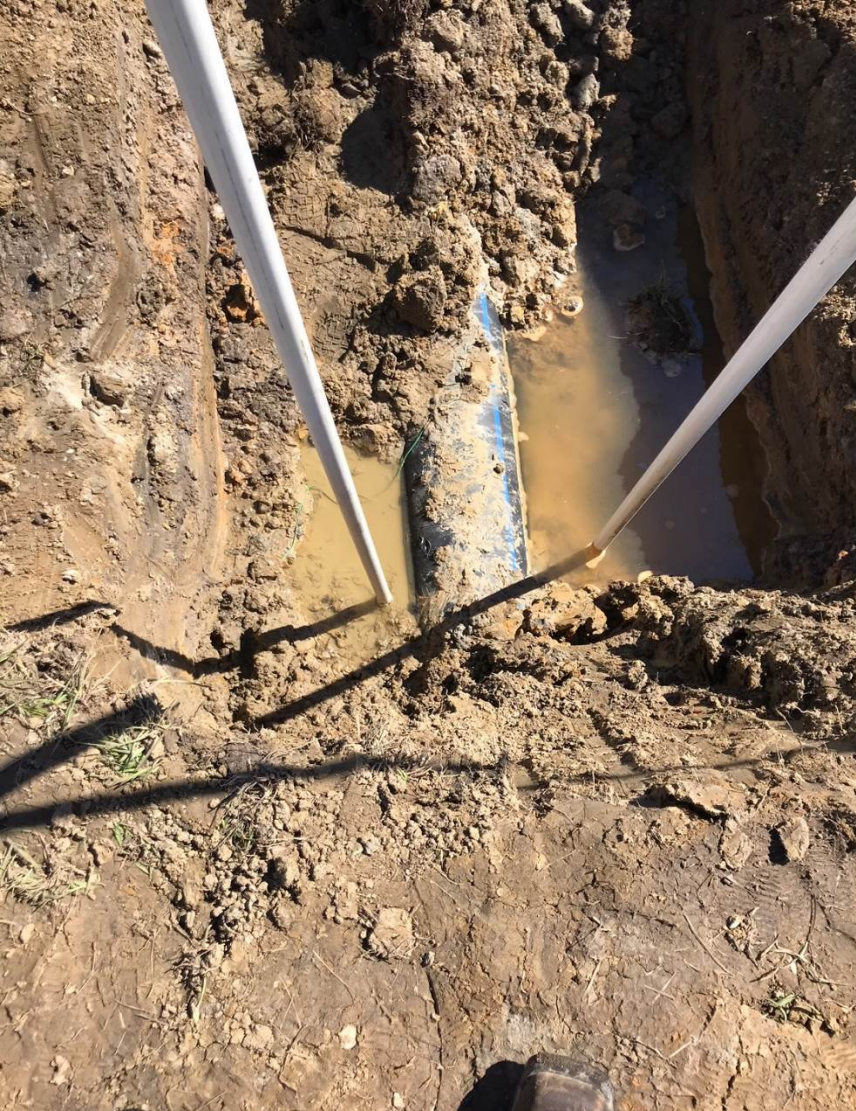
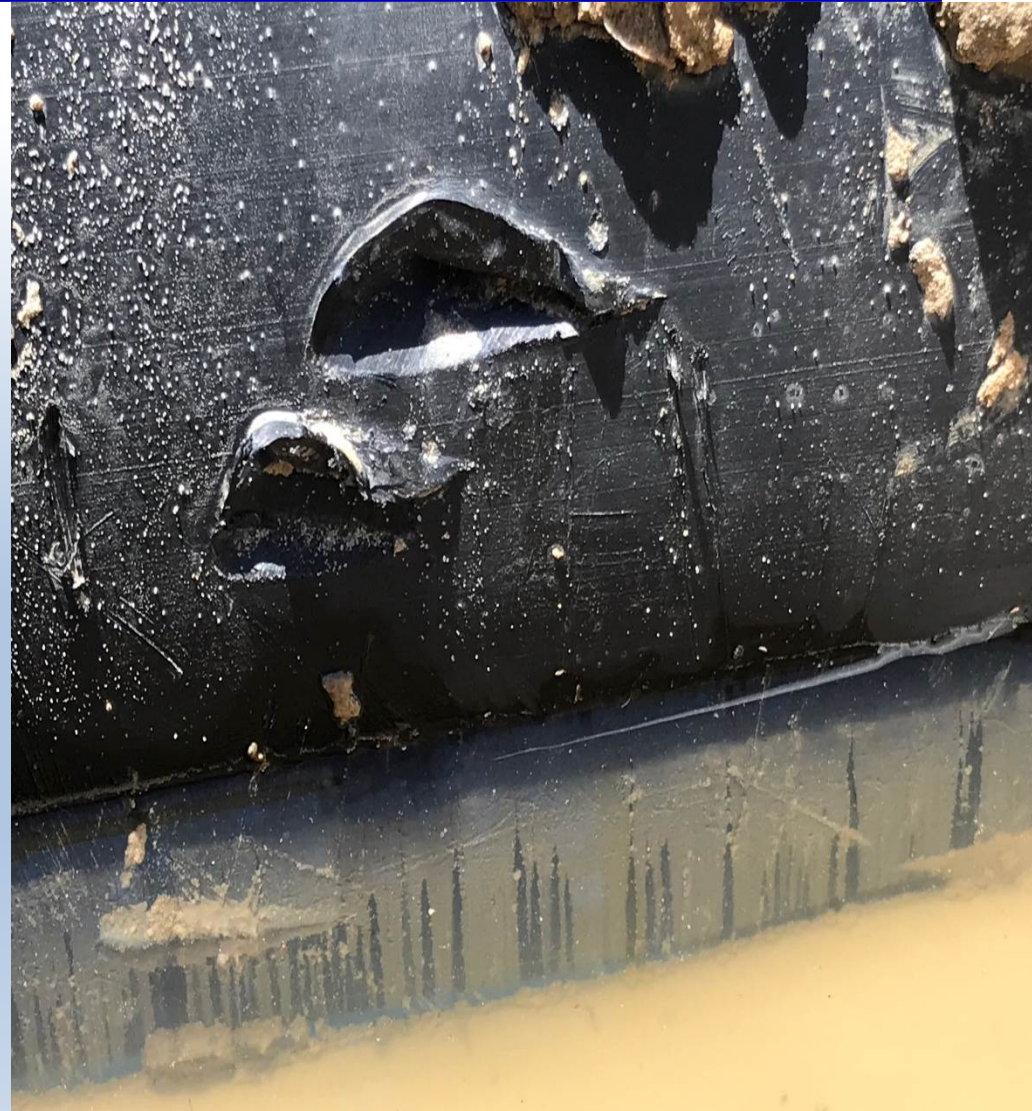
# Construction Safety Findings:

- **HPG Phase II** While performing earth auguring near A-2 on March 19<sup>th</sup>, the augur struck an underground buried line approximately 3-4 feet deep. (The auger drills holes for sonotubes which are used as base supports for the new above ground gas lines.) The underground line was not identified by utility locators, and not marked on the locate map. The line was later determined to be a 12" HDPE water line. S-3 placed a protective sleeve over the pipe scar. The HDPE never leaked any water. A 1627 was prepared and submitted.
