SSC Construction Inspection  
Safety Findings/Stats

March 2015

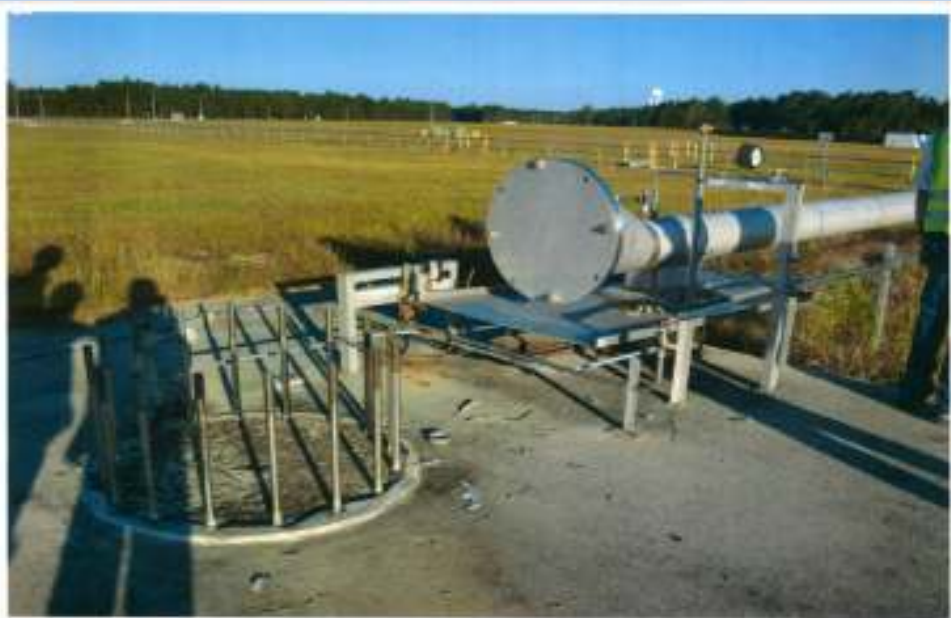
Before

1. While unloading/loading of sheet pile, a sub-contracted employee ran over and damaged the anchor bolts on an abandoned pad for a B Test Stand flare stack.

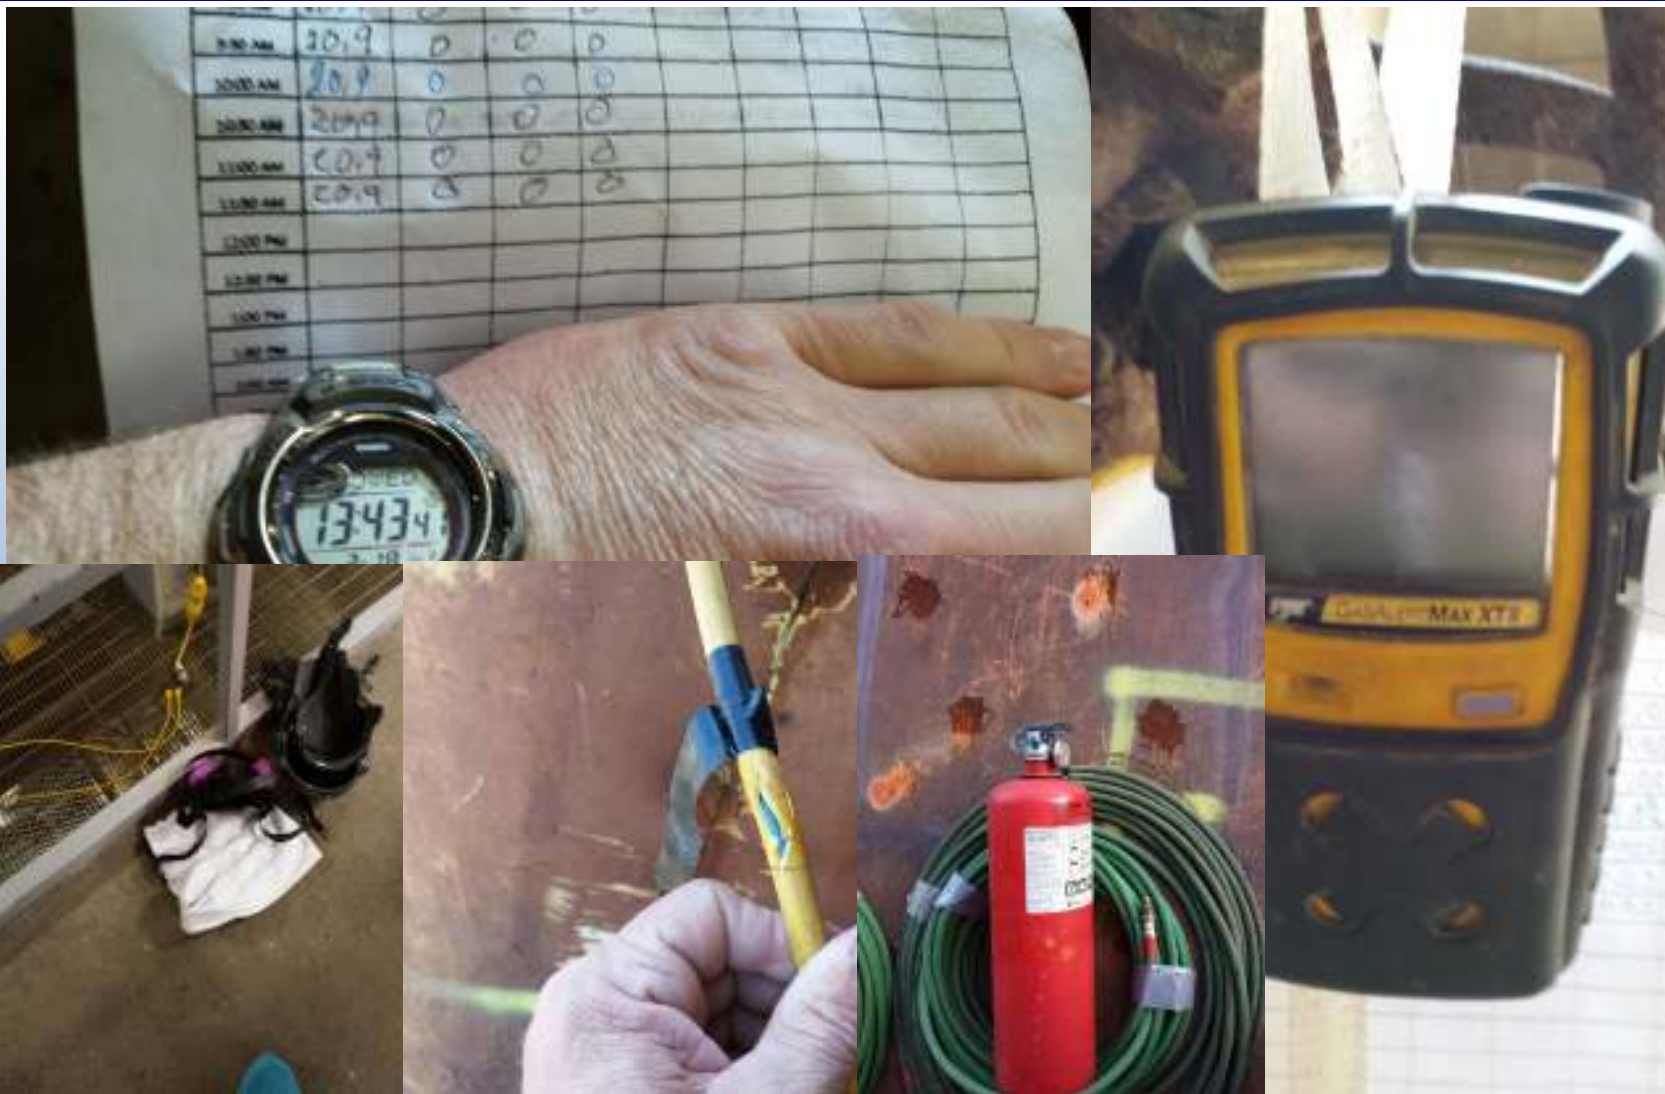
1. Sub contracted employees inside the reclassified confined space (B Test Stand Header Gallery) failed to ensure atmospheric readings were being taken and documented on the log every half hour, as described within the approved reclassification plan. The log was found empty for a period of just over two (2) hours. Additionally, the meter was found off. Apparently, the batteries had lost their charge. SCWI-8715-0004 section 5.4(d)

1. A respirator was found on the floor, unattended within the construction site not properly stored to protect from damage and/or contamination. 29CFR1910.134 (h)(2)
2. An electrical extension cord was found in use with damage that was improperly repaired with vinyl electrical tape. SCWI-8715-0006(6.2)(f)
3. A fire extinguisher being used by a fire watch was found defective, with the safety pin wired to the handle and no nozzle. 29 CFR 1926.150(a)(4)

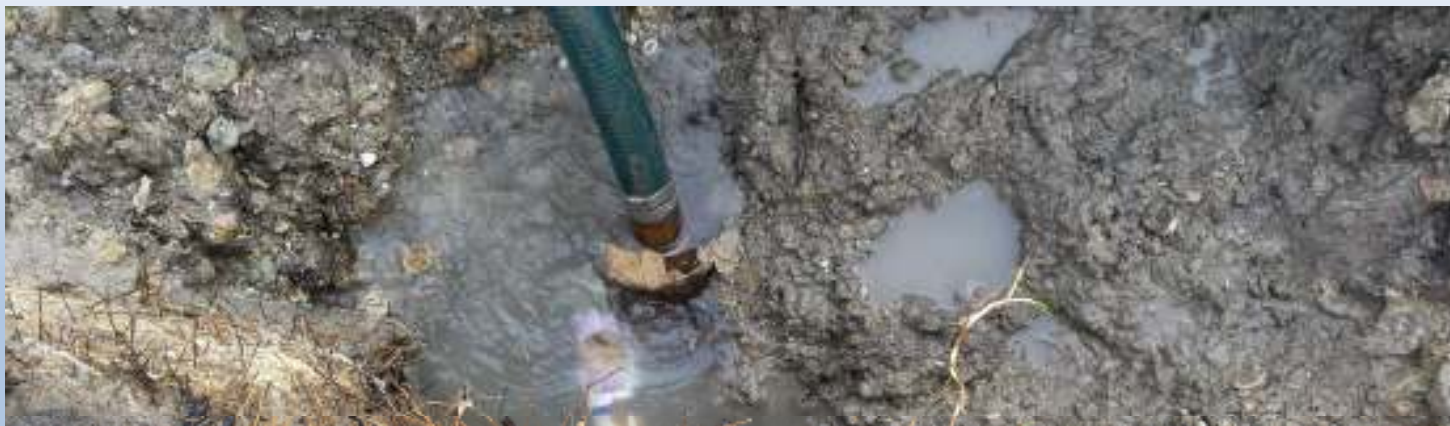
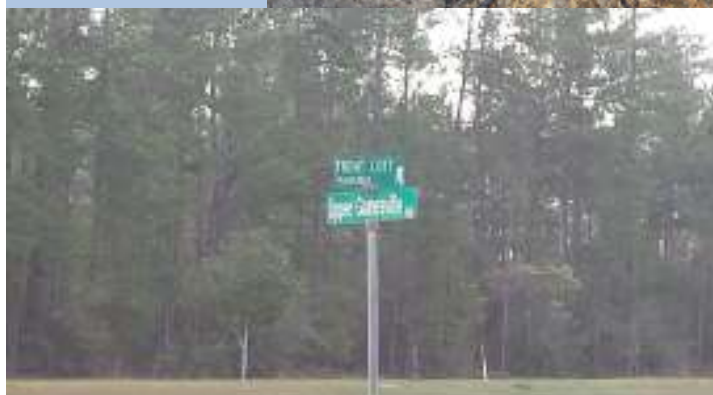
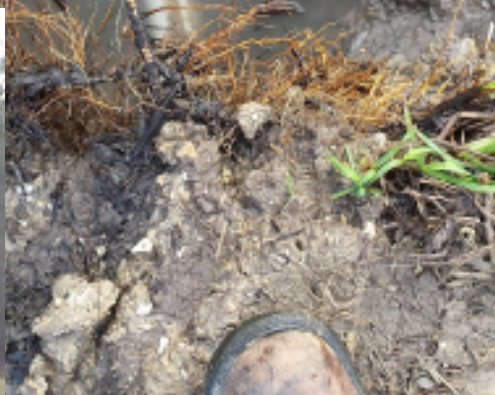
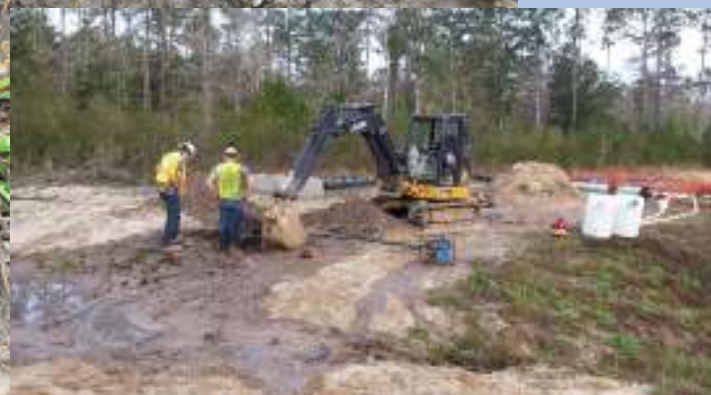
1. A two inch buried water line damaged from construction equipment driving on/near valve assembly located on the shoulder of Trent Lott Parkway at Upper Gainesville Road.

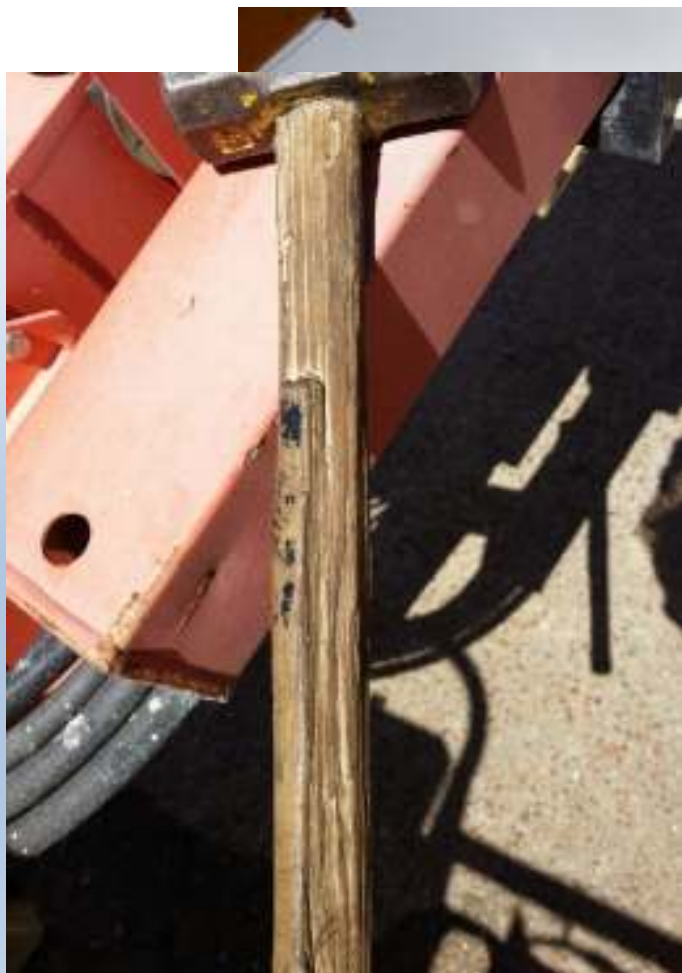
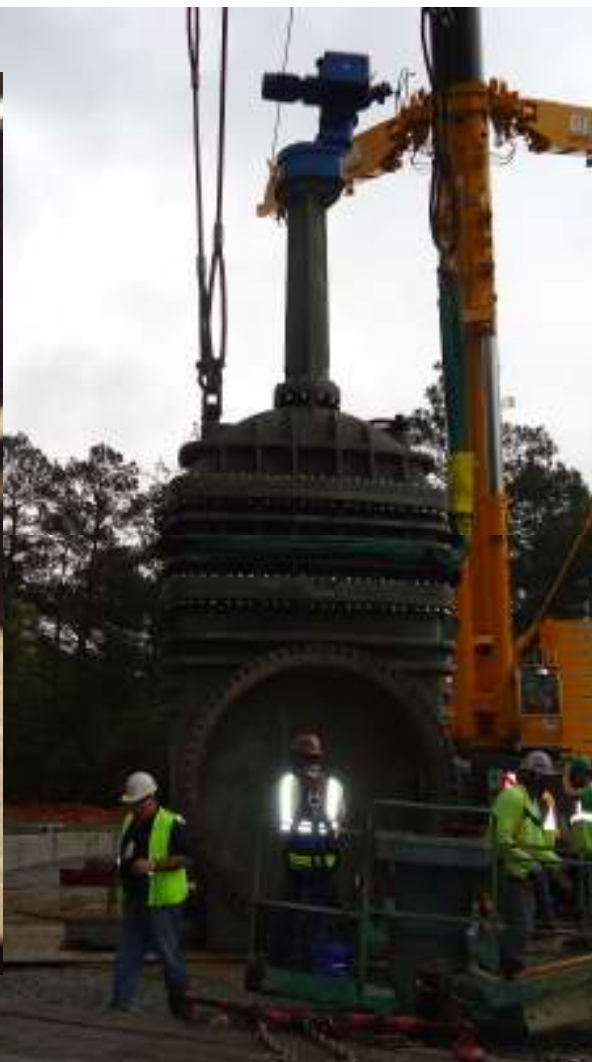
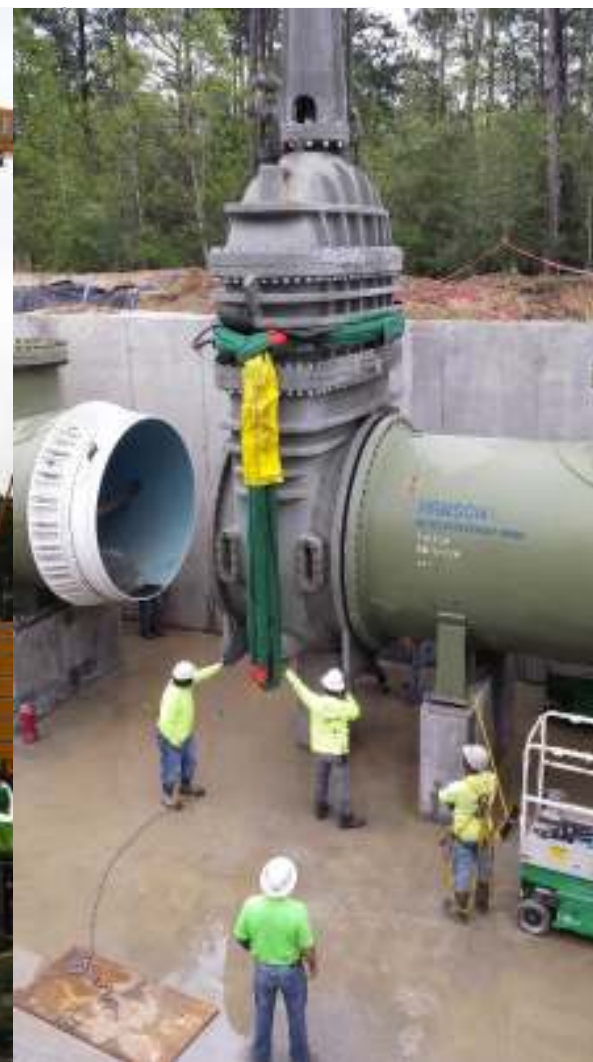
1. Two wooden handle maul hammers found in use on the job site were not in safe, serviceable condition. Both had cracked handles and one maul head was loose and not properly secured to wood handle. 29CFR1926.301(d)

1. Job Well Done to the entire crew involved with the placement of the new 96 inch water valve on Thursday, March 26, 2015. There was a tremendous amount of activity in and around the crane lift, along with less than desirable weather conditions. The lift went well and minor issues along the way were properly addressed by the crew. This is a good example of how hazardous activities should be planned and safely executed.
