Construction Safety

SSC Construction Inspection
Safety Findings/Stats

July 2012

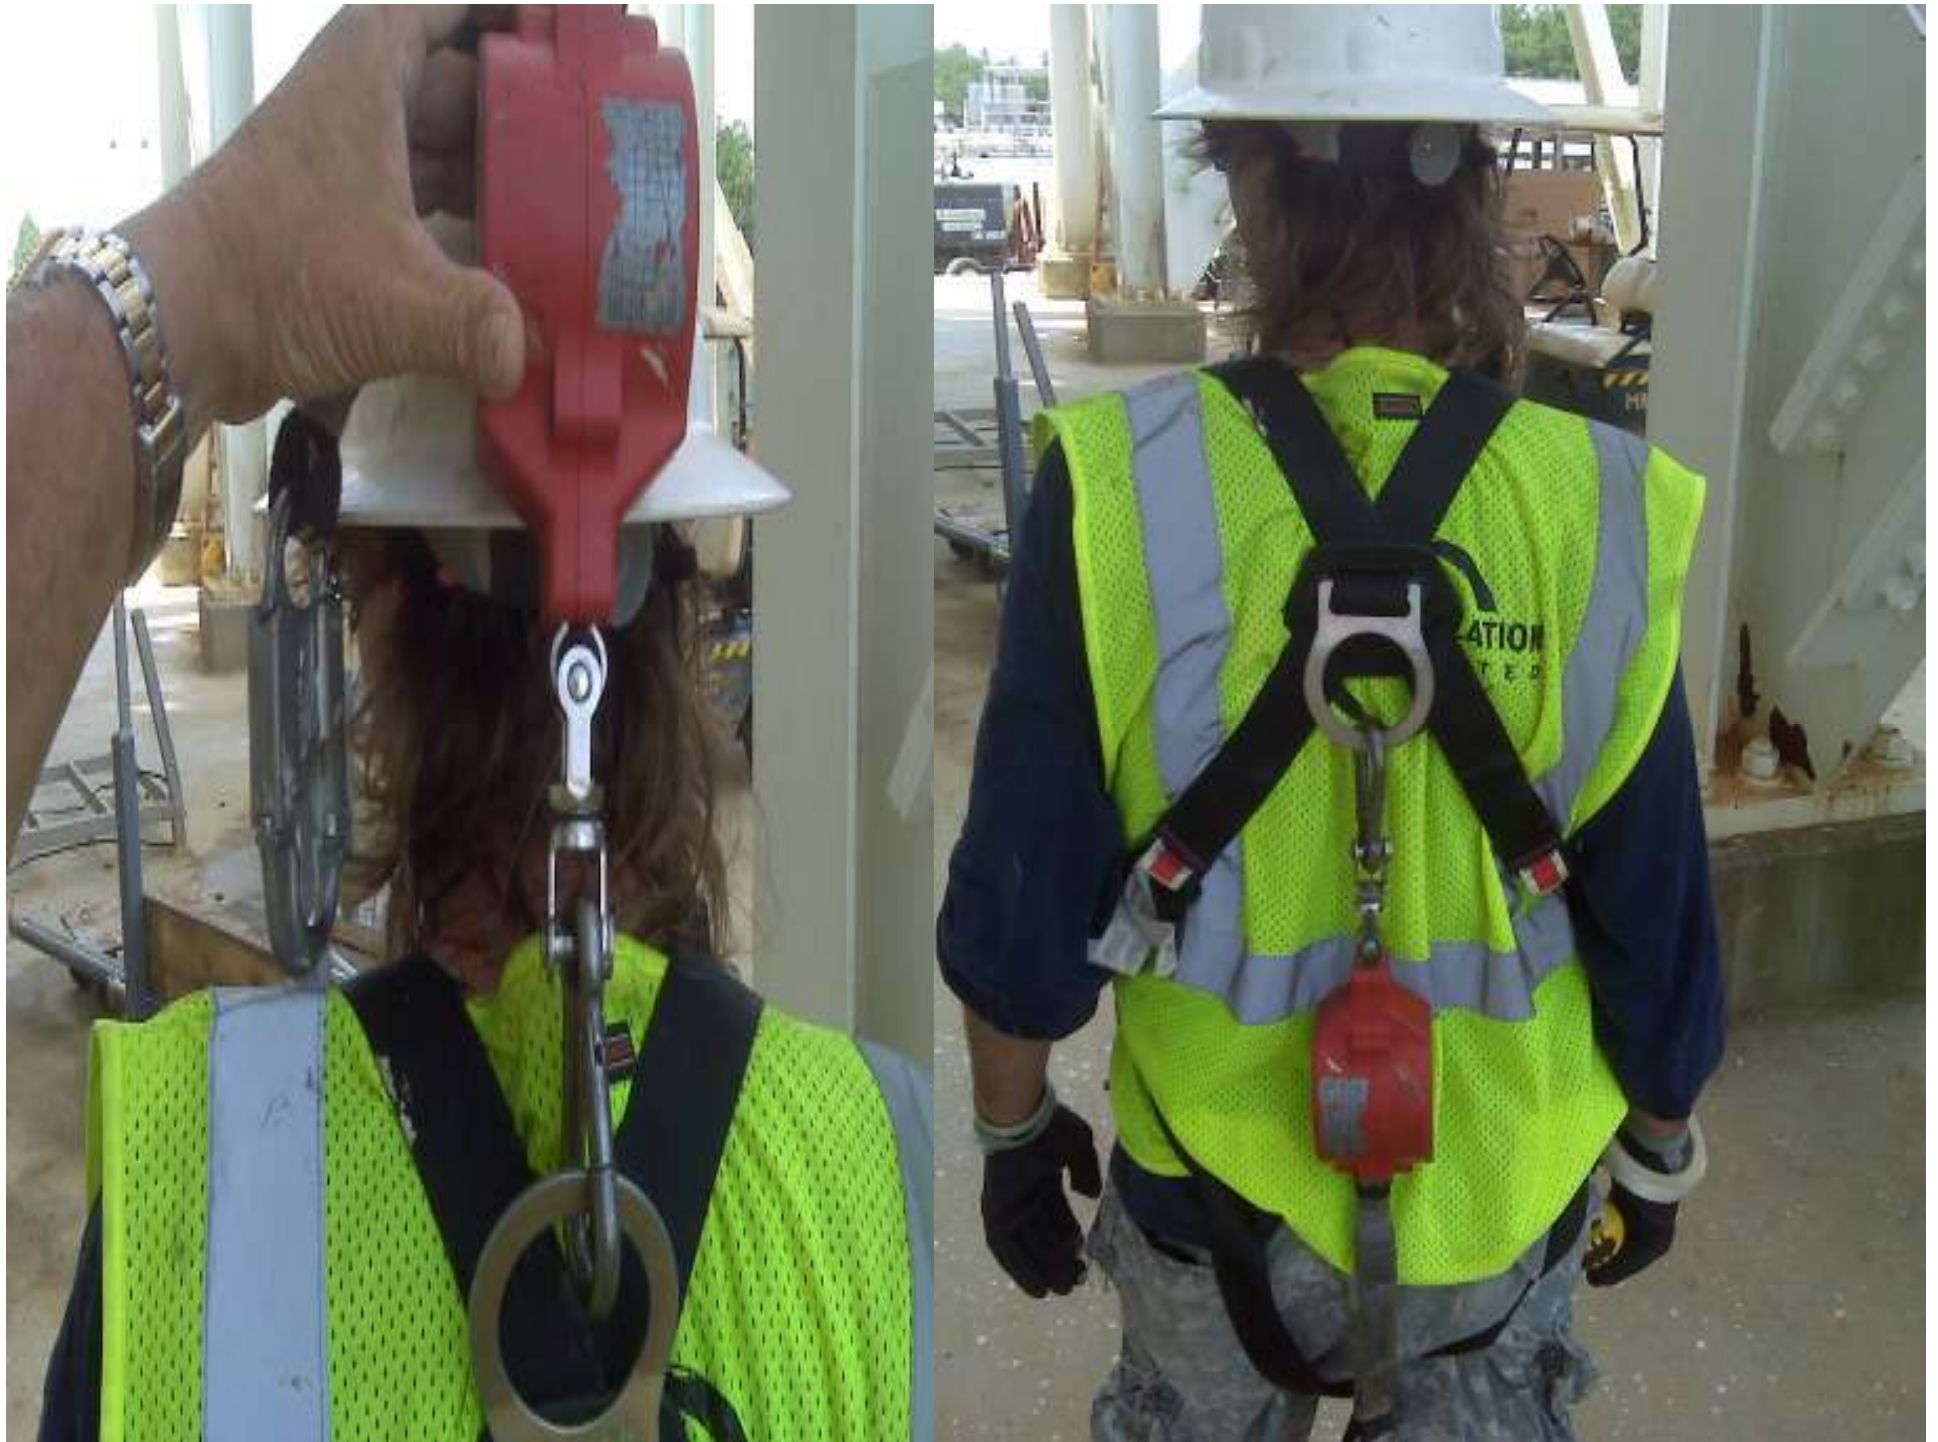
1. Workers were found to be wearing their Self Retracting Lanyards (SRL) in reverse, with the body of the SRL attached to the D-ring on the full body harness. After review, it was determined that some SRL manufactures do allow this practice. NASA SMA is currently reviewing the risks associated with this practice to determine if site policies should be revised to address this issue.

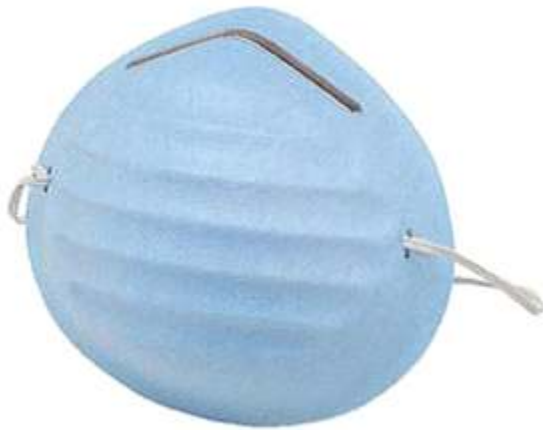
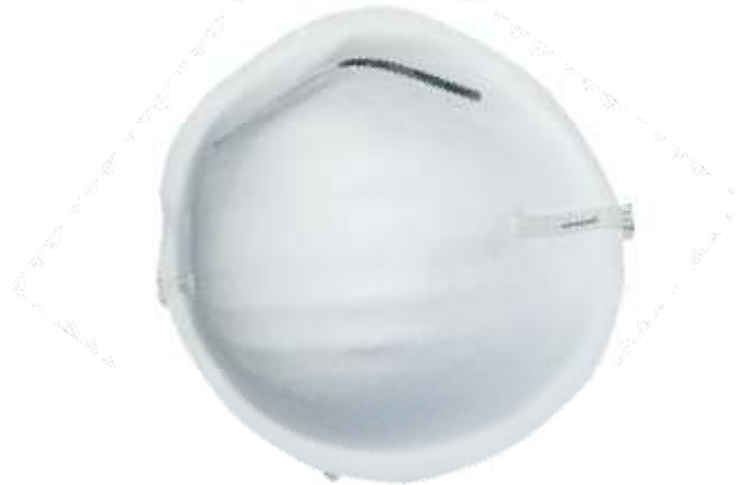
Dust Masks/Filtering Face Pieces

1. Congratulations! FOSC was granted their VPP STAR with no 90 day follow-up items.
2. Safety reviewed contractor employees preparing to chip concrete. The employees planned to wet the area but, the contractor also offered particulate respirators (Dust Masks) for voluntary use. It was noticed that the employer provided surgical masks, not certified N95 or P95 respirators. Prior to beginning the task, certified respirators were provided to the employees. Without reading the product data, it is hard to tell the difference.
