Construction Safety

SSC Construction Inspection
Safety Findings/Stats

August 2011

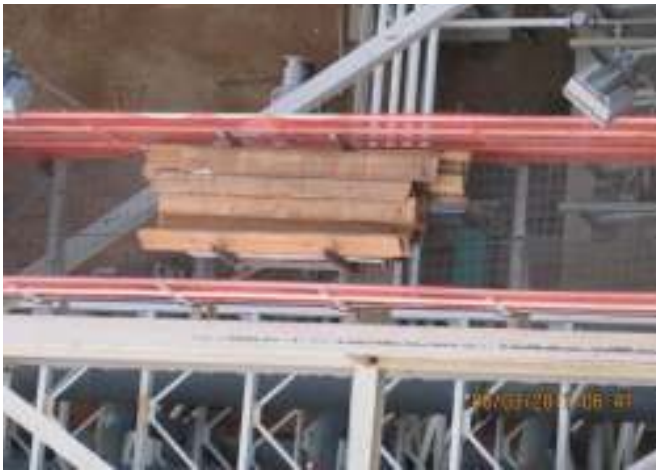
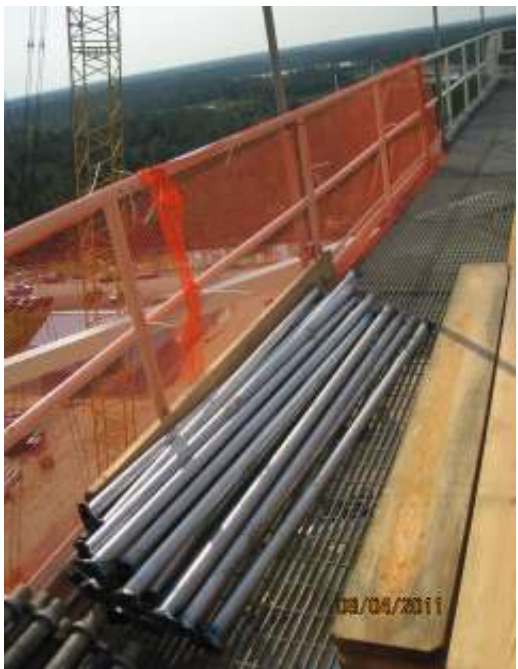
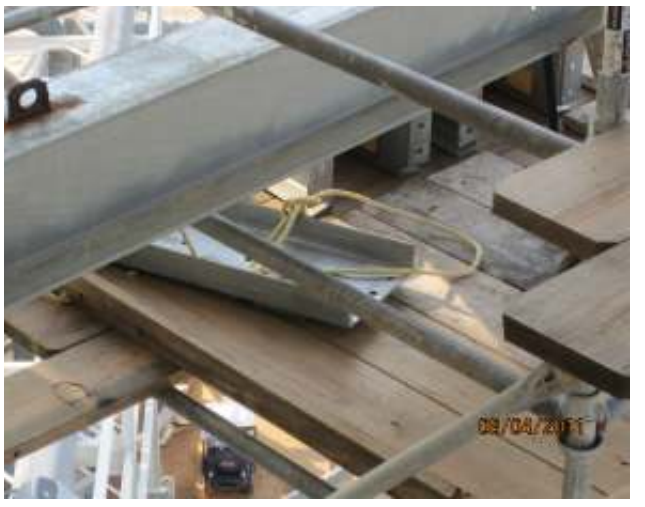
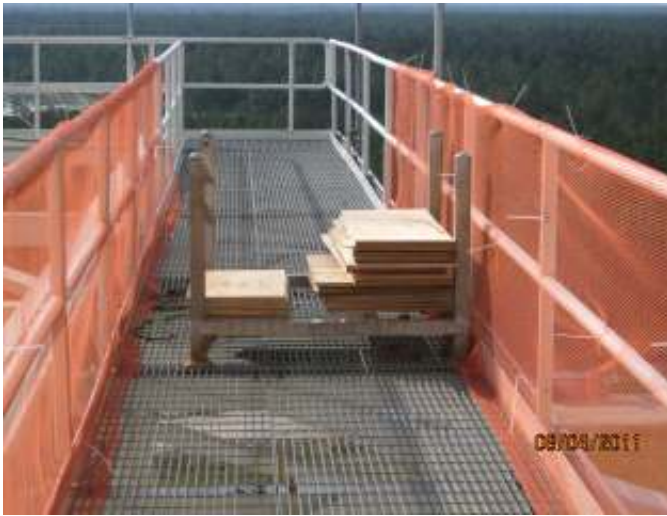
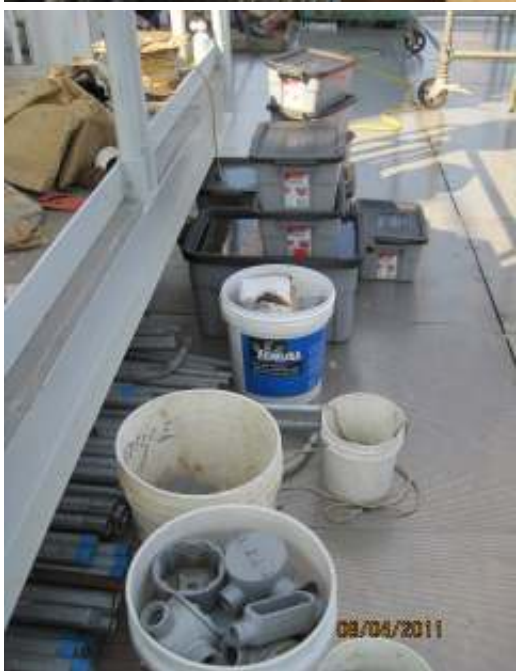
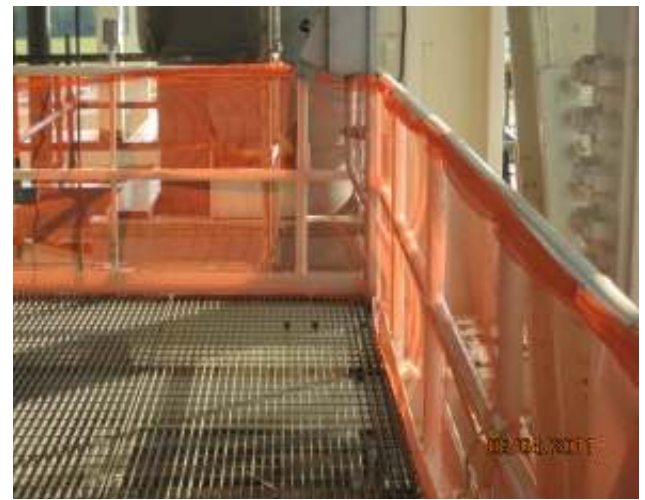
- Netting and chicken wire
- FOD walks
- COTRs, Safety, Construction Mgt, and Contractor PM forum for improvement ideas and action (very productive)
 - Worker inputs, buy-in, motivation and recognition programs
 - Suggestion box
 - Focused awareness and training (workers/foreman/supervisors)
 - Safety Councils/walk downs with craftsmen/workers
- Called in Guardian to design personal/debris netting
