# SSC Construction Contractor Safety Meeting

November 04, 2021

SSC Construction Inspection  
Safety Findings/Stats

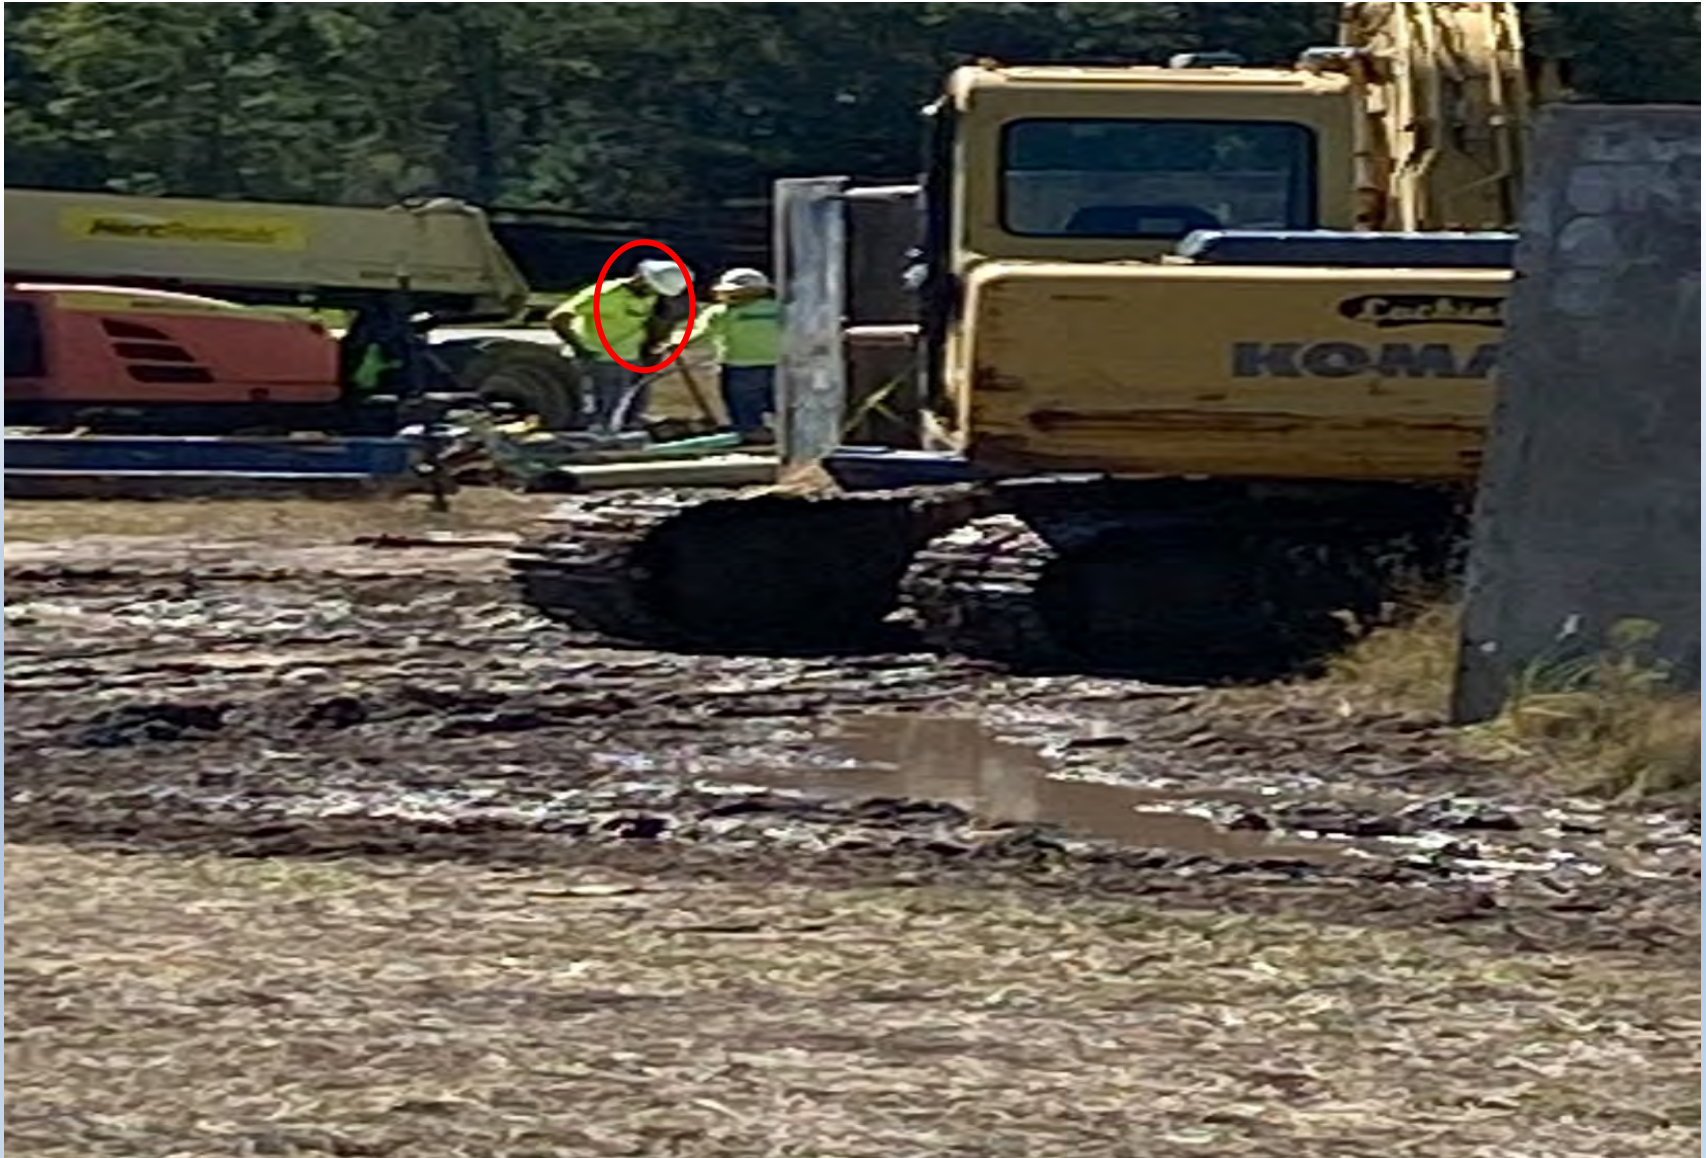
## PPE Violation

- Contractor was observed without proper safety eyewear. Corrected on spot. *Ref: 29CFR1926.102 (a)(1). SHEtrak ID# 112899.*
- Contractor was observed without proper safety eyewear. *Ref: 29CFR1926.102 (a)(1). ID#112904*
- A set of lifting slings were observed on site without the required hook safety latches attached. Removed from site. *Ref: 29CFR1926.1433 (d)(4)(i). SHEtrak ID# 112900*

Contractor not wearing the required safety eyewear

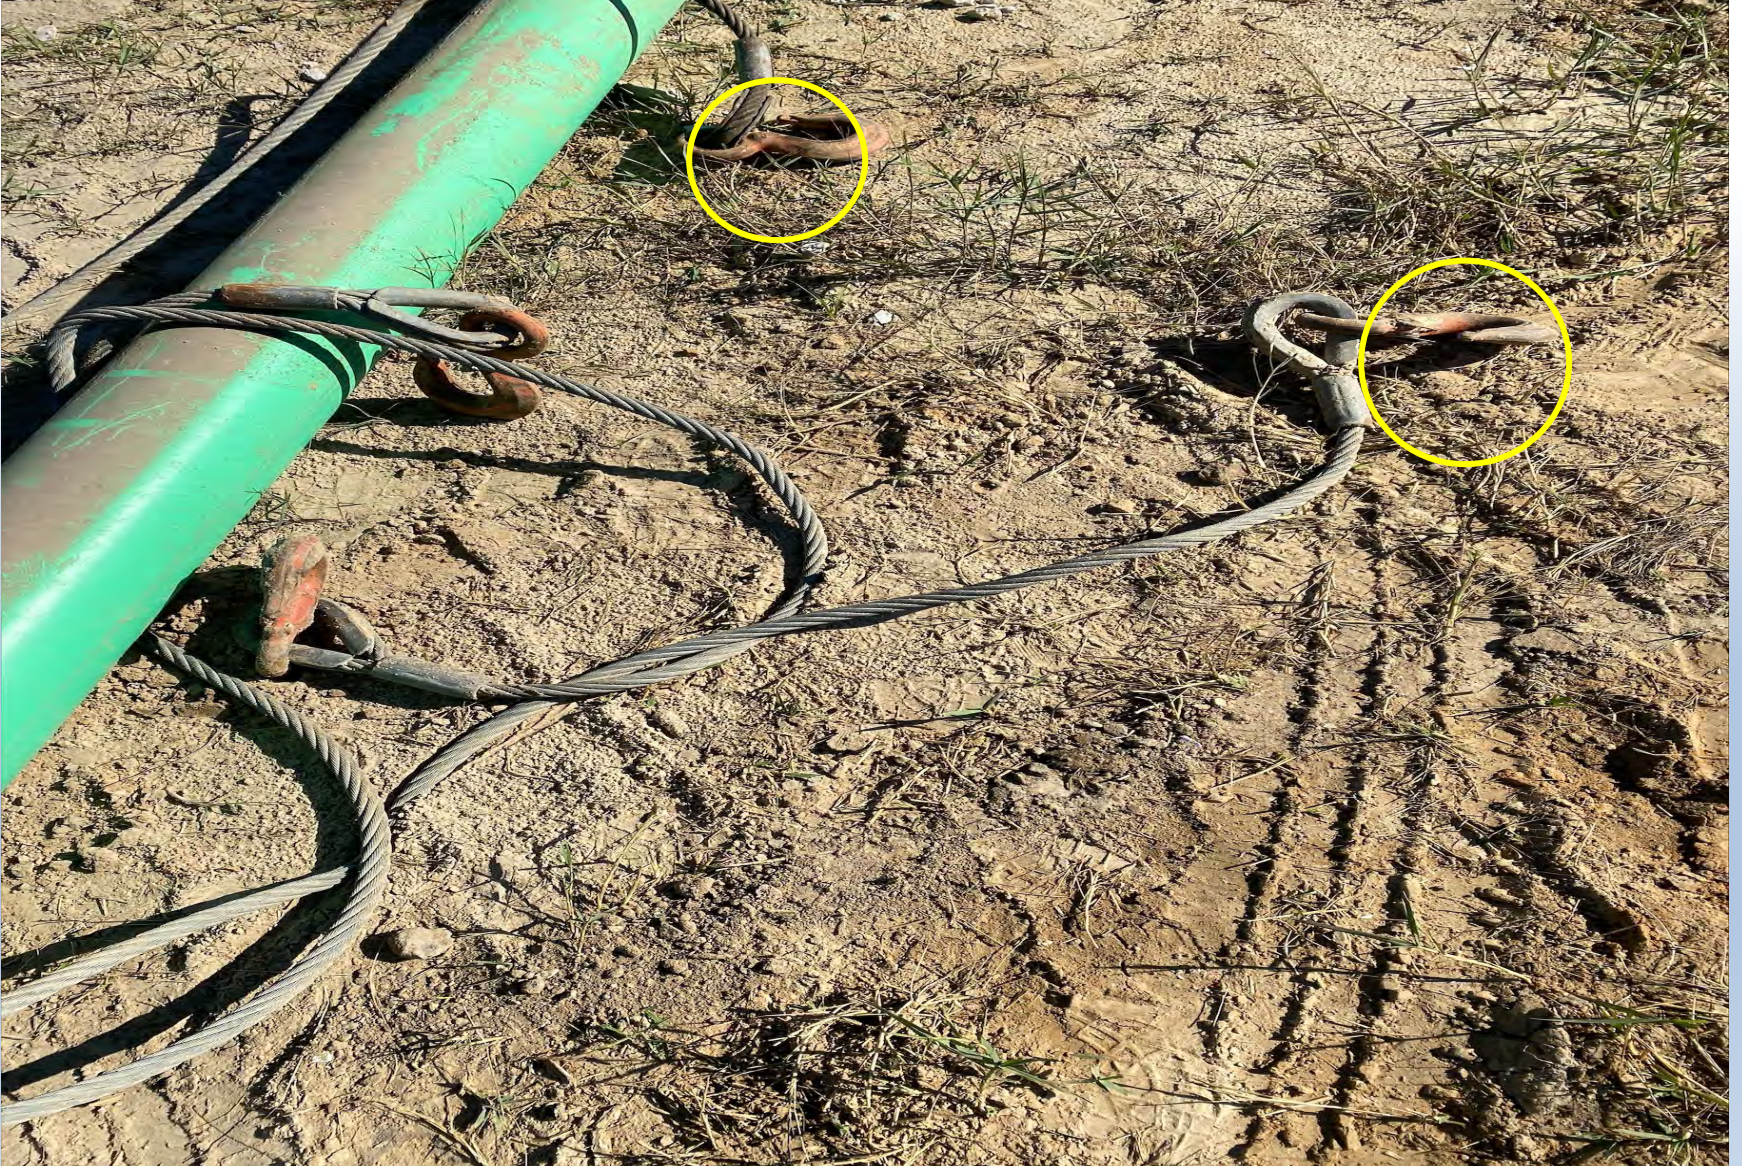
# Lifting hooks without required safety latches

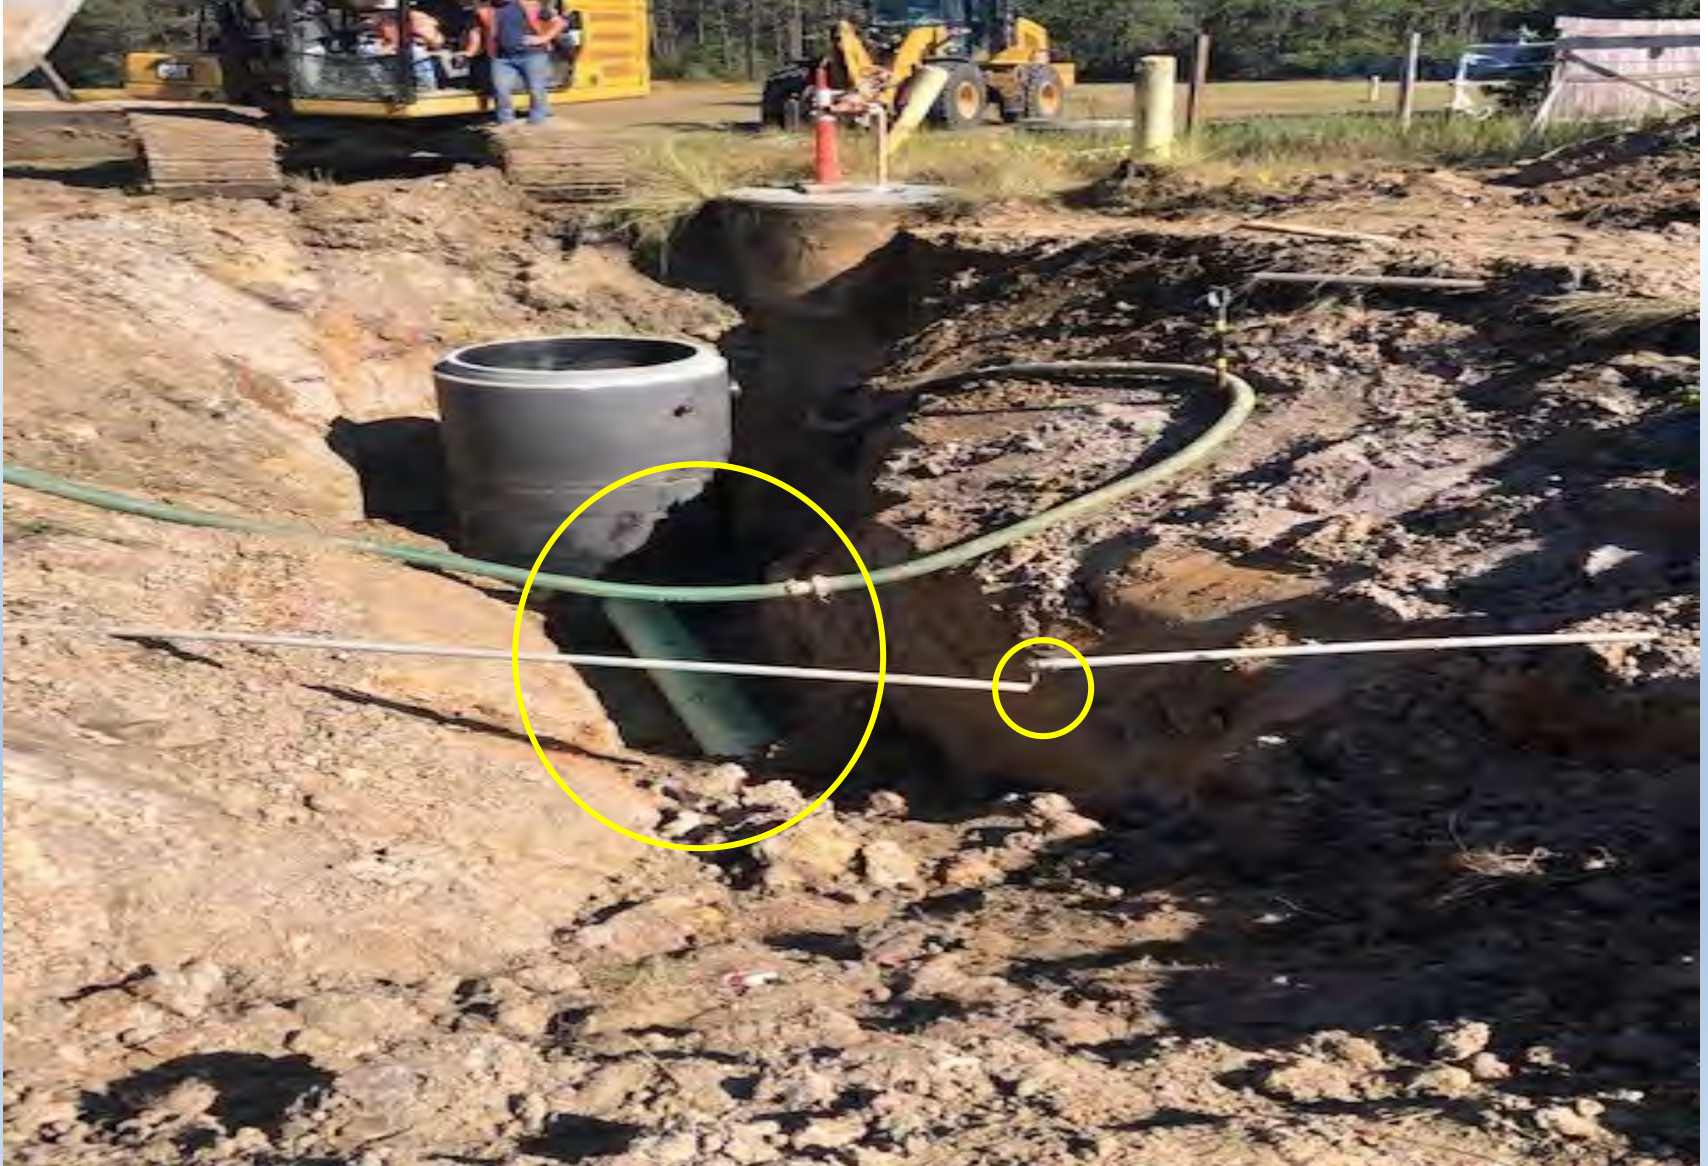
- Contractor was observed occupying an improperly sloped and non shielded excavation. *Ref: 29CFR1926.652 (a)(4)(i). SHEtrak ID# 112901*

# Improper Excavation

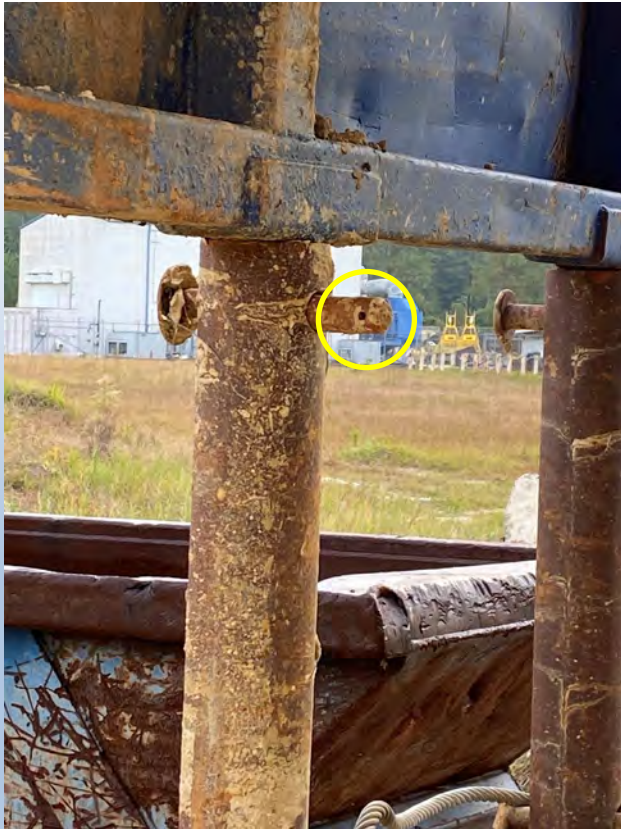
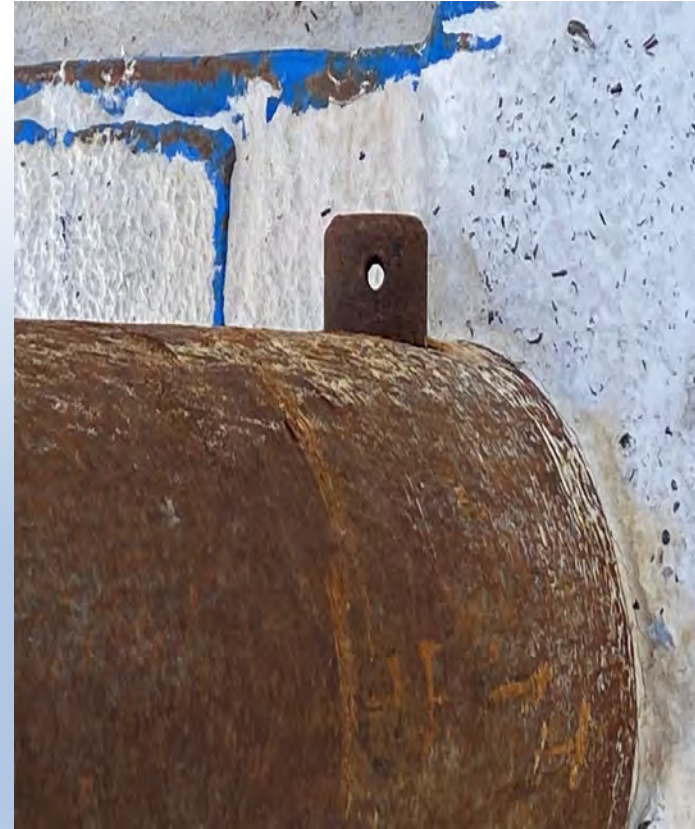
Missing Trench Box Pins  
(box was not in use)

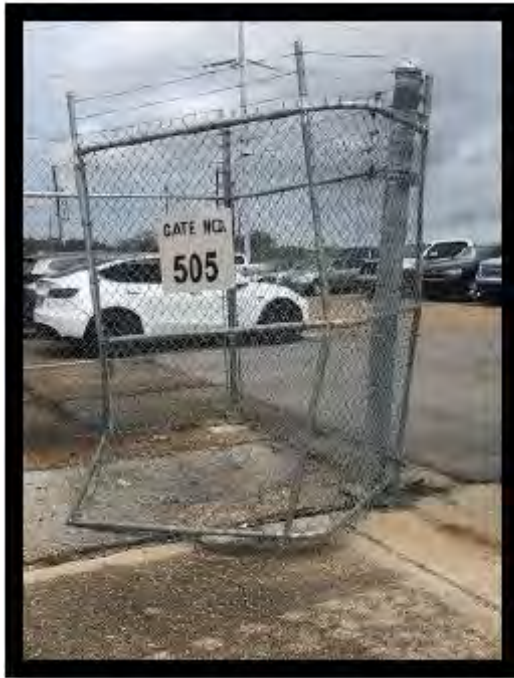
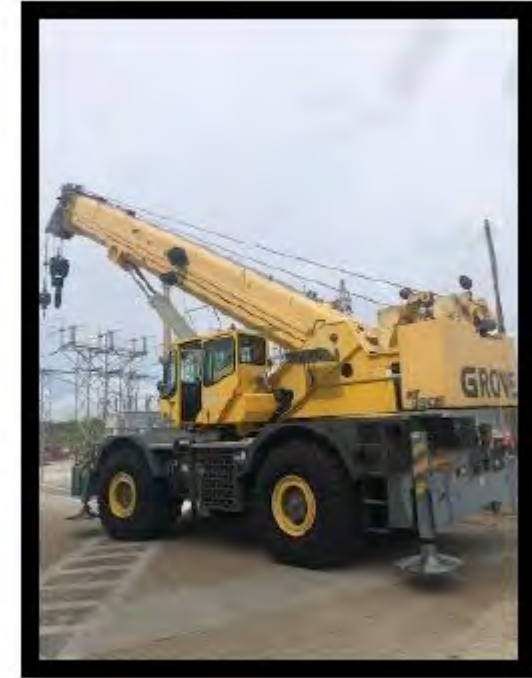
On September 28, 2021, a MAF Contractor heavy equipment operator was setting up a 90-ton crane to make a lift and hit a gate resulting in damages to the gate (no damage to the crane).  
The assigned spotter was not present at the time of this operation.

- Utilize a spotter to safely maneuver motorized equipment in congested areas
- Spotters should be utilized any time you are operating a piece of equipment, or any motorized vehicle in a congested area or a high hazard area
- If you don't have a spotter and need one, STOP!
- Pay attention to your surroundings such as structures, obstacles, people, equipment, roadways, ditches, etc.
- You should note the proximity of any obstacle to your equipment or vehicle and plan your route prior to moving!
