Construction Safety

SSC Construction Inspection
Safety Findings/Stats

June 2015

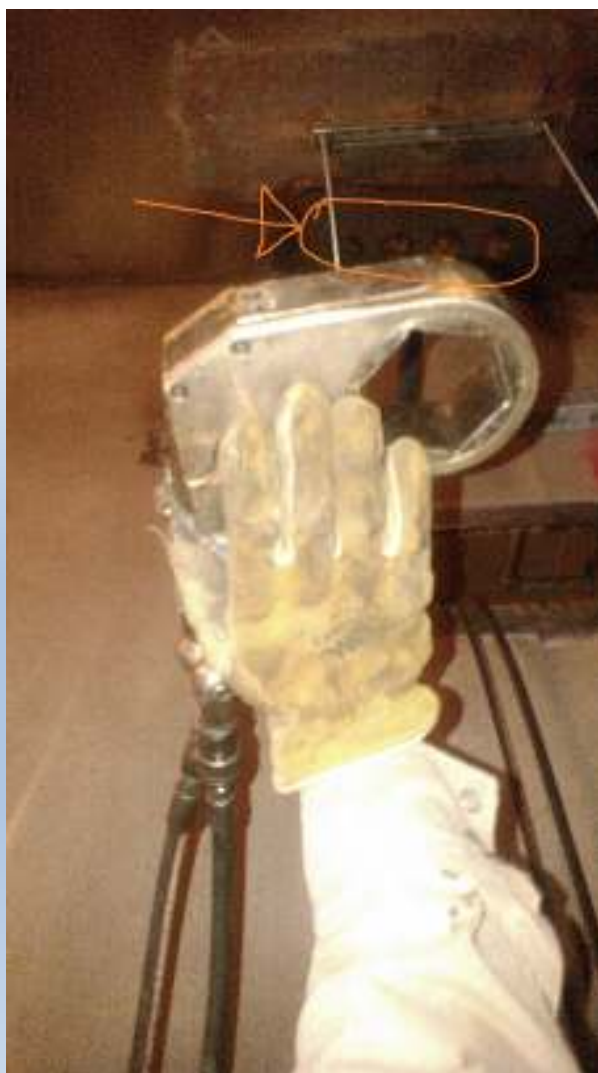
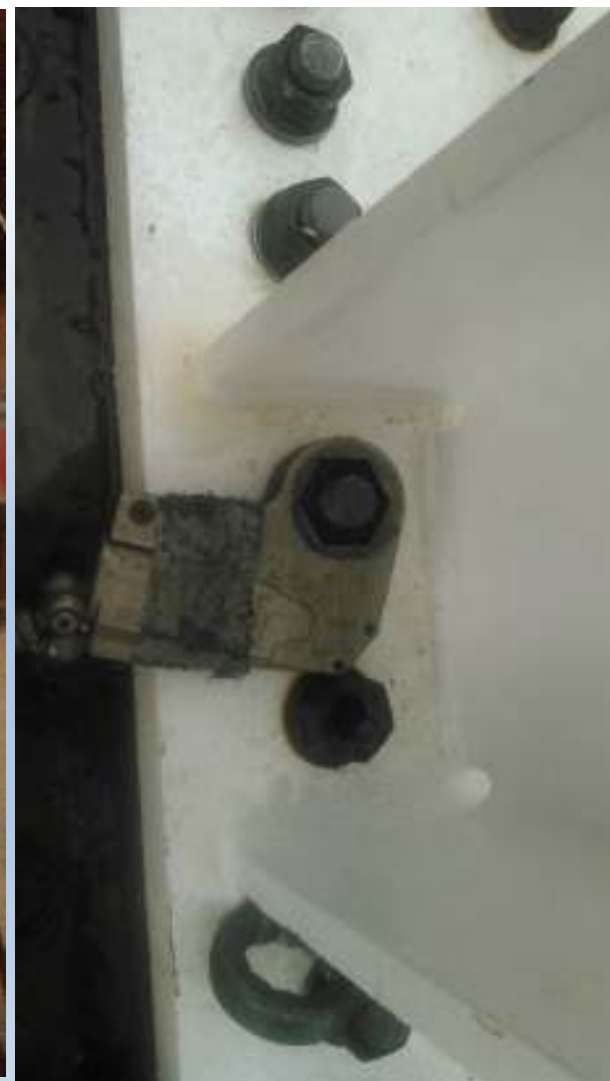
1. A worker was operating a grinder inside a 66" HPIW pipe at the B Test Stand when a metal shaving blew into the left eye. The worker was transported to an off-site clinic where the item was removed from the eye and a medication was prescribed, making this an OSHA Recordable incident or NASA Type D Mishap. The worker returned to work the following day with no restrictions.
2. A worker was operating a pneumatic torque wrench by hand. The wrench turned, causing the worker's middle finger on the right hand to come in contact with the nearby structural steel, breaking a bone in the finger. The worker was transported to a clinic, provided first aid treatments and prescription medication, making this an OSHA Recordable incident or NASA Type D Mishap.
