## **Construction Safety**

## SSC Construction Inspection Safety Findings/Stats

## October 2016

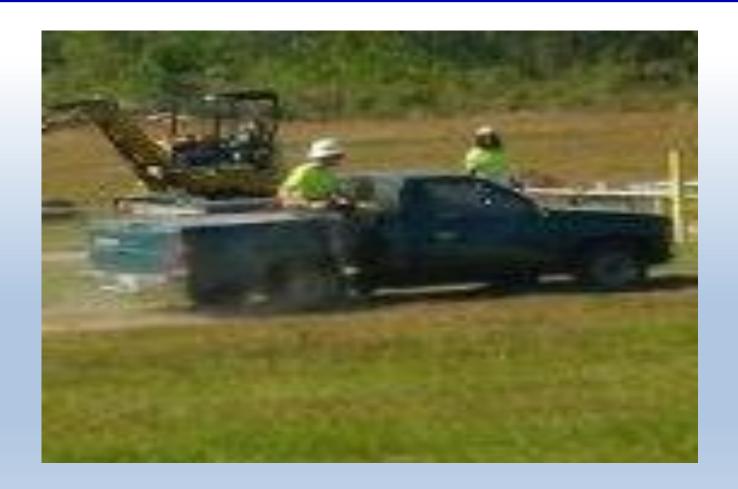
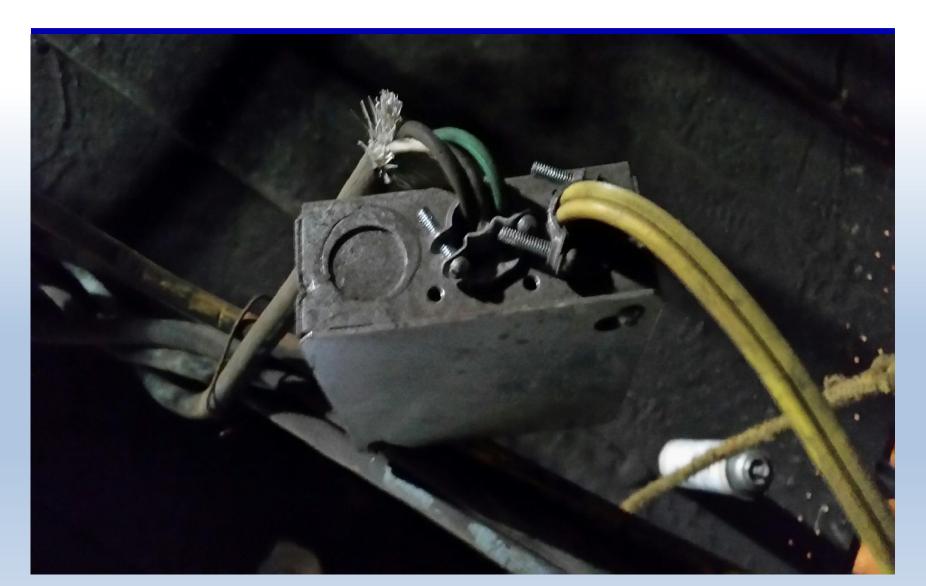
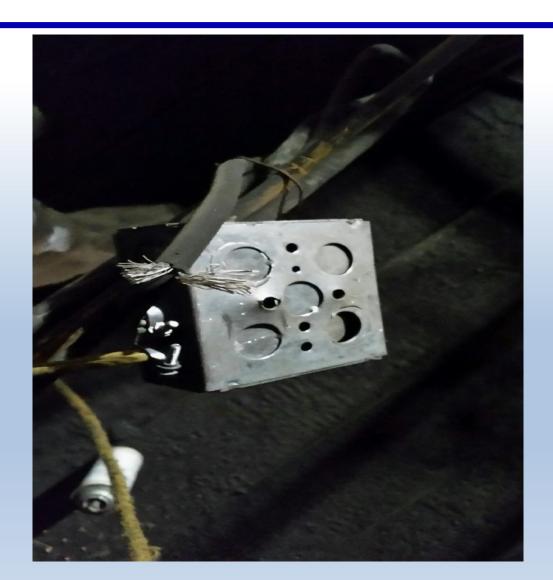
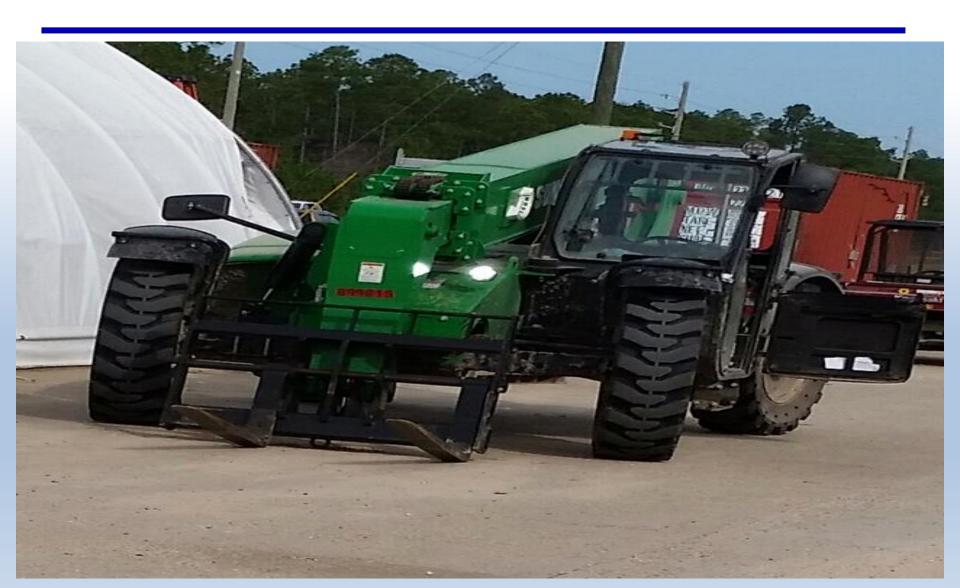
# Missing Blanks or Breakers and Poorly Written Breaker Schedule

- Serious: 0
- Other than Serious: 4
  - <u>B2 WP3</u>: The temporary power panel in the B-2 lead containment area was found to be missing several breakers, thus leaving open holes in the dead front cover. 29CFR1926.405 (b)(1)
