# SSC Construction Inspection Safety Findings/Stats

# October 2010

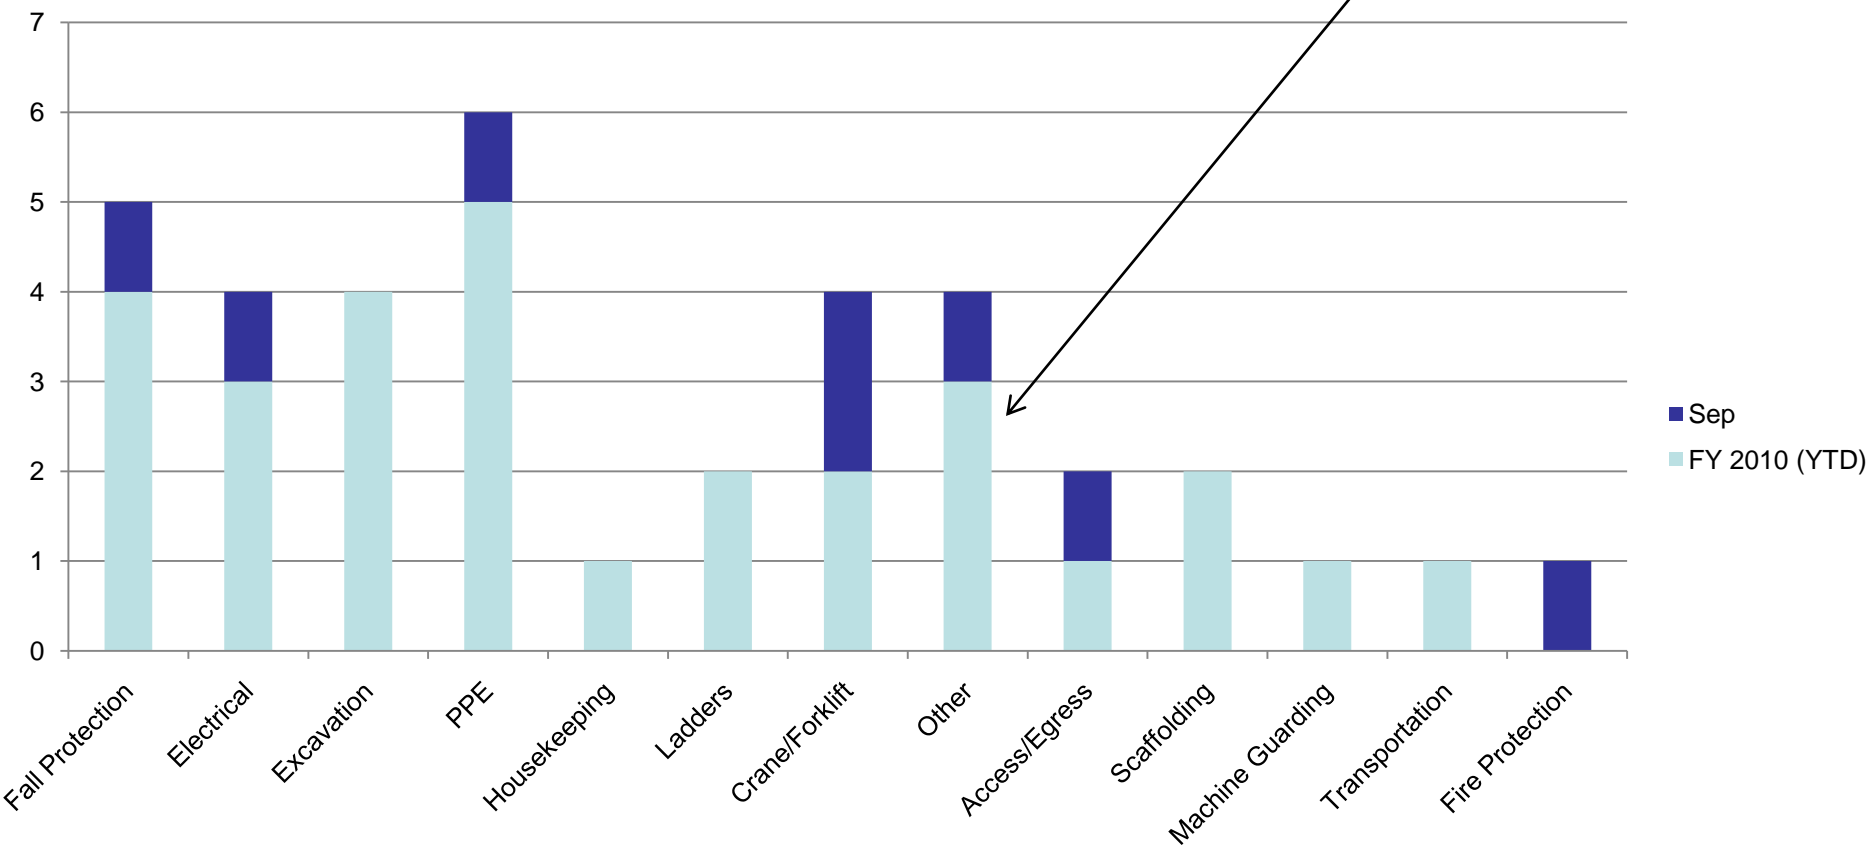
# Construction Safety Data: Construction Site Findings

Contractors failed to get the site specific safety orientation, missed the monthly construction meeting, using a vest as a traffic flag.
