# SSC Monthly Construction Contractor Meeting

### Beware Of Pinch Points

# National Data Buoy Center (NDBC) Warehouse Battery Preventive Maintenance (PM) Mishap

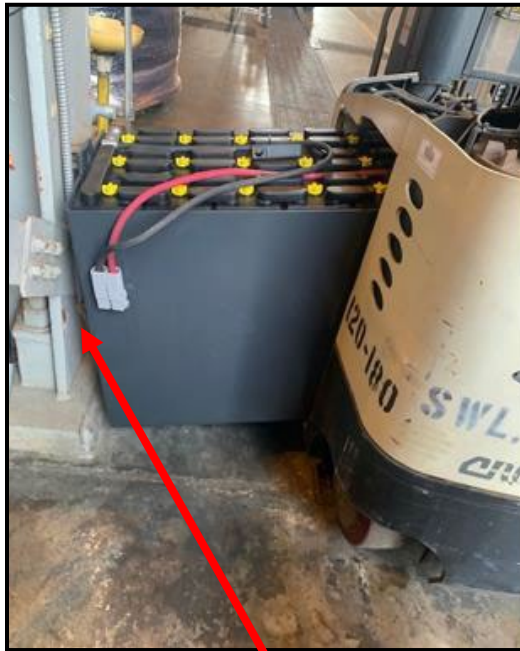
An employee was performing a preventative maintenance (PM) task on a forklift battery when it rolled too far, tipped, and fell, pinching their fingers between the battery and a structural beam. The battery was a several hundred-pound industrial battery. Their coworker used a pry bar to free them, but they had sustained injuries to their fingers which required a trip to the emergency room for treatment.

The battery reached its "tipping point" just as the worker reached out to stop the movement.

In this case, support for the battery could have prevented the mishap.

A battery roll-out stand was purchased and placed into use to prevent unsupported movement during battery maintenance.
