Construction Safety

SSC Construction Inspection
Safety Findings/Stats

October 2017

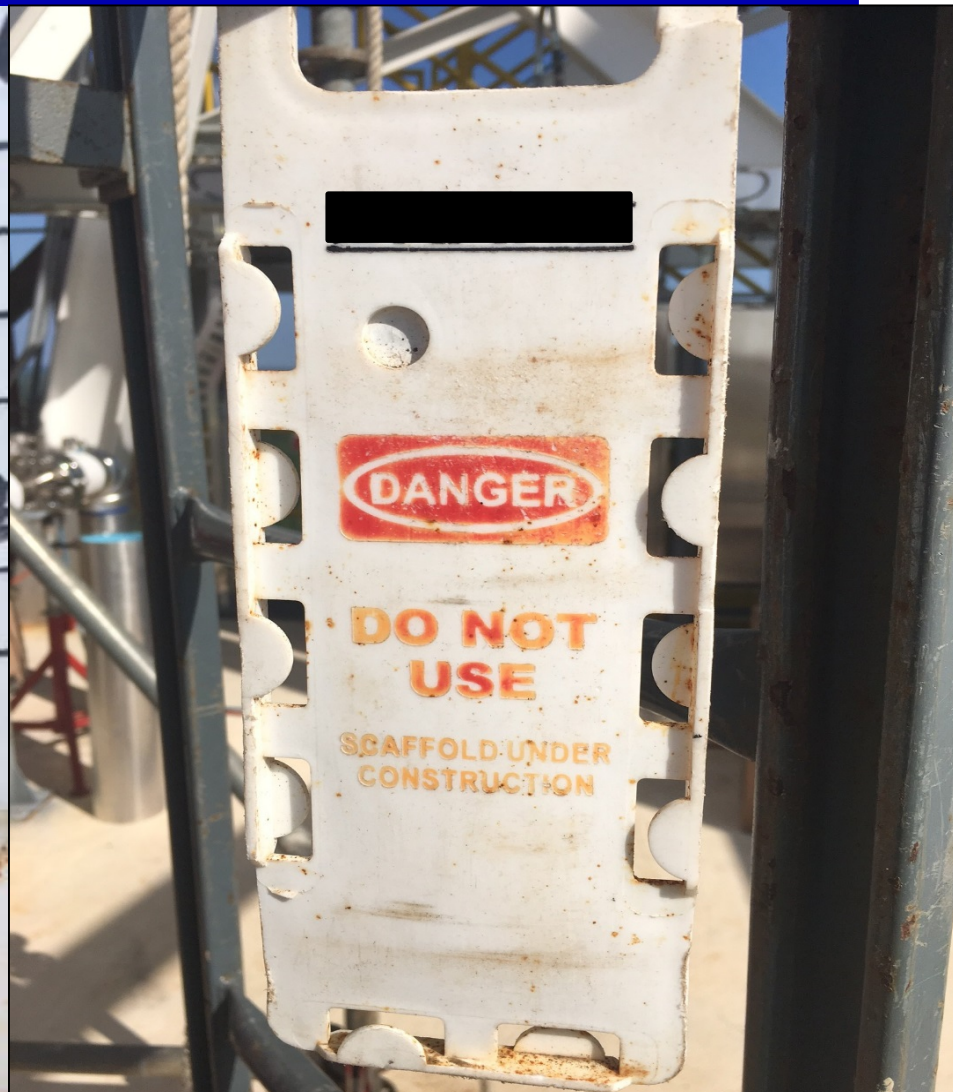
Construction Safety Findings:

- **STE Phase 1:** Two contractor employees were utilizing a scaffold without first completing the required scaffold inspection and tag sign-off. “ Danger -Do Not Use” was displayed because the inspection tag was also missing. Ref: SCWI-8715-0008 Section 6.8.3 SHEtrak Closed. ID # 97779

Corrective Actions:

Lesson Plan Outline

- **Course:**
 - Scaffold User Knowledge
 - Fall Protection & Hazards associated with working at Heights

- **Objective:**
 - Have a complete understanding of the importance of scaffold inspection before performing any type work on a scaffold and the process of insuring the safety of any scaffold user.
 - As a person working at heights you are responsible for drawing on your experience, awareness, and good judgement to ensure safe work practices are followed before, during and after your work on a scaffold.

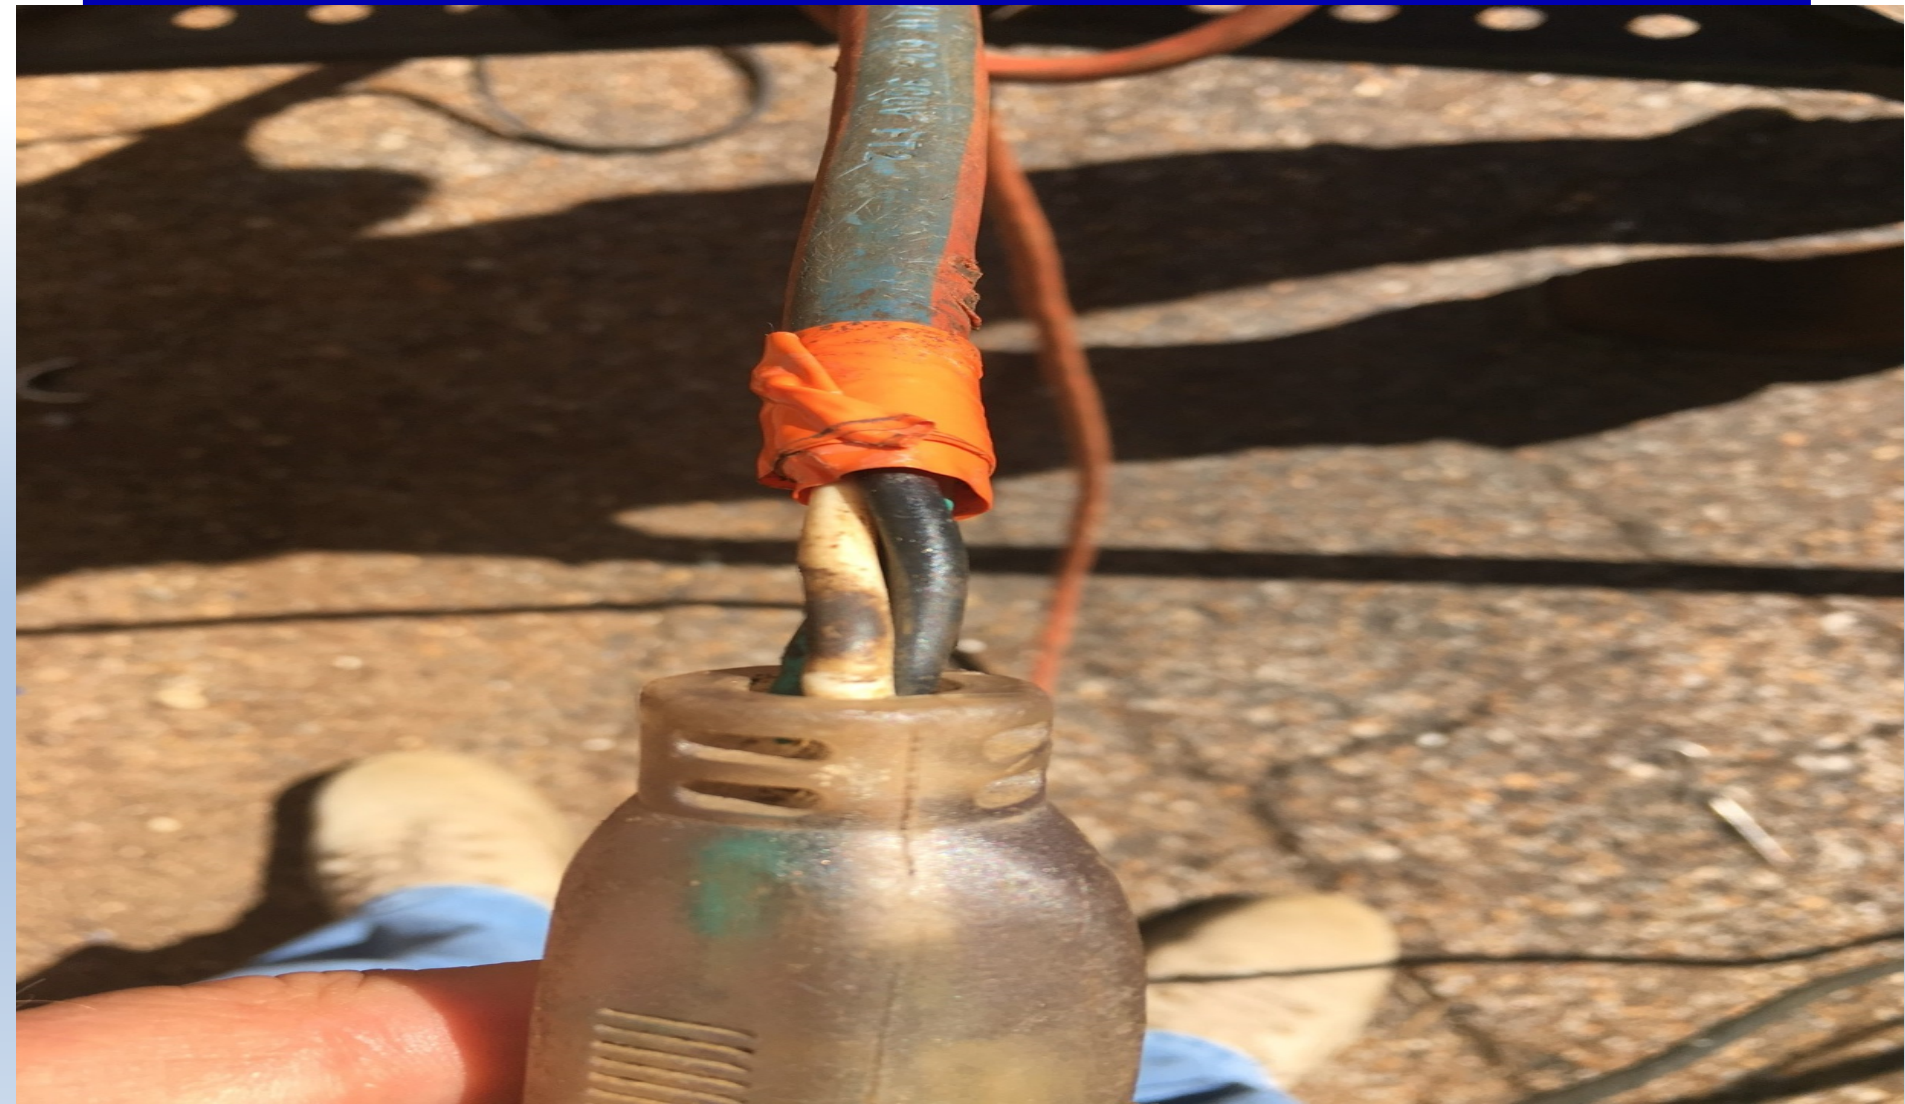
Construction Safety Findings:

- **STE Phase 1:** Contractor was observed using an extension cord with visible strain relief damage. The current month's inspection tape was concealing the exposed wires. Ref: 29CFR1926.405 (g) (2) (IV). The cord was immediately taken out of service. SHEtrak Closed. ID# 82886
