# Construction Safety

SSC Construction Inspection  
Safety Findings/Stats

November 2016

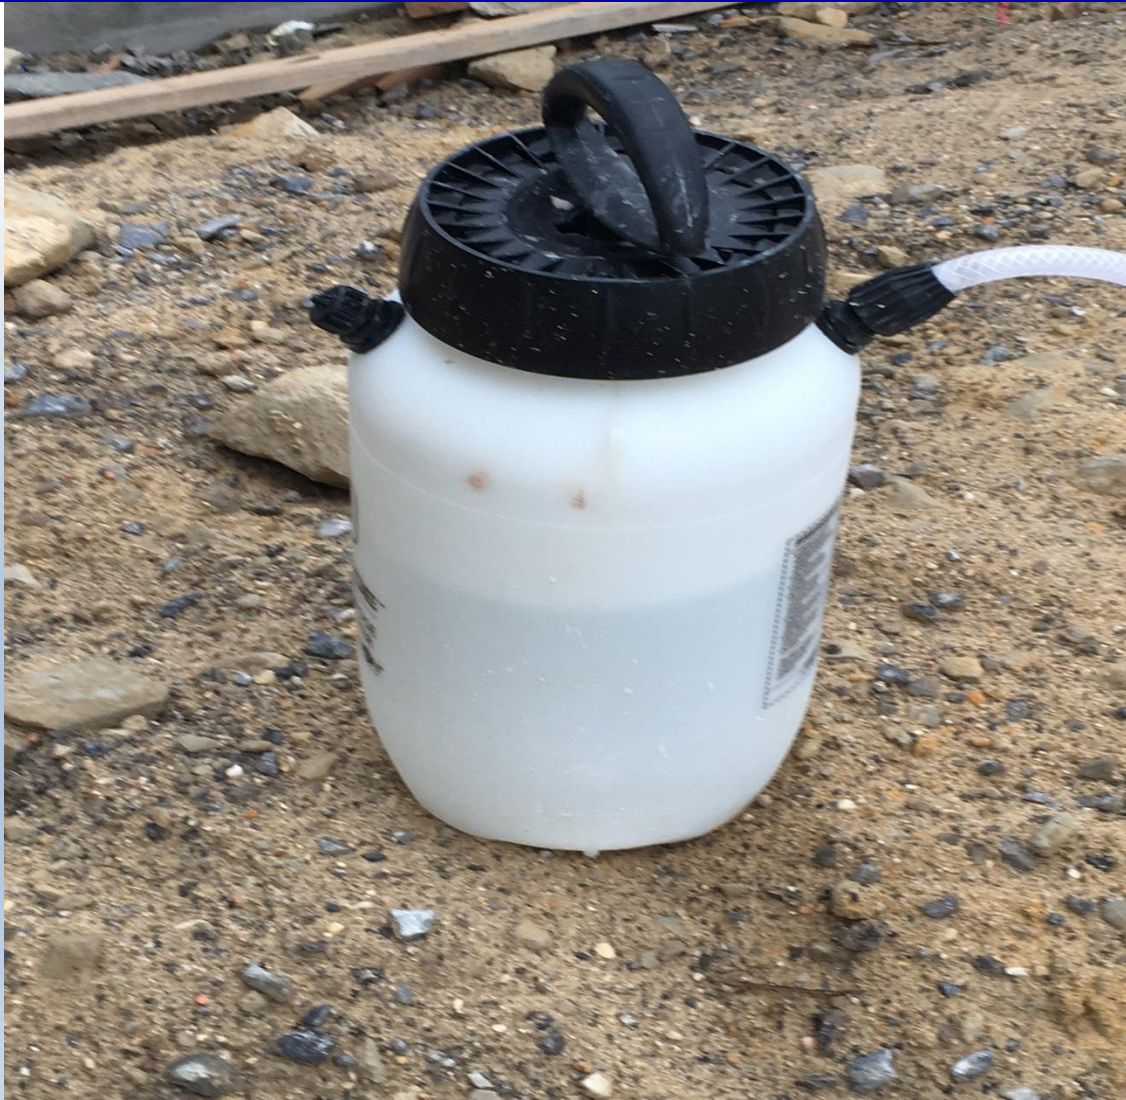
# Construction Safety Findings: 07 – 12 November 2016

- **B2 Tarmac** – Contractor failed to label pump sprayer container as required. All chemical containers (Including small transfer containers for an employee's own immediate use) shall be labeled or tagged. Ref: SCWI-1800-0005 5.5

- **B2 Tarmac**- Contractor failed to properly extinguish and dispose of a lit cigarette, creating a small grass fire. Ref: SCWI-

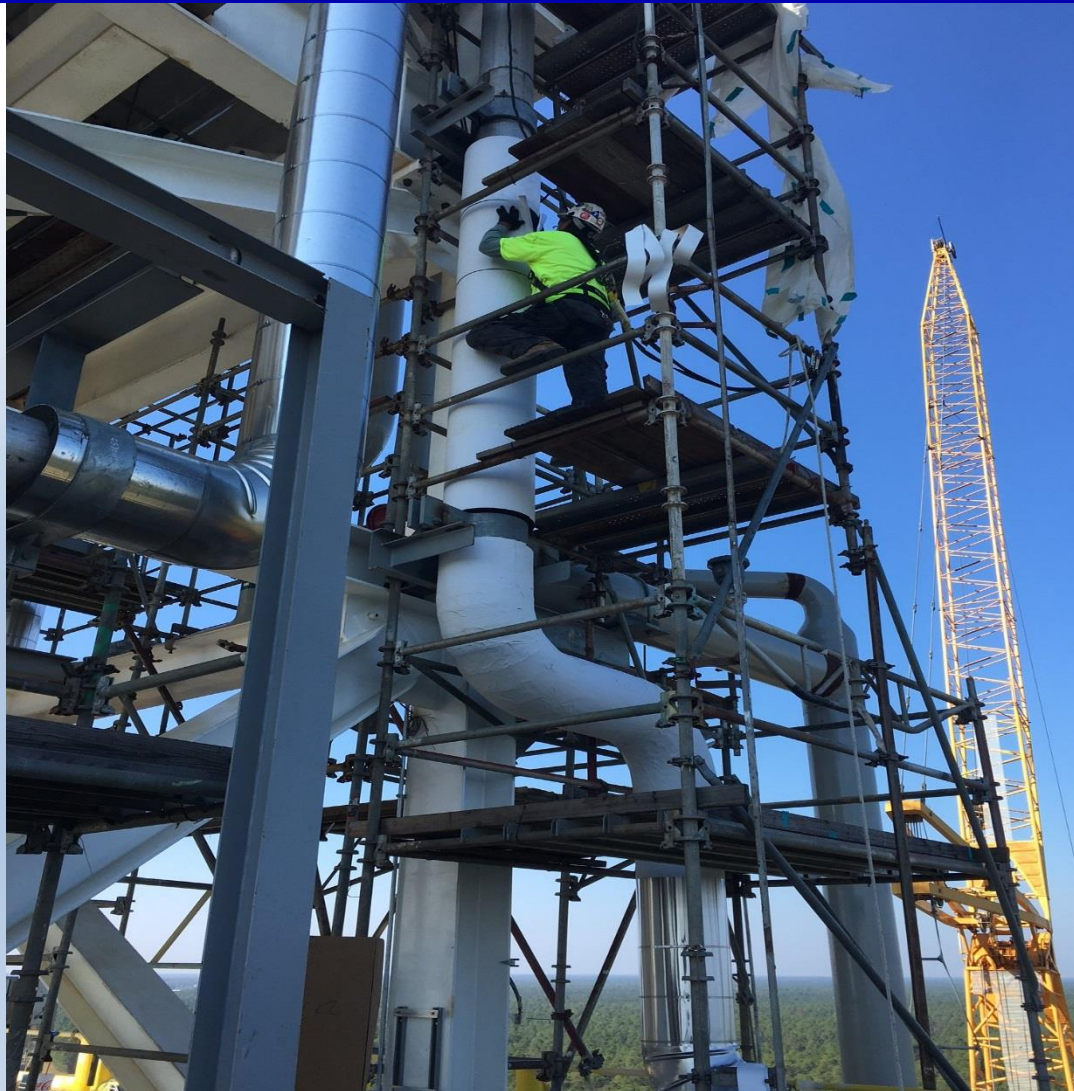
# Construction Safety Findings: 14 – 19 November 2016

- **B2 WP3** – Contractor utilizing scaffold without having the required inspection or tag prior to use. Reference: SCWI8715-0001 Paragraph 3.16 Item a

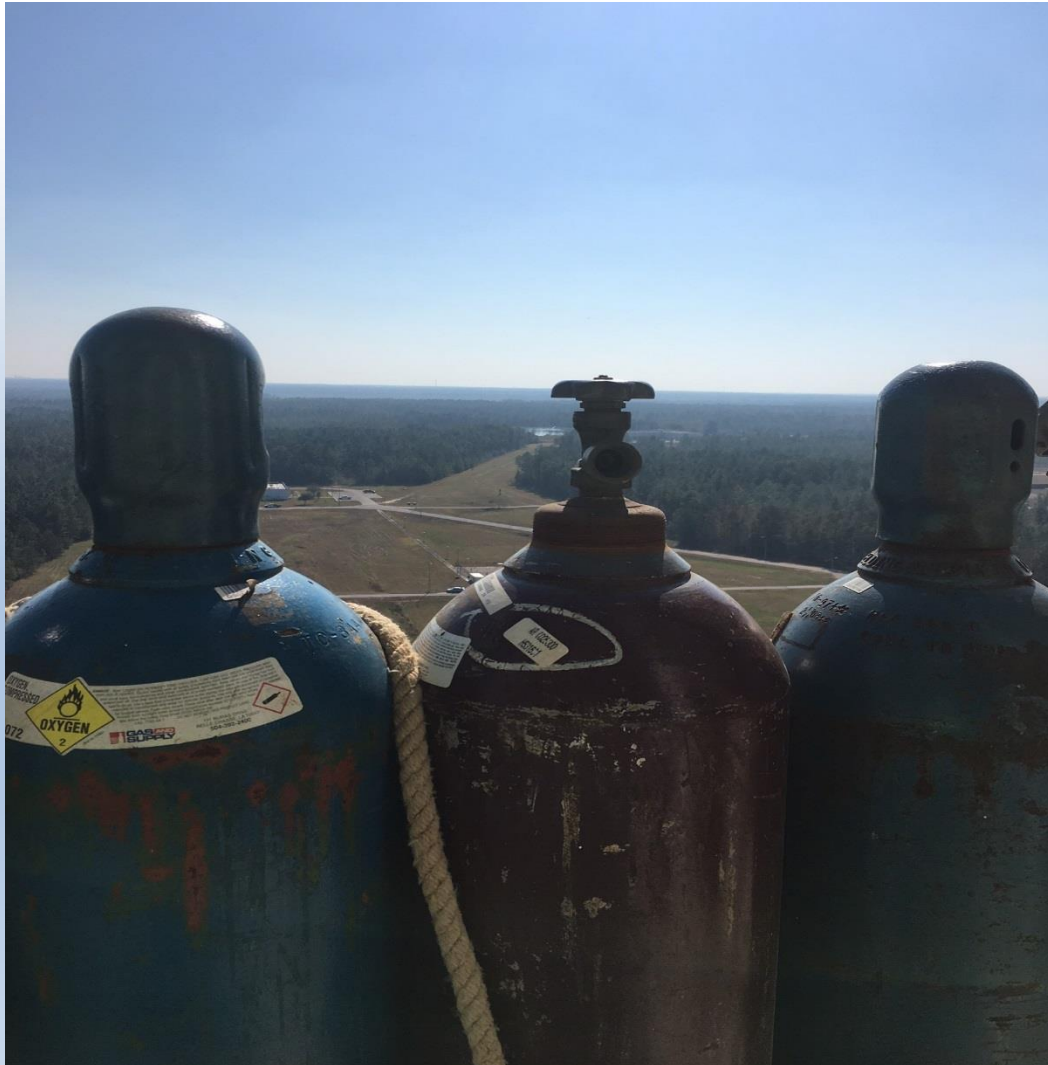
# Construction Safety Findings: 14 – 19 November 2016

- **B2 WP3** – Stored unused oxygen cylinder without required protective valve cap  
Ref: 29CFR1910.253 (b) (2) (iv)
- **B2 WP3** – Extension cord plug connection with visible evidence of strain relief  
Ref: 29CFR1910.334 (a) (2) (ii)

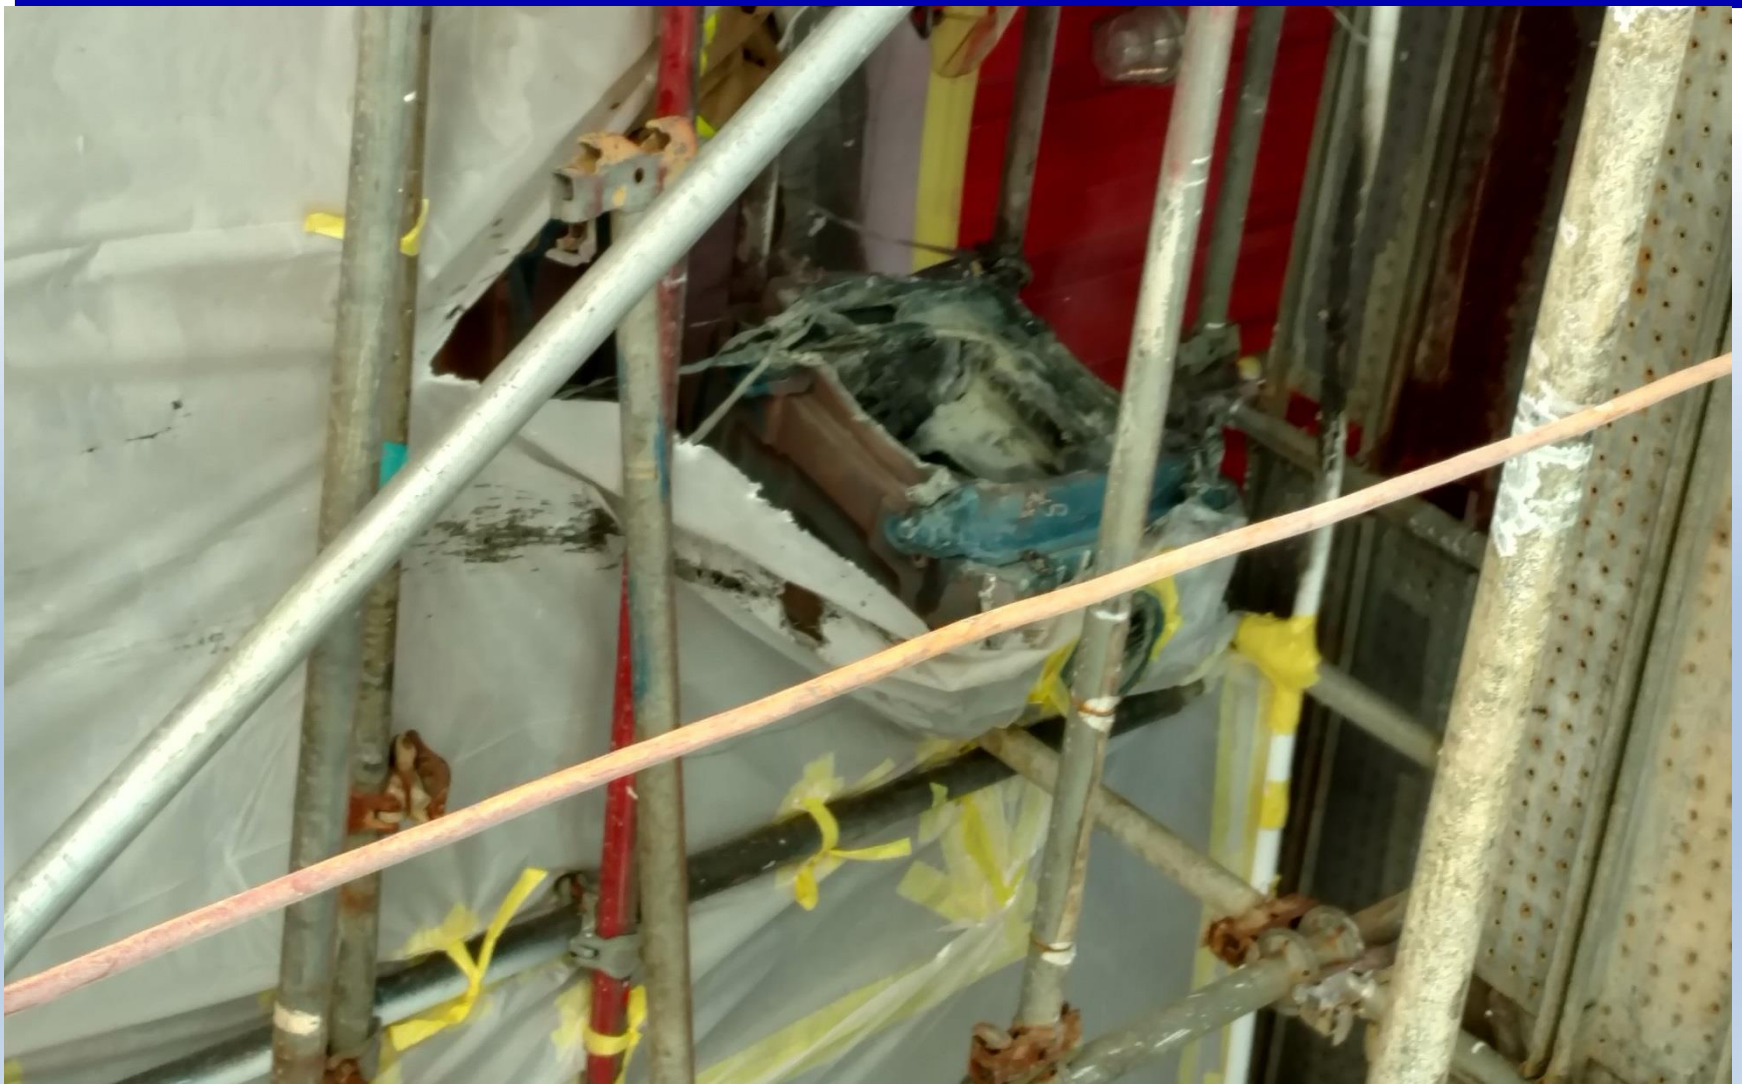
# Construction Safety Findings: 14– 19 November 2016

- **B2 WP3**- On Saturday November 19<sup>th</sup> at approximately 11:05 am, the abatement contractor was using a sanding disc on a grinder in the containment on level 16. Metal slag caught the negative air machine and a small area of the plastic containment on fire. A fire extinguisher was used to quickly put out the fires. The fire department was called and declared the area fire safe. No test stand damages or employee injuries. This incident was entered into NMIS and an incident report is being generated.

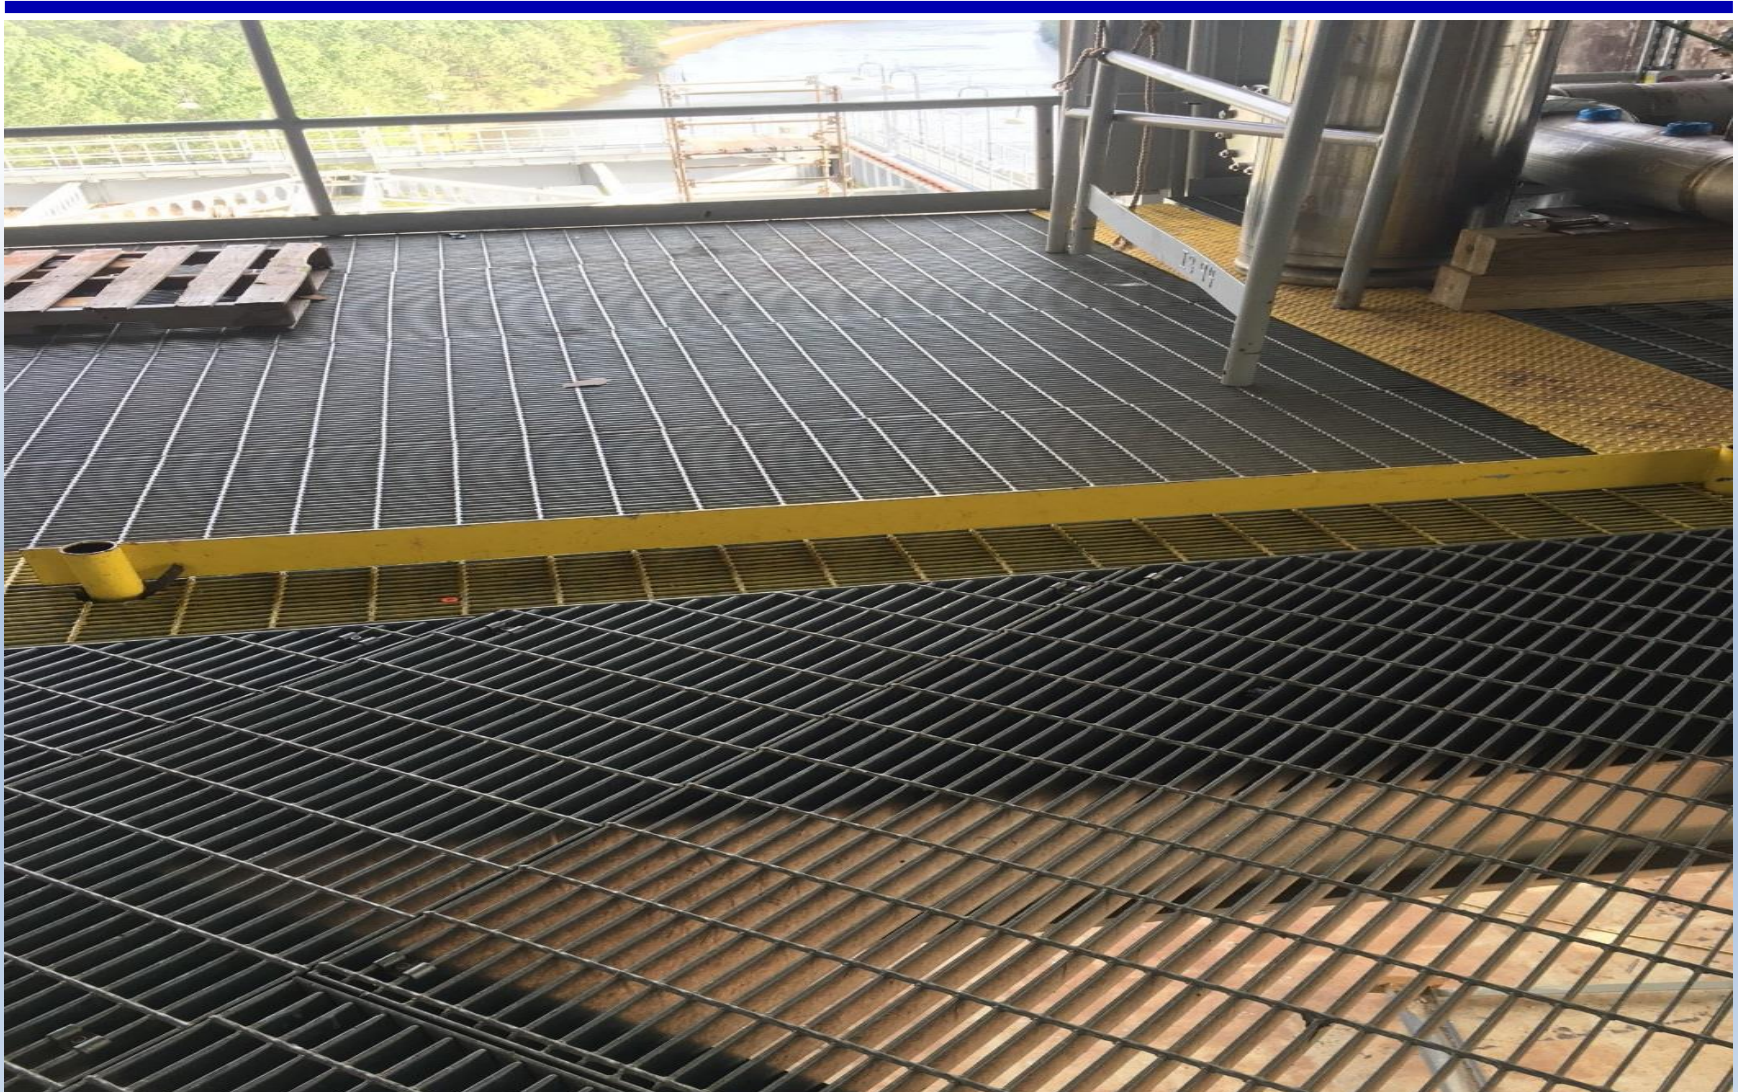
# Construction Safety Findings: 21– 26 November 2016

- **B2 WP3**- A contractor was unloading a full argon cylinder from a pallet on level 8. The cylinder was not in full grasp and therefore accidentally fell to the grating. The employee stepped backwards to remove the cylinder and tripped over a removable toe board (In yellow). He lightly bumped his head and glasses on the grating, as a result, his safety glasses right side shield caused a minor abrasion to his temple. First-aid not required.
