STOP USE AND INSPECTION NOTICE

Specific 3M™ DBI-SALA® Nano-Lok™ Self Retracting Lifeline with Anchor Hook

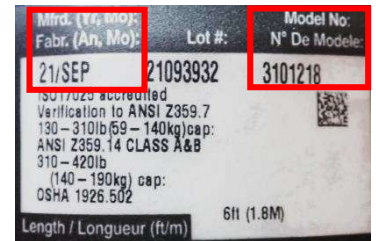
Step 2: Locate the label on the device (see photograph to right) to determine the model number and if it was manufactured between September 1, 2020 and August 31, 2021. If the device is an impacted model and was manufactured during the affected date range, please continue to Step 3.

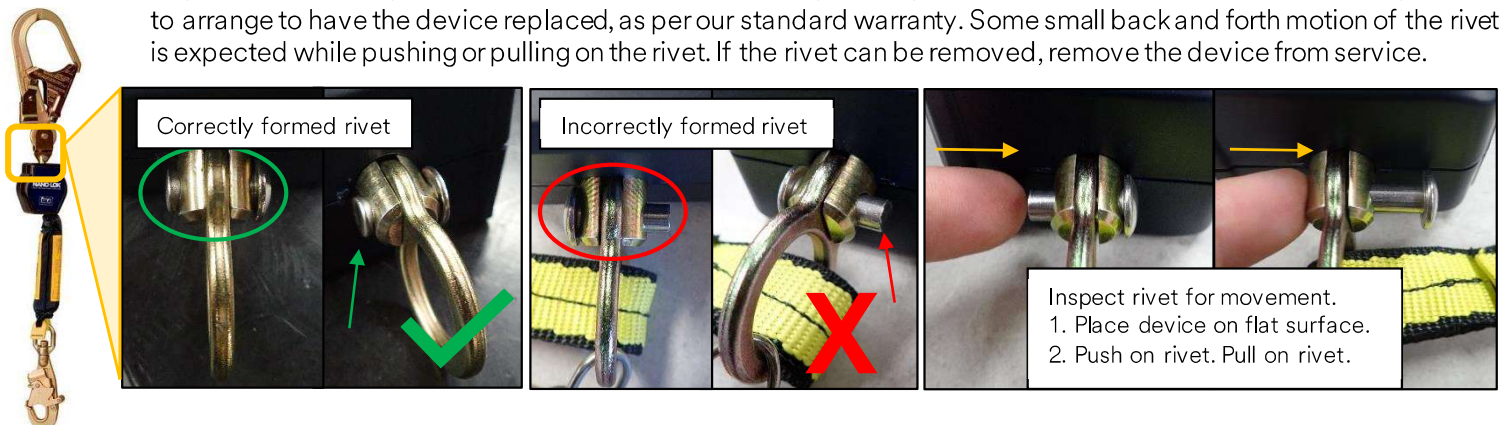
Step 3: Once you have confirmed the part number & affected date, inspect the connection from the self retracting lifeline top swivel eye to the anchor hook to ensure the rivet is properly formed, as shown in the images below. If the device passes the inspection, it is acceptable for use. If the device does not pass inspection, contact our Customer Service Department to arrange to have the device replaced, as per our standard warranty. Some small back and forth motion of the rivet is expected while pushing or pulling on the rivet. If the rivet can be removed, remove the device from service.
