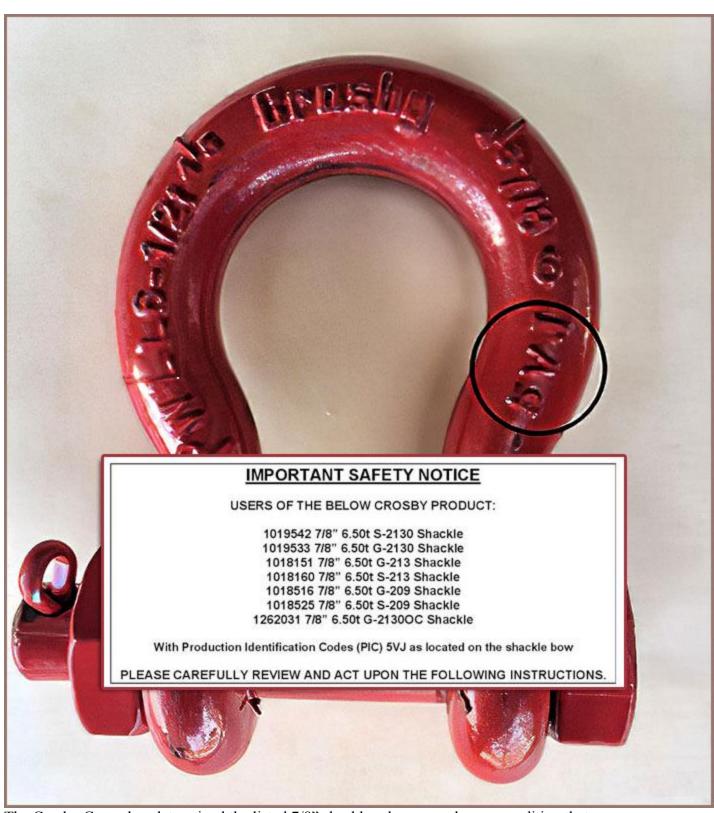
The Crosby Group has determined the listed 7/8" shackles above may have a condition that can reduce the ultimate load capacity from the published catalog values. The shackle bow may have

a previously undetected defect, and continued use may result in loss of load, property damage, severe injury, or death.

By use of the production identification code (PIC) symbols appearing on the product, Crosby has determined that the 7/8" 6.5t shackles with PIC 5VJ shown on the bow may have this condition.

They are requesting that industry personnel identify all such shackles, remove them from service, and arrange for return and replacement by contacting their Crosby distributor. For more information concerning the safety notice, contact technical support at 800-772-1500.
